**MEMORANDUM**

DATE: 20 August 2005 Proj No. P52-7207  
TO: File  
FROM: Nathan Schmidt  
RE: Hardisty Creek Post-Flood Inspection Notes – 15 July 2005

**Photo Survey and Notes – 15 July 2005**

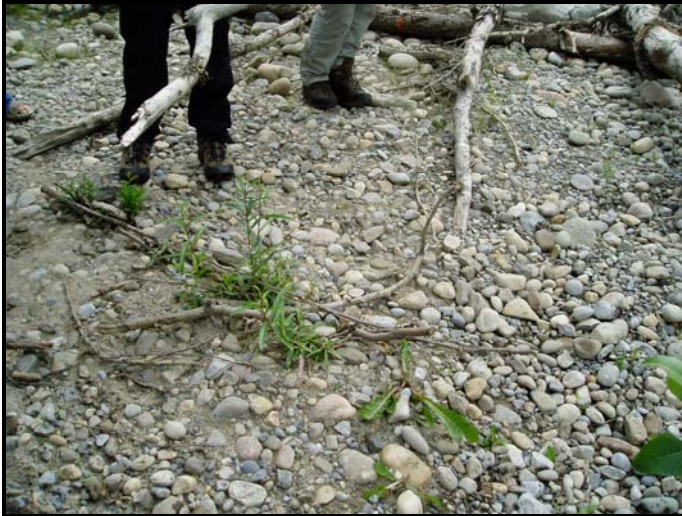
Live staking appeared to have been successful, with buds and small branches observed emerging from stakes during the site inspection (see photos 1, 4, 20, 25 and 30).

**Photo: 1**  
**Location:** Below Riffle 9 on RDB  
**View:** Upstream  
**Description:** Successful live stakings

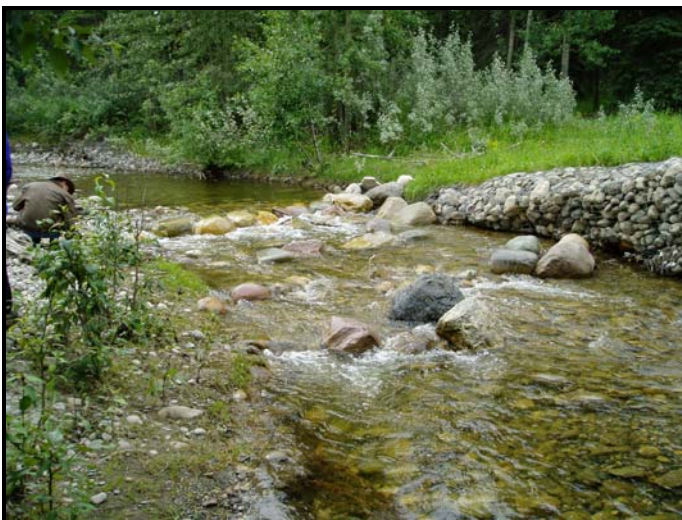
Boulder clusters (3 to 5 boulders) were installed at various locations in the channel to enhance fish habitat (see photos 2, 5, 6, 11, 19, 23 and 31). These clusters appear to have been stable during the recent flooding.

**Photo: 2**  
**Location:** Below Riffle 9  
**View:** Upstream  
**Description:** Riffle 9 in background  
and boulder clusters below riffle

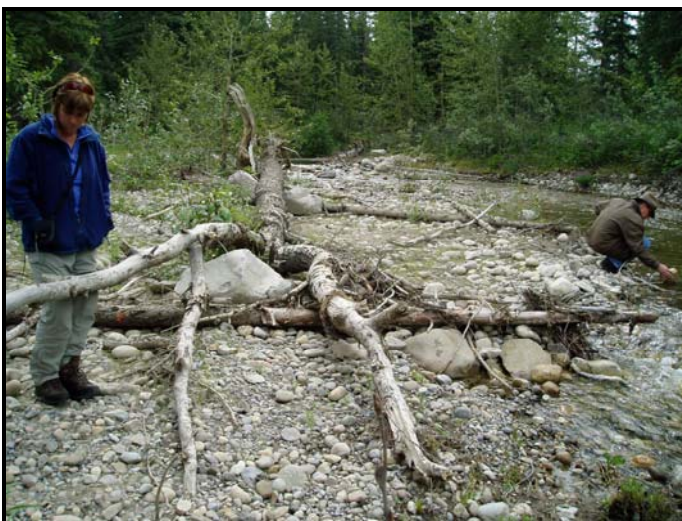
**Photo: 3**  
**Location:** At Riffle 9 on RDB  
**View:** Upstream  
**Description:** LWD anchored to bed

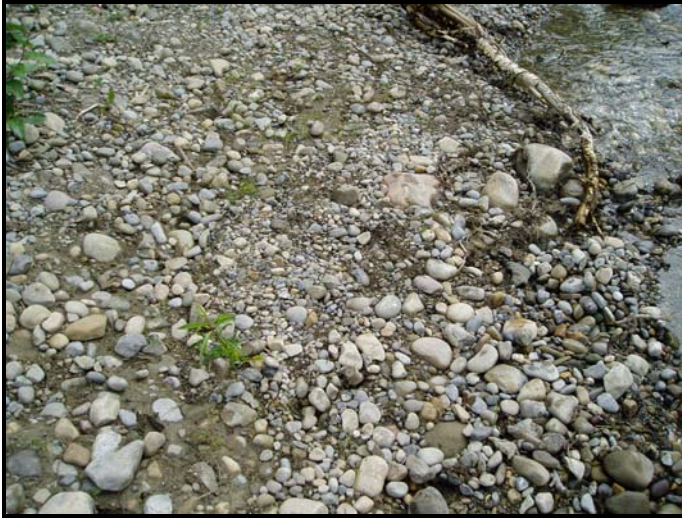
**Photo: 4**  
**Location:** Above Riffle 9 on RDB  
**View:** Upstream  
**Description:** Successful live stakings

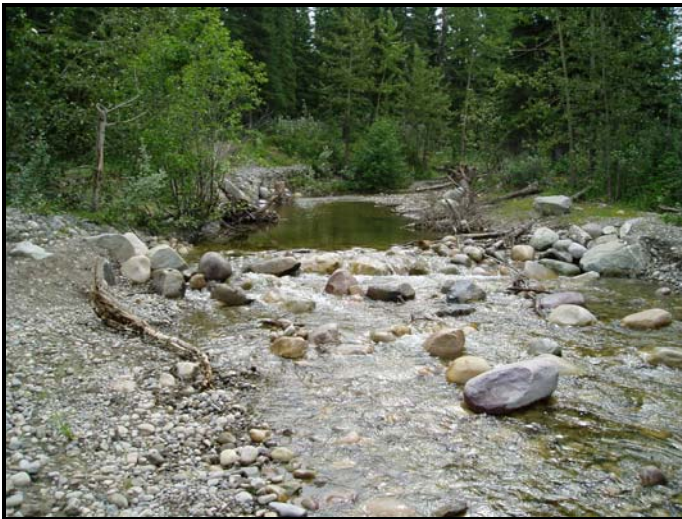
**Photo: 5**  
**Location:** Below Riffle 8  
**View:** Upstream  
**Description:** Riffle 8 in background  
with boulder clusters below riffle

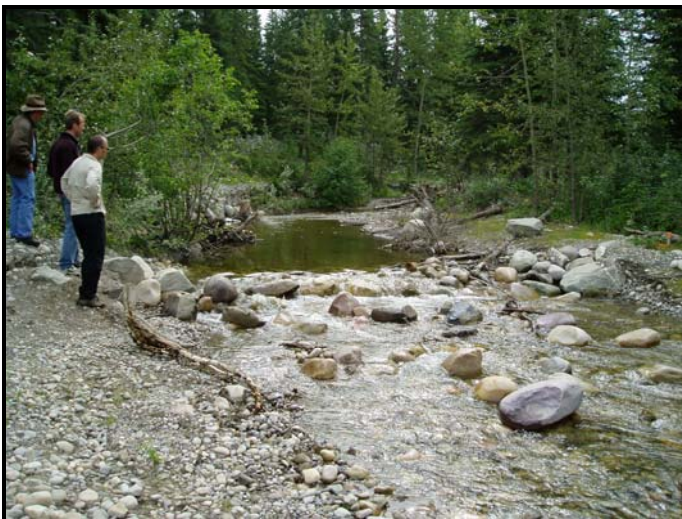
**Photo: 6**  
**Location:** Below Riffle 8  
**View:** Upstream  
**Description:** Riffle 8 in background

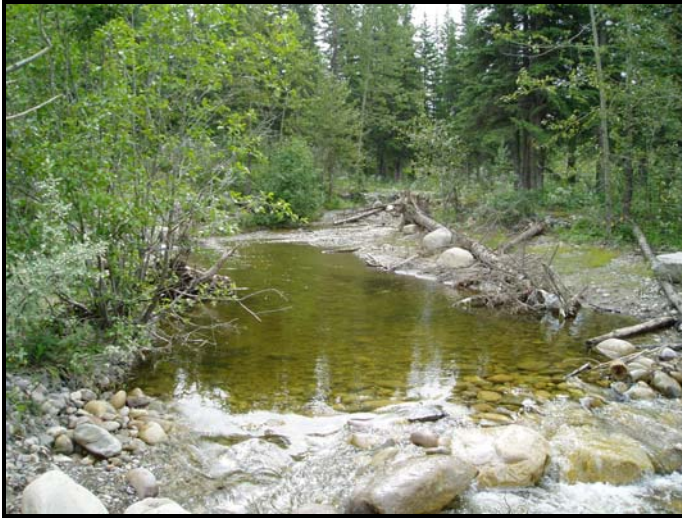
**Photo: 7**  
**Location:** At Riffle 8  
**View:** Upstream  
**Description:** Pool above Riffle 8

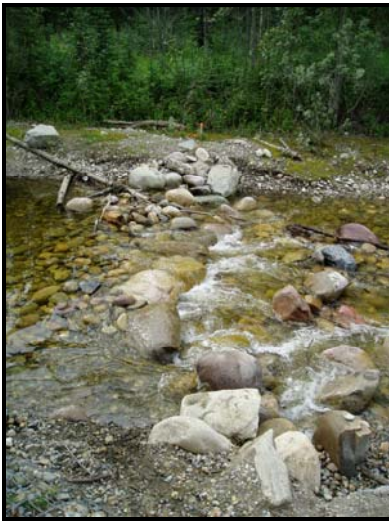
1. 250 minus material placed downstream of riffle boulders was washed downstream, creating a situation where flow spills over the riffle boulders, rather than flowing downstream at a 5% slope. This provides less effective fish passage;
2. In several locations (in particular, at Riffles 2 and 8), several riffle boulders have moved downstream. While this does not currently affect upstream pools, stability of the riffle during future flood events is in question.

**Photo: 8**  
**Location:** At Riffle 8  
**View:** From RDB  
**Description:** Riffle 8

The recommended remediation for at riffles where material has been lost from the downstream face is to place larger material (small boulder and large gravel, with some smaller fractions) on the downstream face of the riffle.

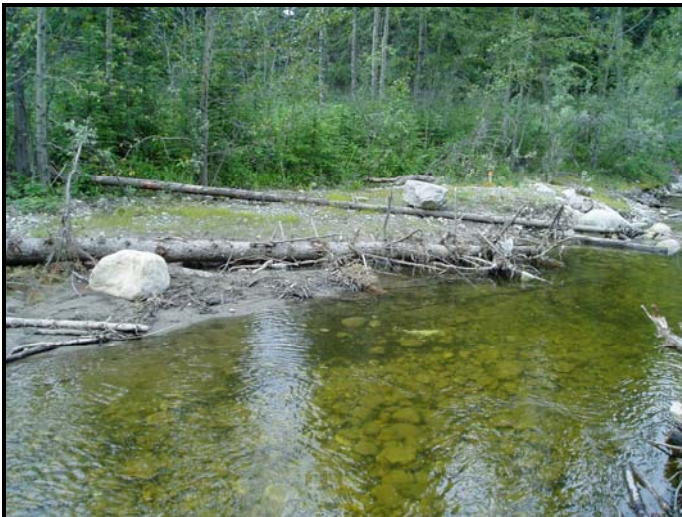
**Photo: 9**  
**Location:** Above Riffle 8  
**View:** From LDB  
**Description:** LWD anchored to bed on RDB, note sediment deposition at upstream end

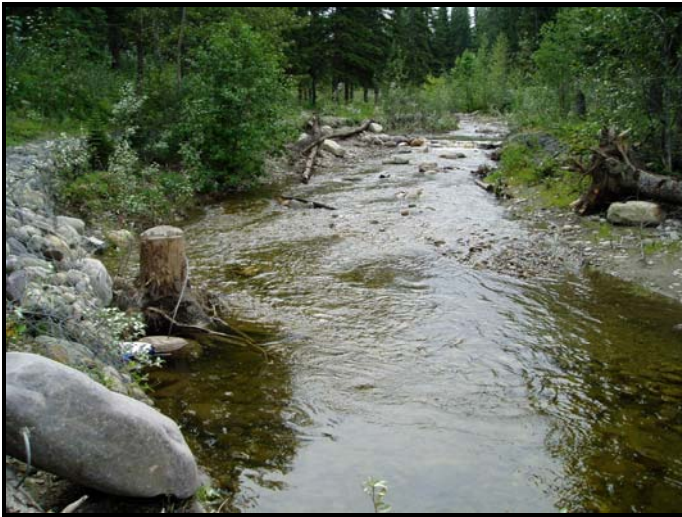
**Photo: 10**  
**Location:** Above Riffle 8  
**View:** Upstream  
**Description:** LWD (root wad)  
anchored to RDB above Riffle 8

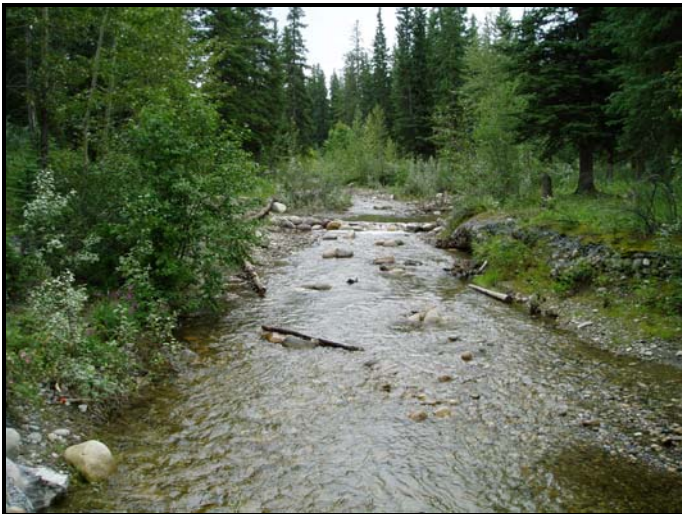
**Photo: 11**  
**Location:** Above Riffle 8  
**View:** Upstream  
**Description:** Boulder clusters  
between Riffle 7 and Riffle 8

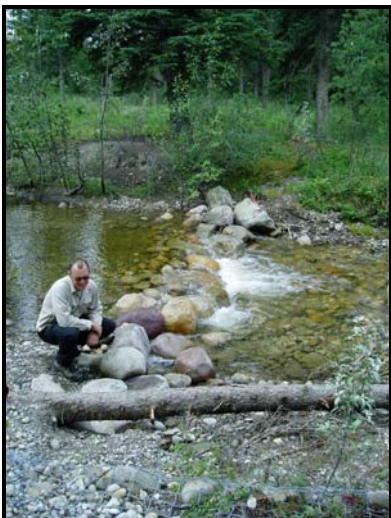
**Photo: 12**  
**Location:** At Riffle 7  
**View:** From LDB  
**Description:** Riffle 7

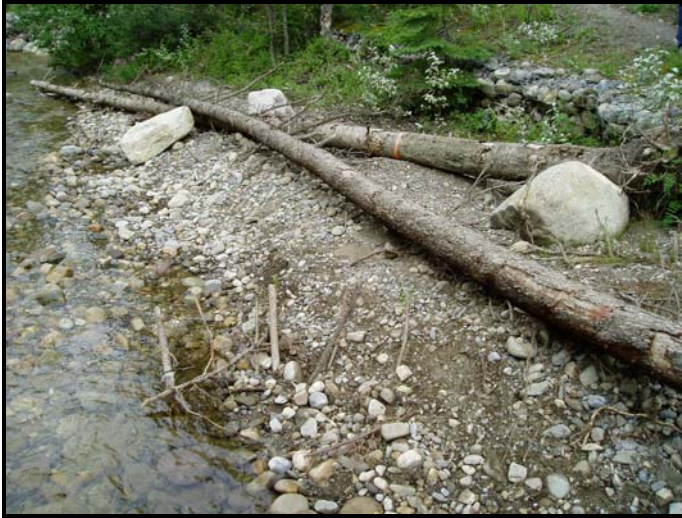
**Photo:** 13  
**Location:** Above Riffle 7  
**View:** Downstream from RDB  
**Description:** LWD anchored to bed on RDB

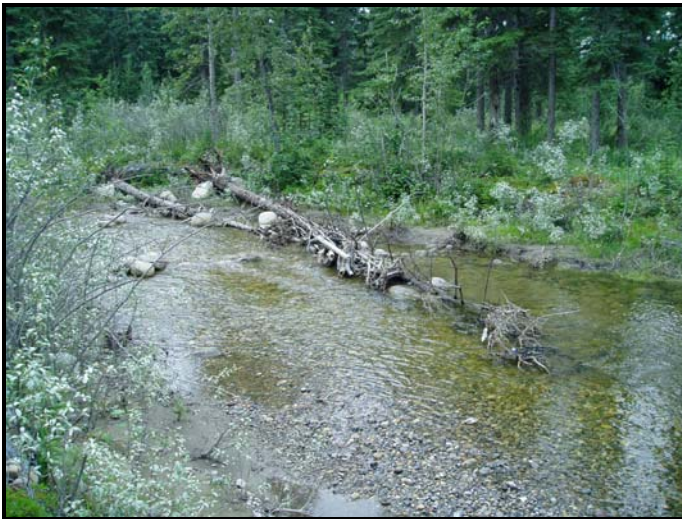
**Photo:** 14  
**Location:** Above Riffle 7  
**View:** Upstream from RDB  
**Description:** LWD anchored to bed on LDB

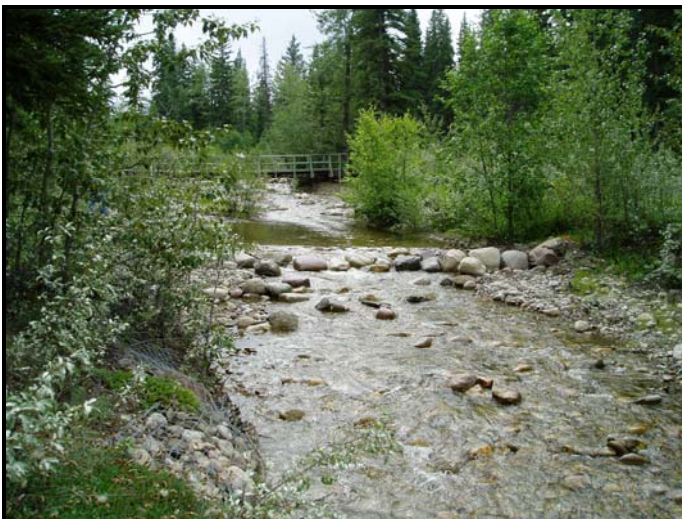
**Photo:** 15  
**Location:** Below Riffle 6  
**View:** Upstream  
**Description:** Riffle 6 and run below riffle

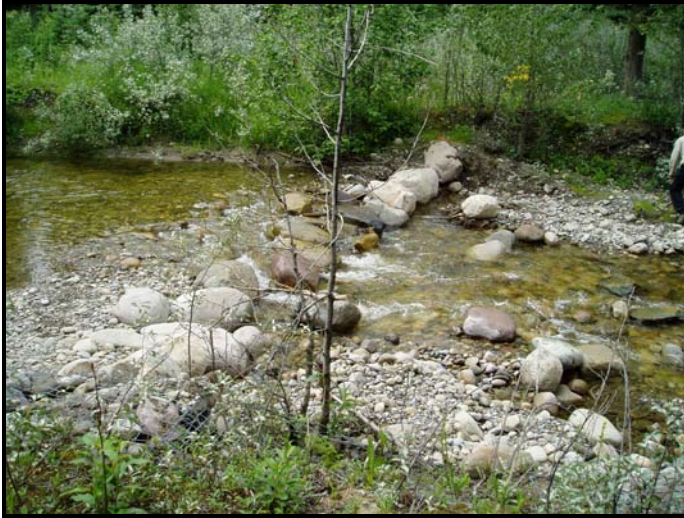
**Photo: 16**  
**Location:** At Riffle 6  
**View:** From RDB  
**Description:** Riffle 6

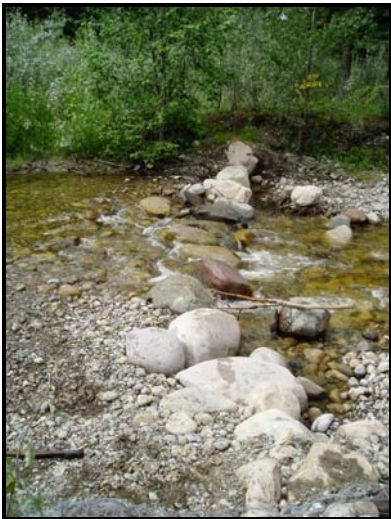
**Photo: 17**  
**Location:** At Riffle 6  
**View:** From RDB  
**Description:** Riffle 6

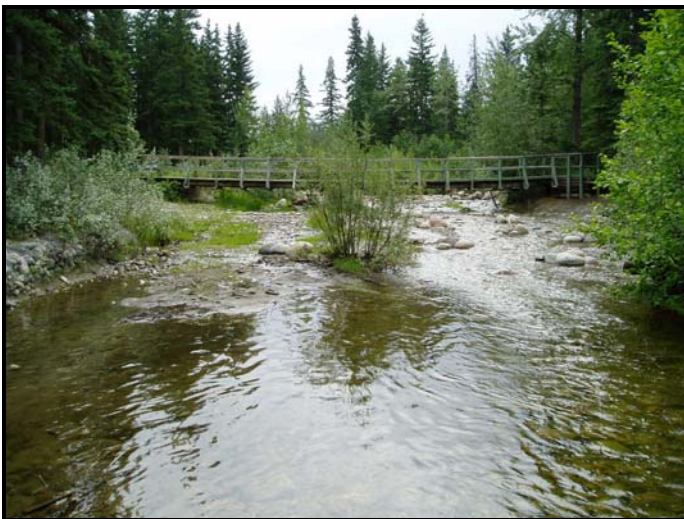
**Photo: 18**  
**Location:** Above Riffle 6  
**View:** Upstream  
**Description:** Pool above Riffle 6

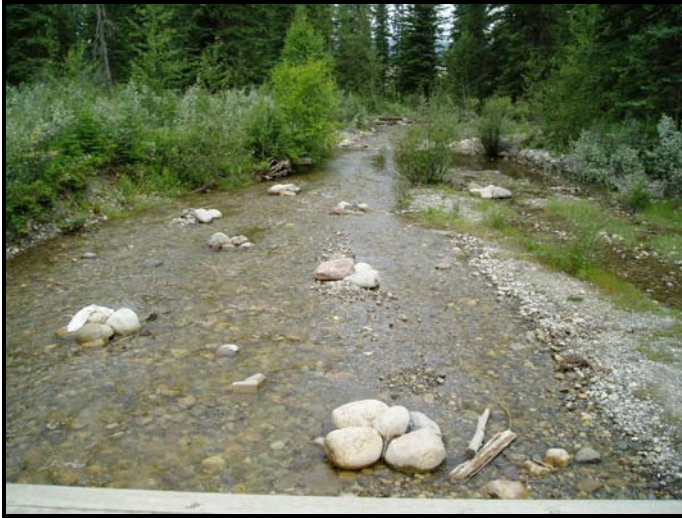
**Photo: 19**  
**Location:** Below Riffle 5  
**View:** Downstream  
**Description:** Boulder clusters  
between Riffles 5 and 6

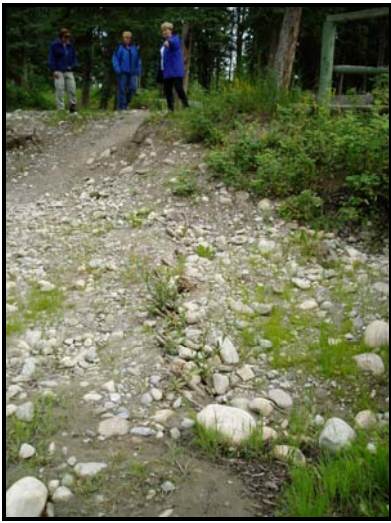
**Photo: 20**  
**Location:** Below Riffle 5 on RDB  
**View:** Towards RDB  
**Description:** Successful live staking  
on RDB

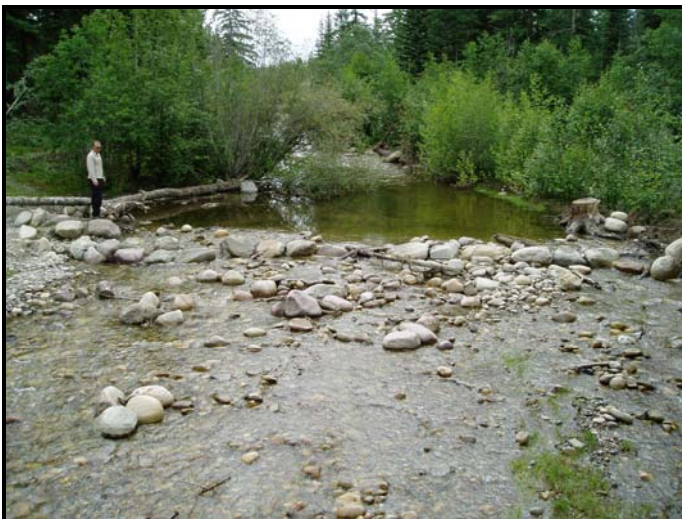
**Photo: 21**  
**Location:** Just below Riffle 5  
**View:** Upstream  
**Description:** Riffle 5

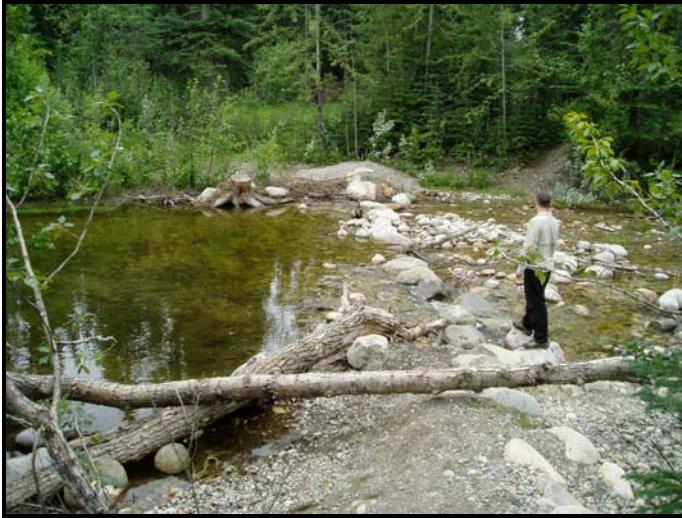
**Photo:** 22  
**Location:** At Riffle 5  
**View:** From RDB  
**Description:** Riffle 5

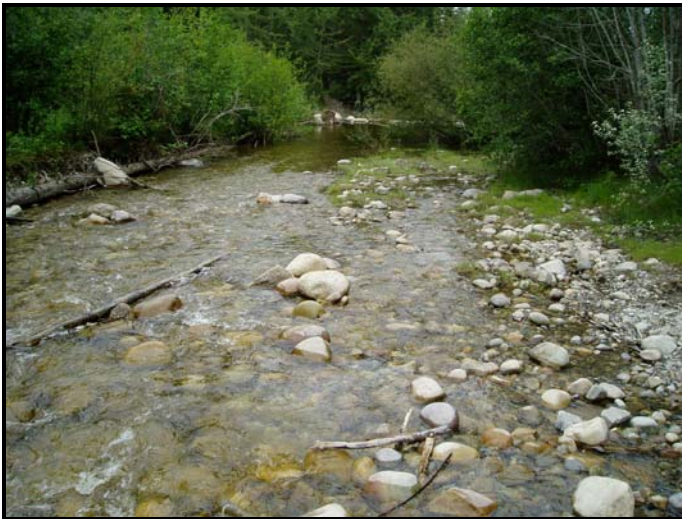
**Photo:** 23  
**Location:** Below Riffle 4  
**View:** Downstream  
**Description:** Boulder clusters below Riffle 4

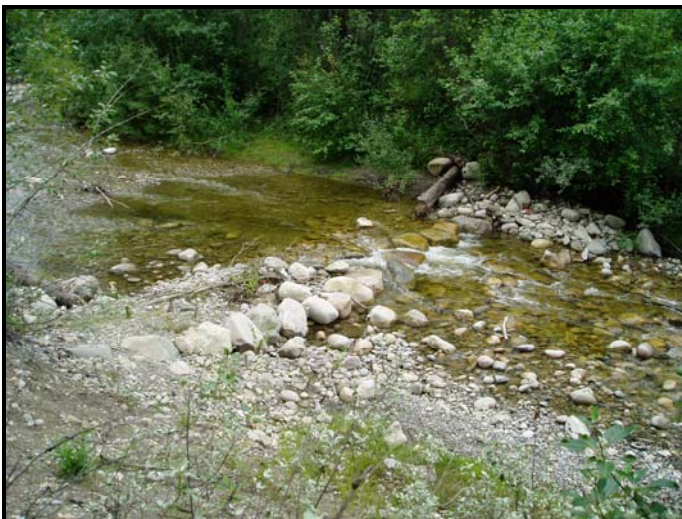
**Photo:** 24  
**Location:** At Riffle 4  
**View:** From RDB  
**Description:** Riffle 4

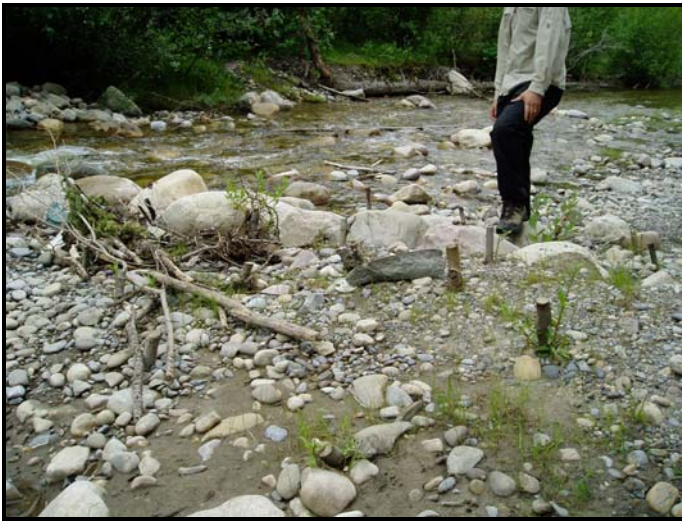
**Photo:** 25  
**Location:** At Riffle 4  
**View:** Downstream from RDB  
**Description:** Live staking at root of Riffle 4

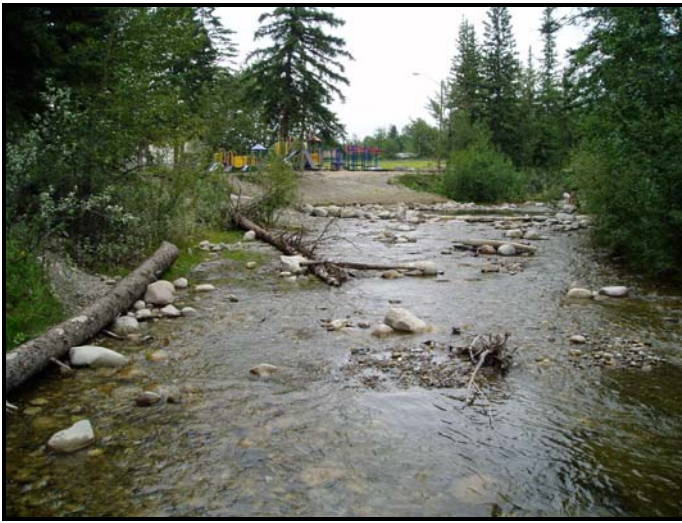
**Photo:** 26  
**Location:** Above Riffle 4  
**View:** Upstream  
**Description:** Channel above Riffle 4

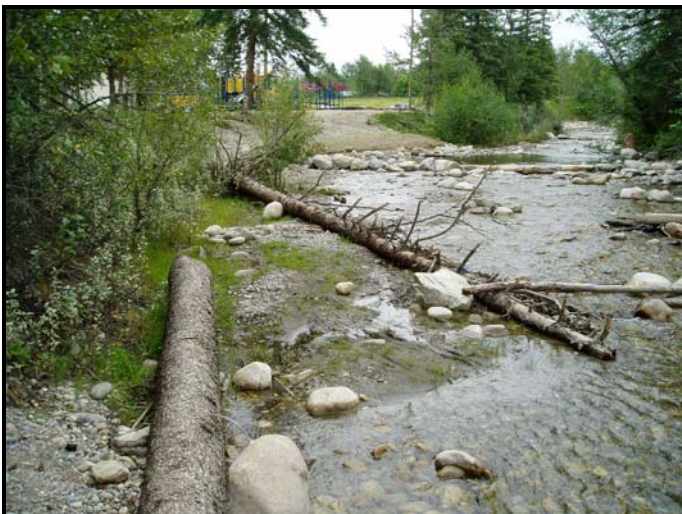
**Photo:** 27  
**Location:** Above Riffle 4  
**View:** Upstream  
**Description:** LWD anchored to bed on RDB above Riffle 4

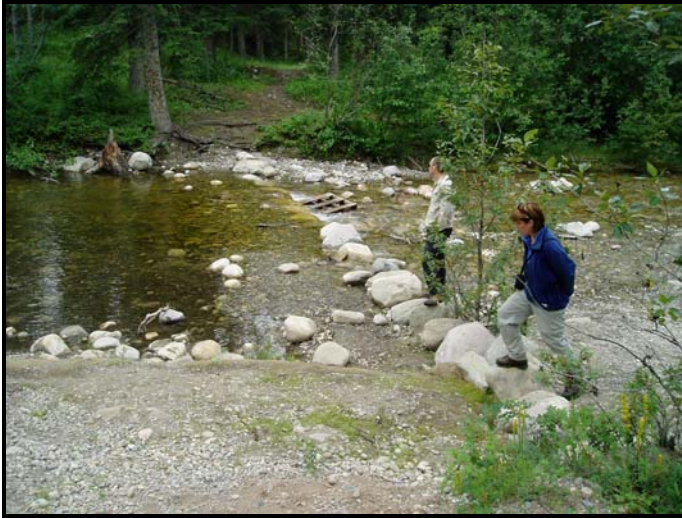
**Photo:** 28  
**Location:** At Riffle 3  
**View:** From RDB  
**Description:** Riffle 3, note reconstructed bank on RDB upstream

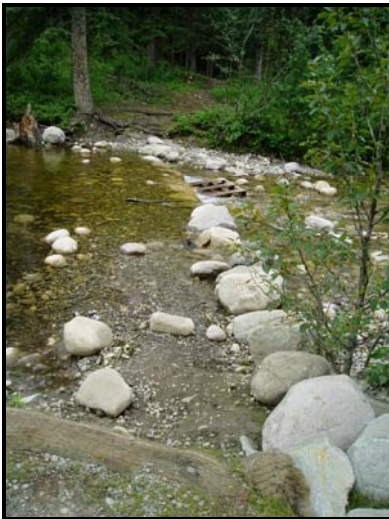
**Photo:** 29  
**Location:** At Riffle 3  
**View:** From RDB  
**Description:** Riffle 3, note reconstructed bank on RDB upstream

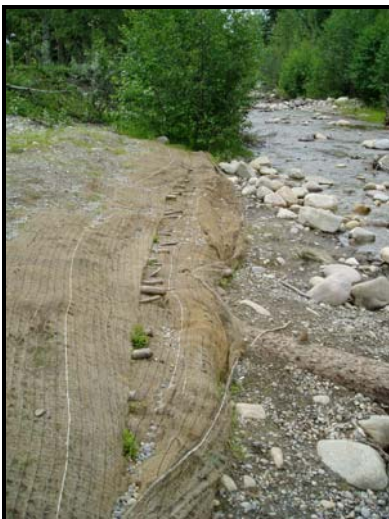
**Photo:** 30  
**Location:** Above Riffle 3  
**View:** Upstream  
**Description:** Reconstructed bank on RDB, note successful live stakings

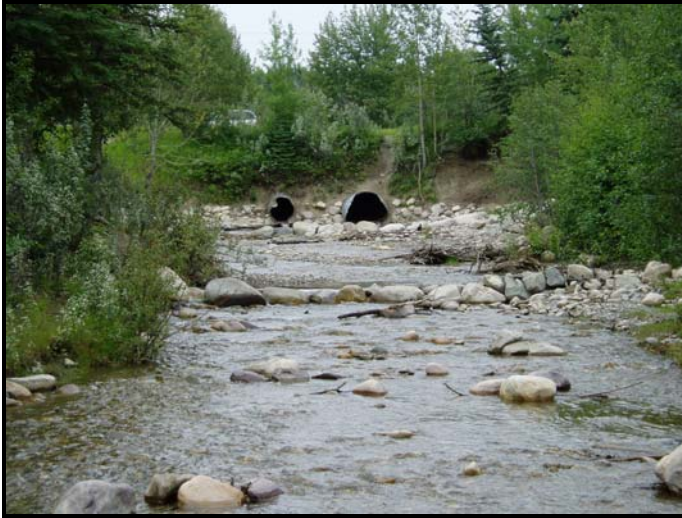
**Photo:** 31  
**Location:** Below Riffle 2  
**View:** Upstream  
**Description:** Riffle 2 and  
downstream boulder clusters

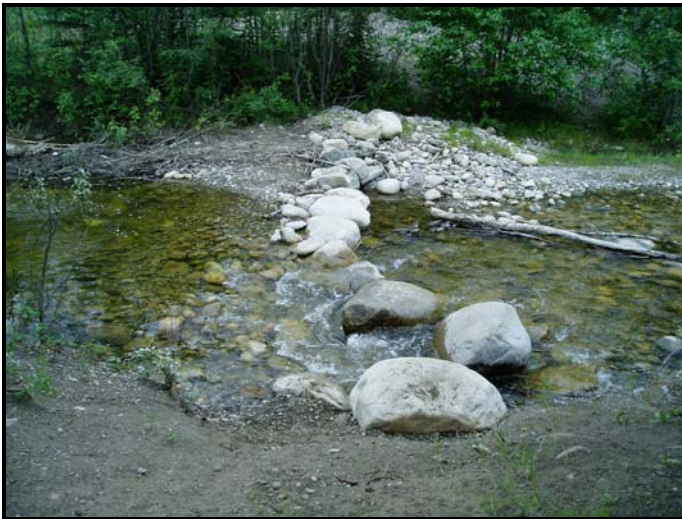
**Photo:** 32  
**Location:** Riffle 2  
**View:** From RDB  
**Description:** Riffle 2

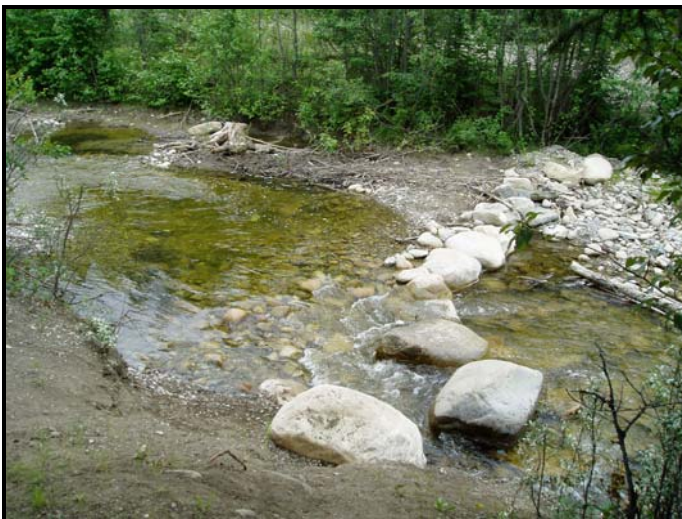
**Photo:** 33  
**Location:** Riffle 2  
**View:** From RDB  
**Description:** Riffle 2

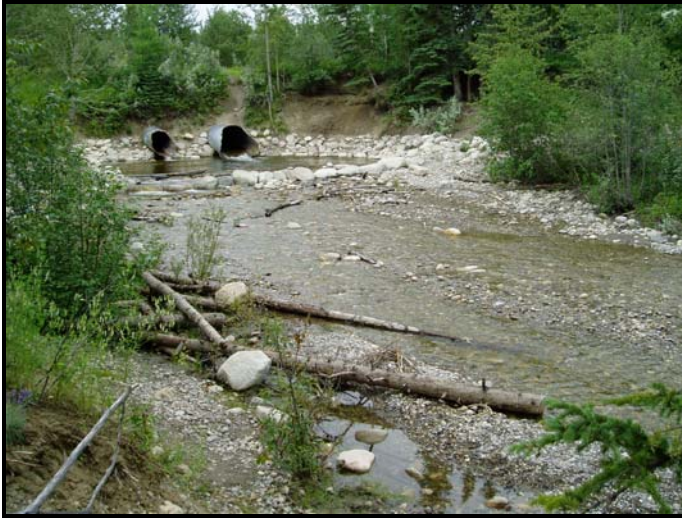
**Photo:** 34  
**Location:** Below Riffle 1  
**View:** Upstream  
**Description:** LWD anchored to RDB below Riffle 1

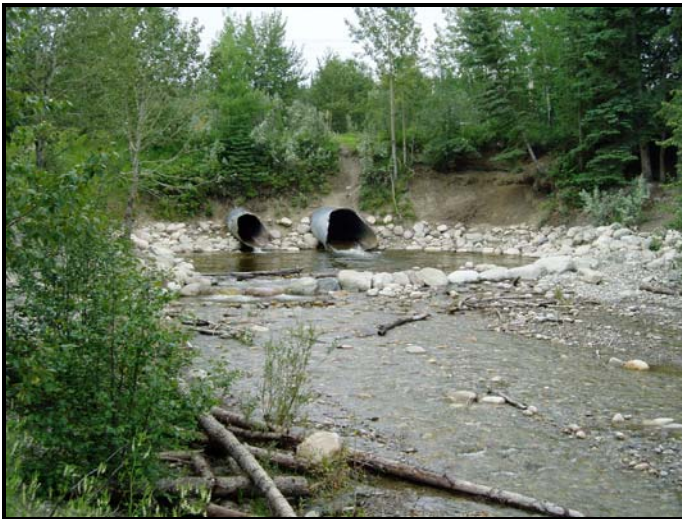
**Photo:** 35  
**Location:** Below Riffle 1  
**View:** Upstream  
**Description:** Riffle 1 and downstream run

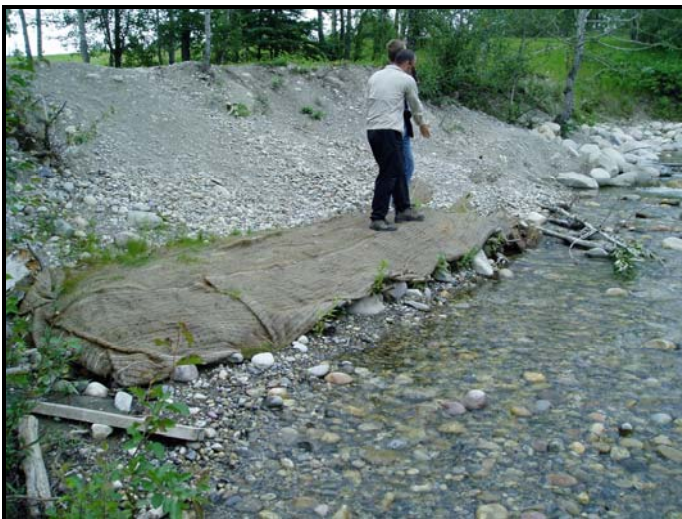
**Photo:** 36  
**Location:** Below Riffle 1  
**View:** Upstream  
**Description:** RDB bank treatment below Riffle 1

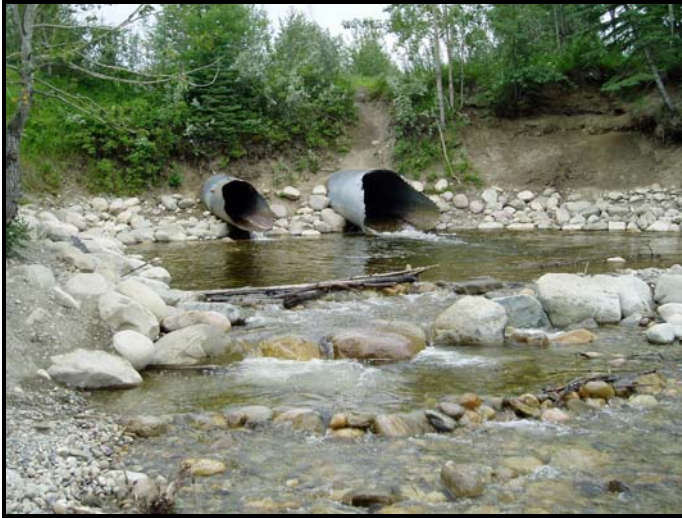
**Photo:** 37  
**Location:** Riffle 1  
**View:** Upstream  
**Description:** Riffle 1 and upstream pool

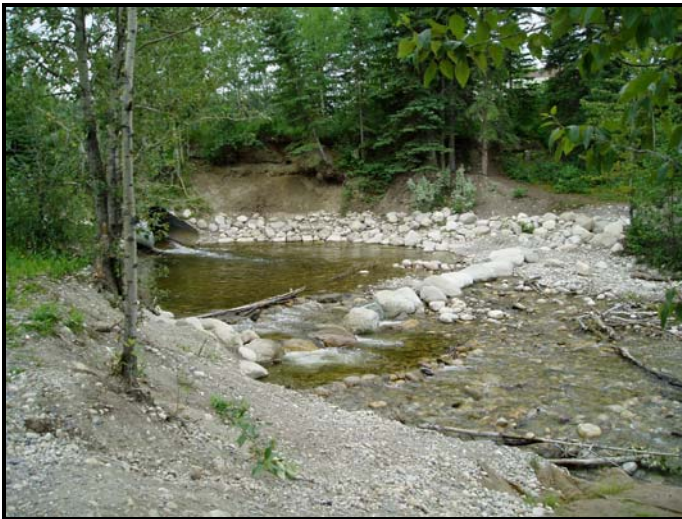
**Photo:** 38  
**Location:** Riffle 1  
**View:** From RDB  
**Description:** Riffle 1

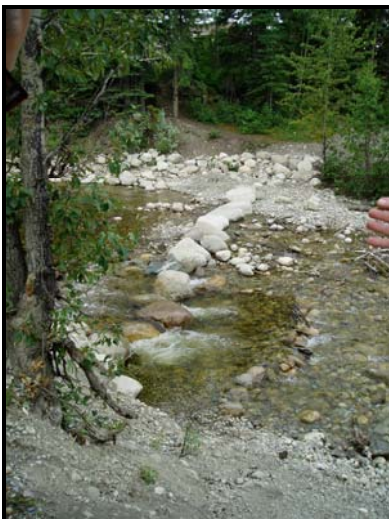
**Photo:** 39  
**Location:** Riffle 1  
**View:** From RDB  
**Description:** Riffle 1

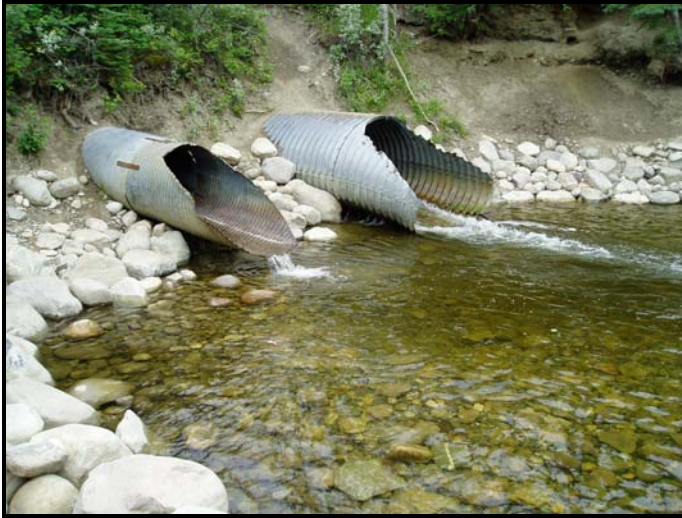
**Photo:** 40  
**Location:** At Hardisty Avenue  
**View:** From RDB  
**Description:** Hardisty Avenue  
culvert outlets

Given the preceding observations, it is also recommended that care be taken in construction of the upper riffle that is intended to backflood the Hardisty Avenue culverts. Consideration should be given to placement of impermeable geotextile in the upstream portion of the riffle, to prevent seepage through the riffle and piping losses of fined. Consideration should also be given to placement of larger diameter rock on the downstream face of Riffle 1 and placement of a large boulder elevation control between Riffle 1 and Riffle 2.
