The Resilient Forest: Looking beyond the stumps

A 35-Year Examination of the Forecasts and Assertions of a 1970s Environmental Campaign

The Foothills Model Forest Adaptive Forest Management/History Program Report #6 in the Adaptive Forest Management/History Series.

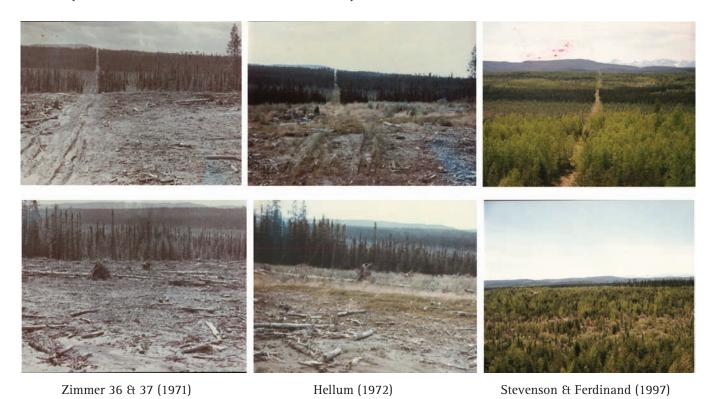
"On slide number 36 we have another viewing of the same area and here we can see the logging access road running through this area former cut line, I suppose, which had been utilized for logging and we also see that the area is washing out all over the place despite the fact this is apparently flat on the surface. Tremendous damage has been done on this particular area (Photo 36).

"The stumps have been either covered with silt or have been torn out by the scarification machinery, which one I cannot tell. However, the situation is very excessive. It appears to me it has been caused by over-use of earth disturbing machinery (Photo 37)."

"Photos 35, 36, and 37 taken along the same Loffland Rig Road as mentioned under 'logging to waters edge,' bear signs of seismic activity damage subsequent to logging and not before logging as Mr. Zimmer states. This area was cut in 1963/64 and disturbed by oil explorations reportedly as late as in 1970. This area was regeneration surveyed in 1969, after scarification in 1964 to give an average stocking of 72%, according to N.W.P. & P. records."

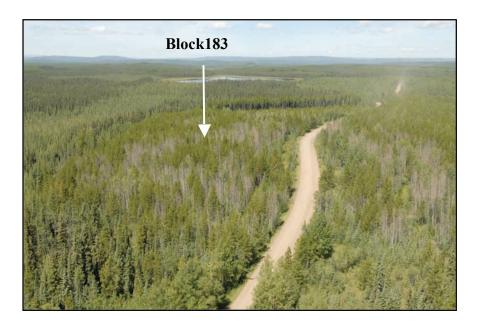
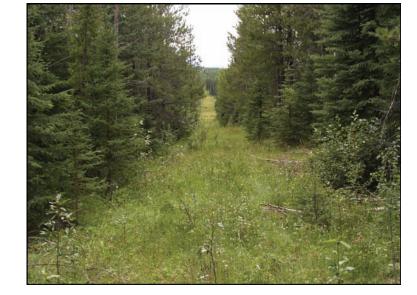
Udell/Carnell (2006)

The seismic cut line remains evident and probably will be a fixture on the land for many years. The line is well-grassed and stable from erosion. A good mix of tree species provides for an interesting mosaic ideal for forestry and wildlife with good potential for maintaining watershed values.

The above 2006 aerial photo looks northwest across Block 183. The picture below highlights conifer regeneration along the former open seismic line. Also, note the mat of grass vegetation on the line right-of-way.

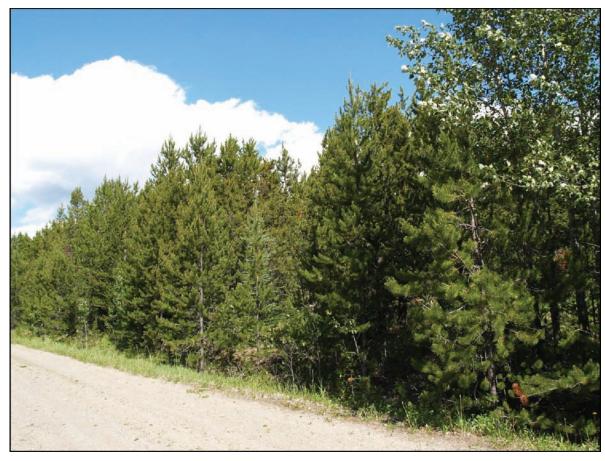
View of Block C-20 from the old road. The siltation that was such a concern to Mr. Zimmer in 1971 is no longer evident. Photopoint: N 53 43.348, W 118 16.126

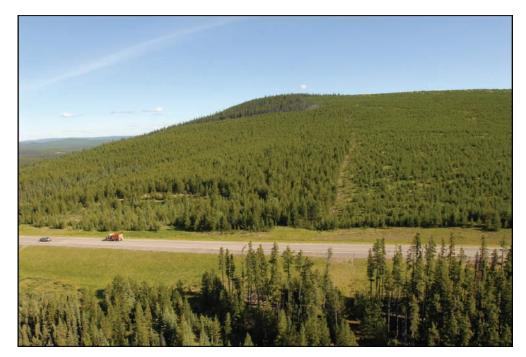
As the above photo shows, the area is "not stripped of all plant life." Good growth and yield in a sustainable forest is evident along east side of Highway 40 (looking northwest), both from the air and along the road. The ground level view below shows the reclaimed and reforested "borrow pit." Photopoint: N 53 39.438, W 118 13.377.

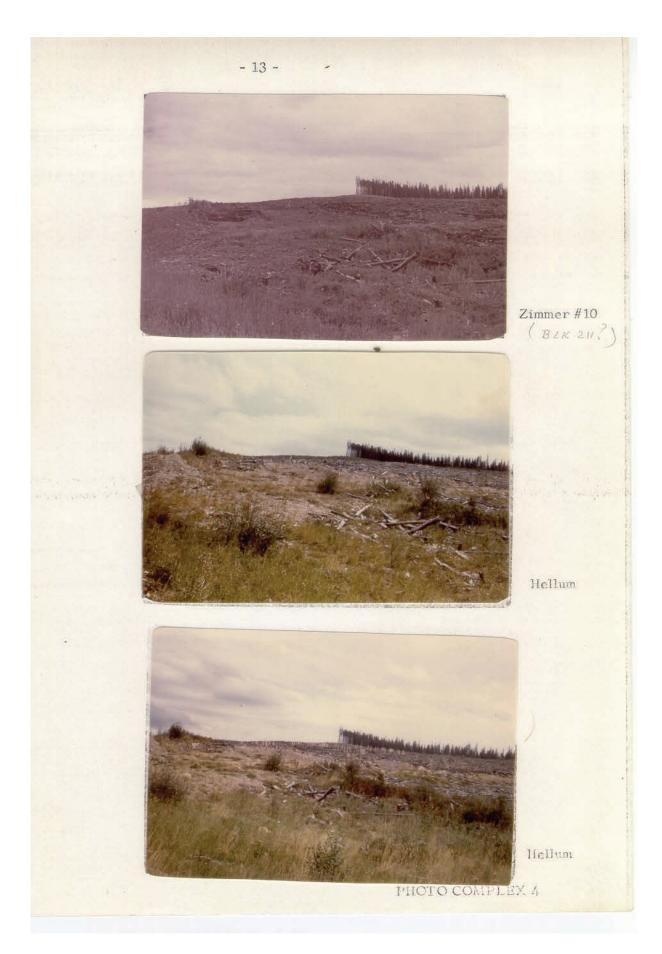
Photo #41. "...What we see here is that slash covers the area to an average depth of about one foot in solid wood. The walking in this area would of course be very difficult and therefore the slash would require treating before any planting could be undertaken".

If all the visible slash were spread evenly all over the ground in photos 10 and 41, the ground would not be covered anywhere near 12" in solid wood. While Mr. Zimmer may be correct in diagnosing this area to be in need of supplemental planting, access or slash treatment is not a problem.

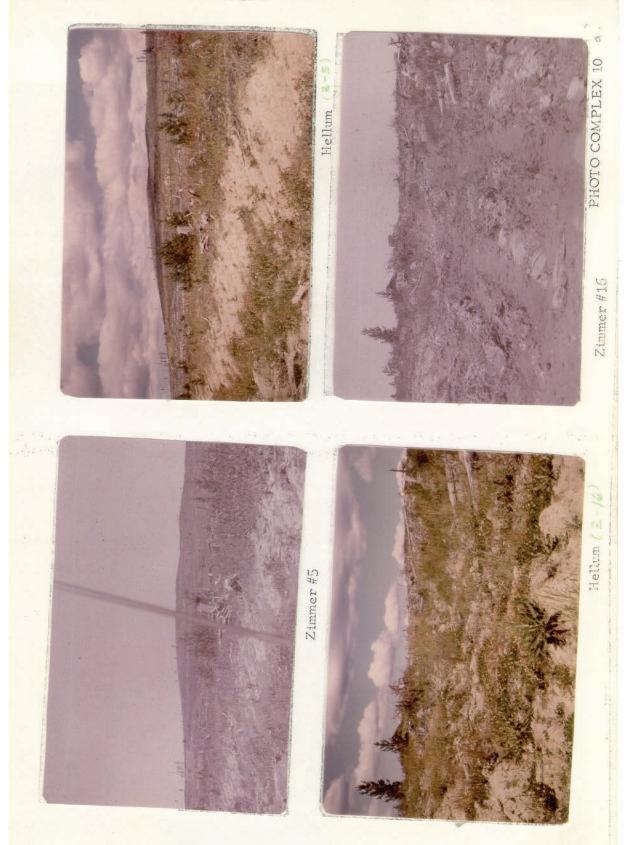
Photo 16 shows a 1971 cat track onto the area scarified in July of 1971. Photo Complex 10 shows that this cat track, which was made only days before Mr. Zimmer visited the area, had grassed in well by late August of 1972.

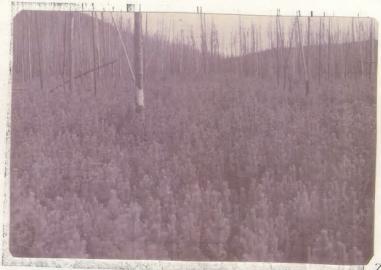
Zimmer #60

Photo Complex 12 shows where N.W.P.&P. "accidentally" thinned the pine in photo 60 in between the time that Mr. Zimmer took his photo in July of 1971 and August of 1972 when the colour photos were taken. The background of photo 60 and 61 contain about 53,600 lodgepole pine seedlings per acre judging by two sample plots 10 x 10 feet in area located within the camera angle of photo 60. The thinned part contains over 1,670 seculings per acre and this is still far too dense for good tree growth.
