## **Foothills Stream Crossing Partnership**

### **Geotextile Reinforced Soil Arch Photo Gallery**

Hardisty Creek – July 2009

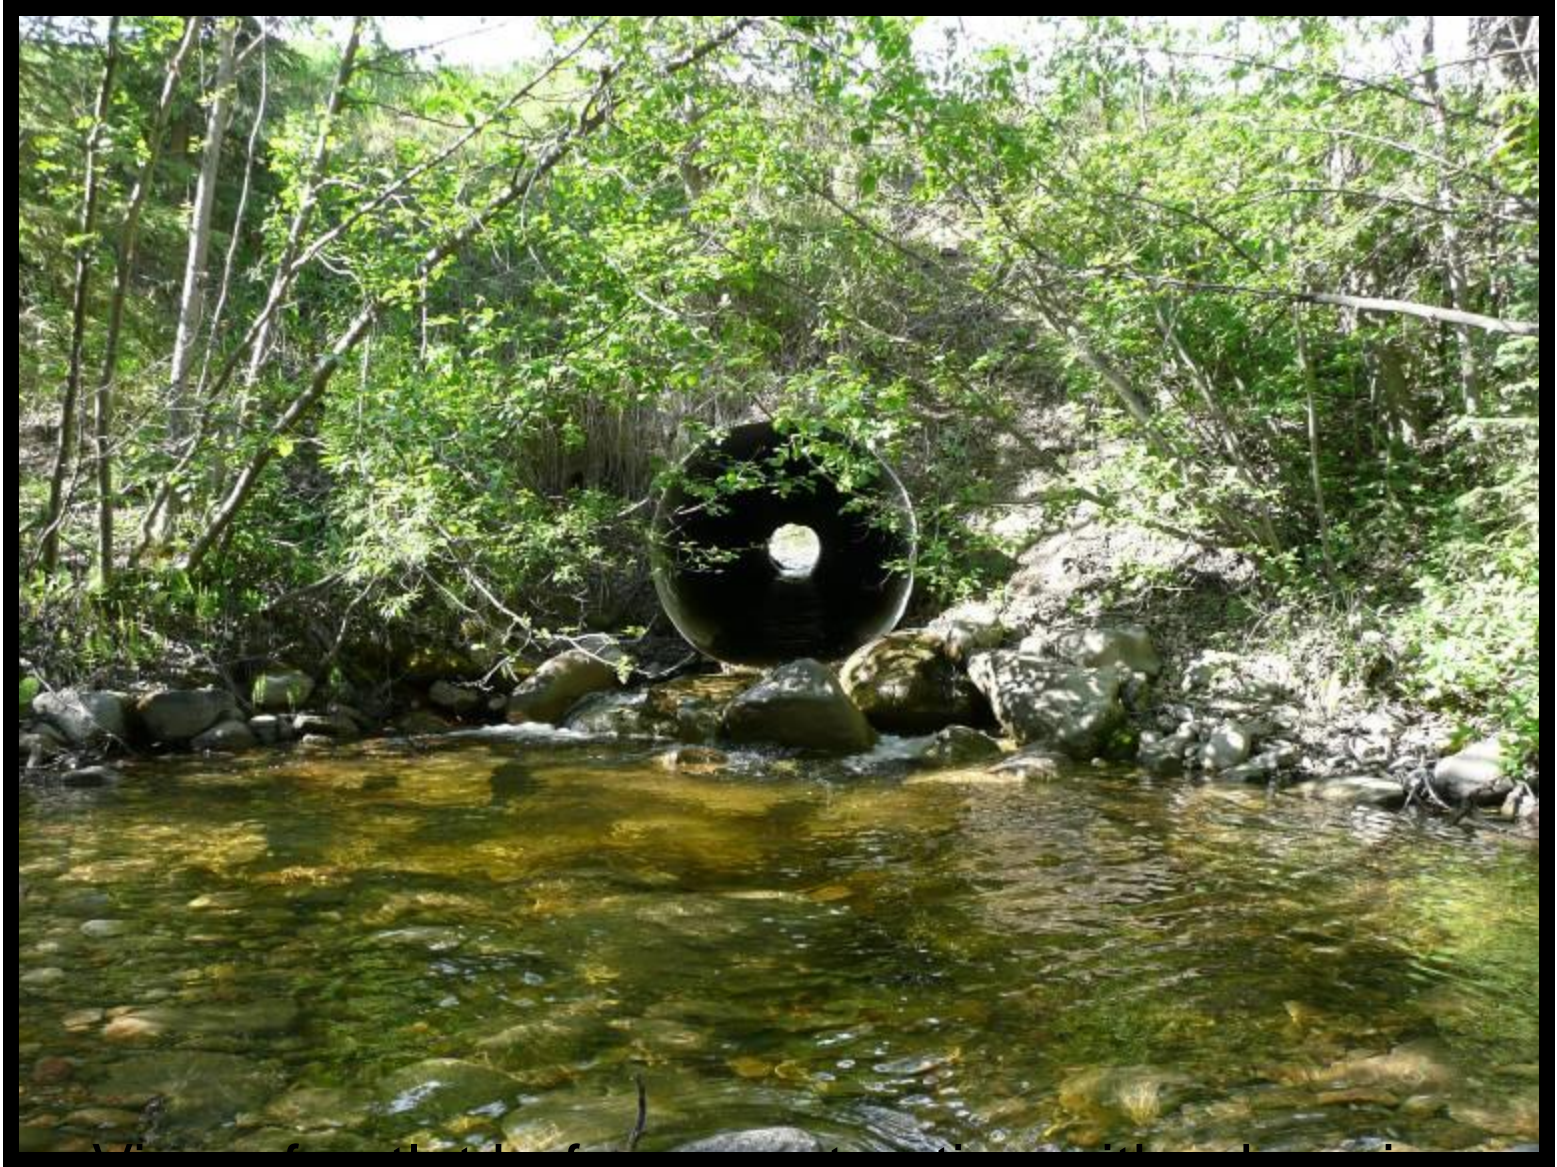
View of outlet before construction with a hanging culvert

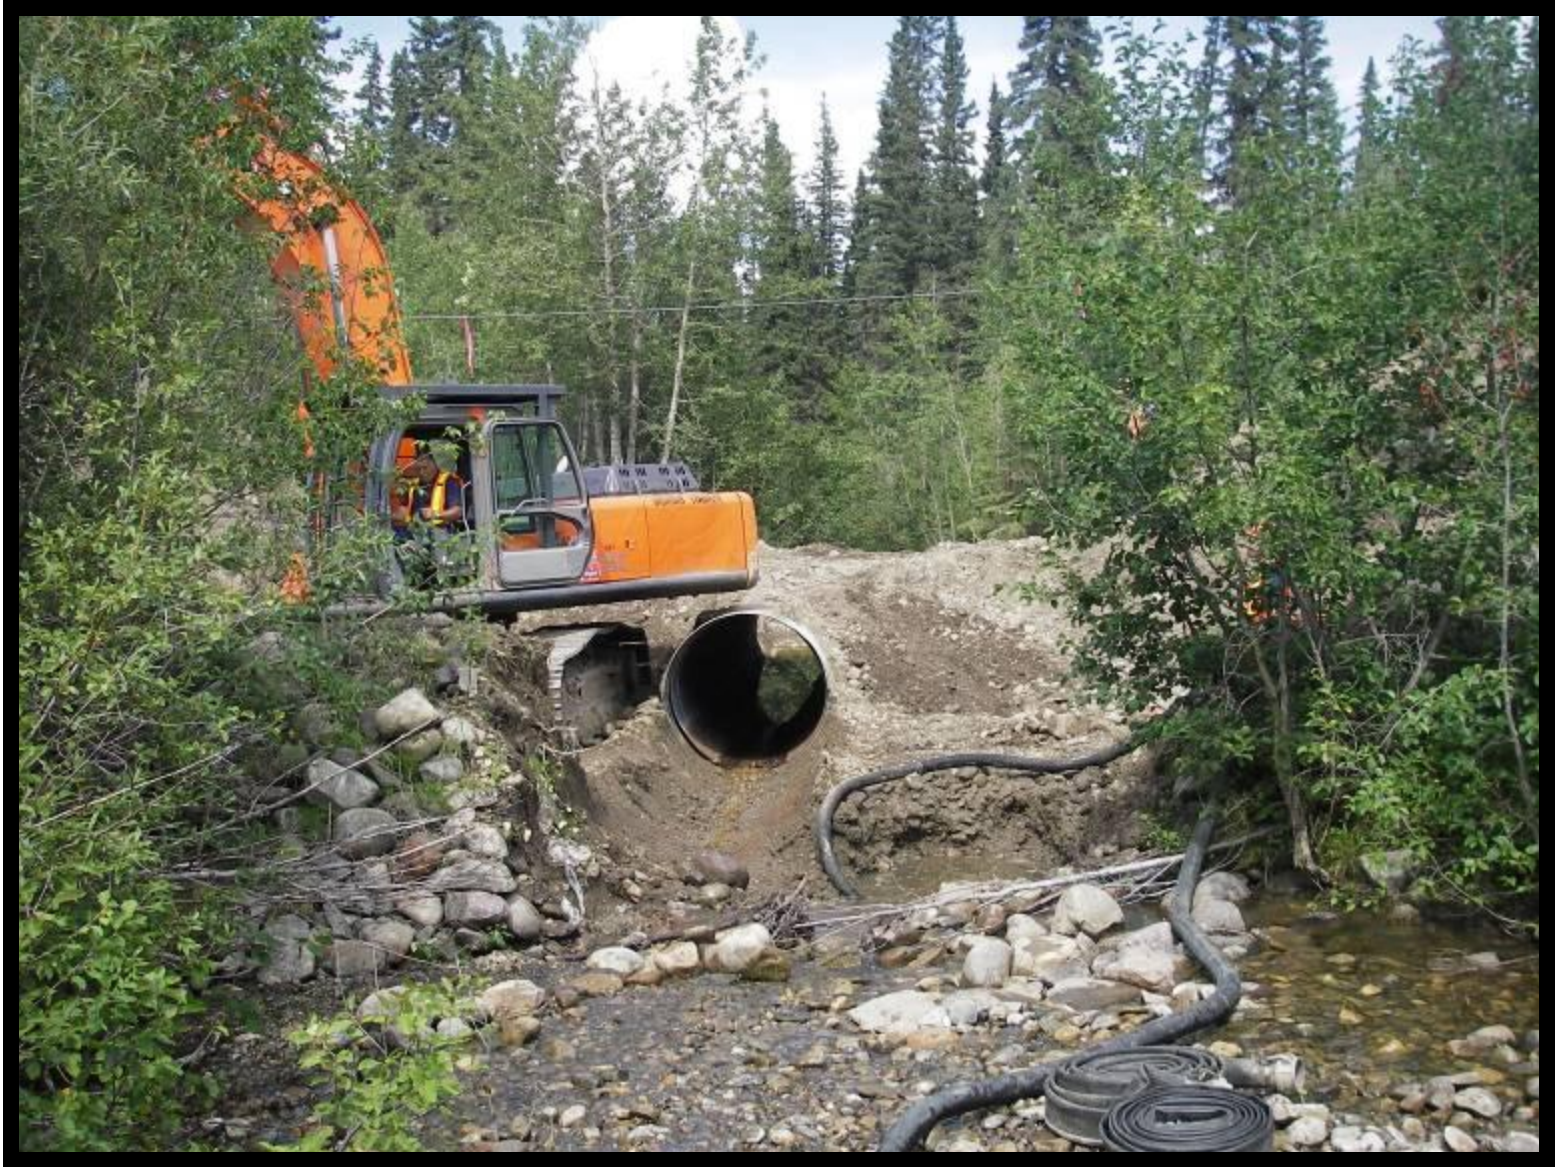
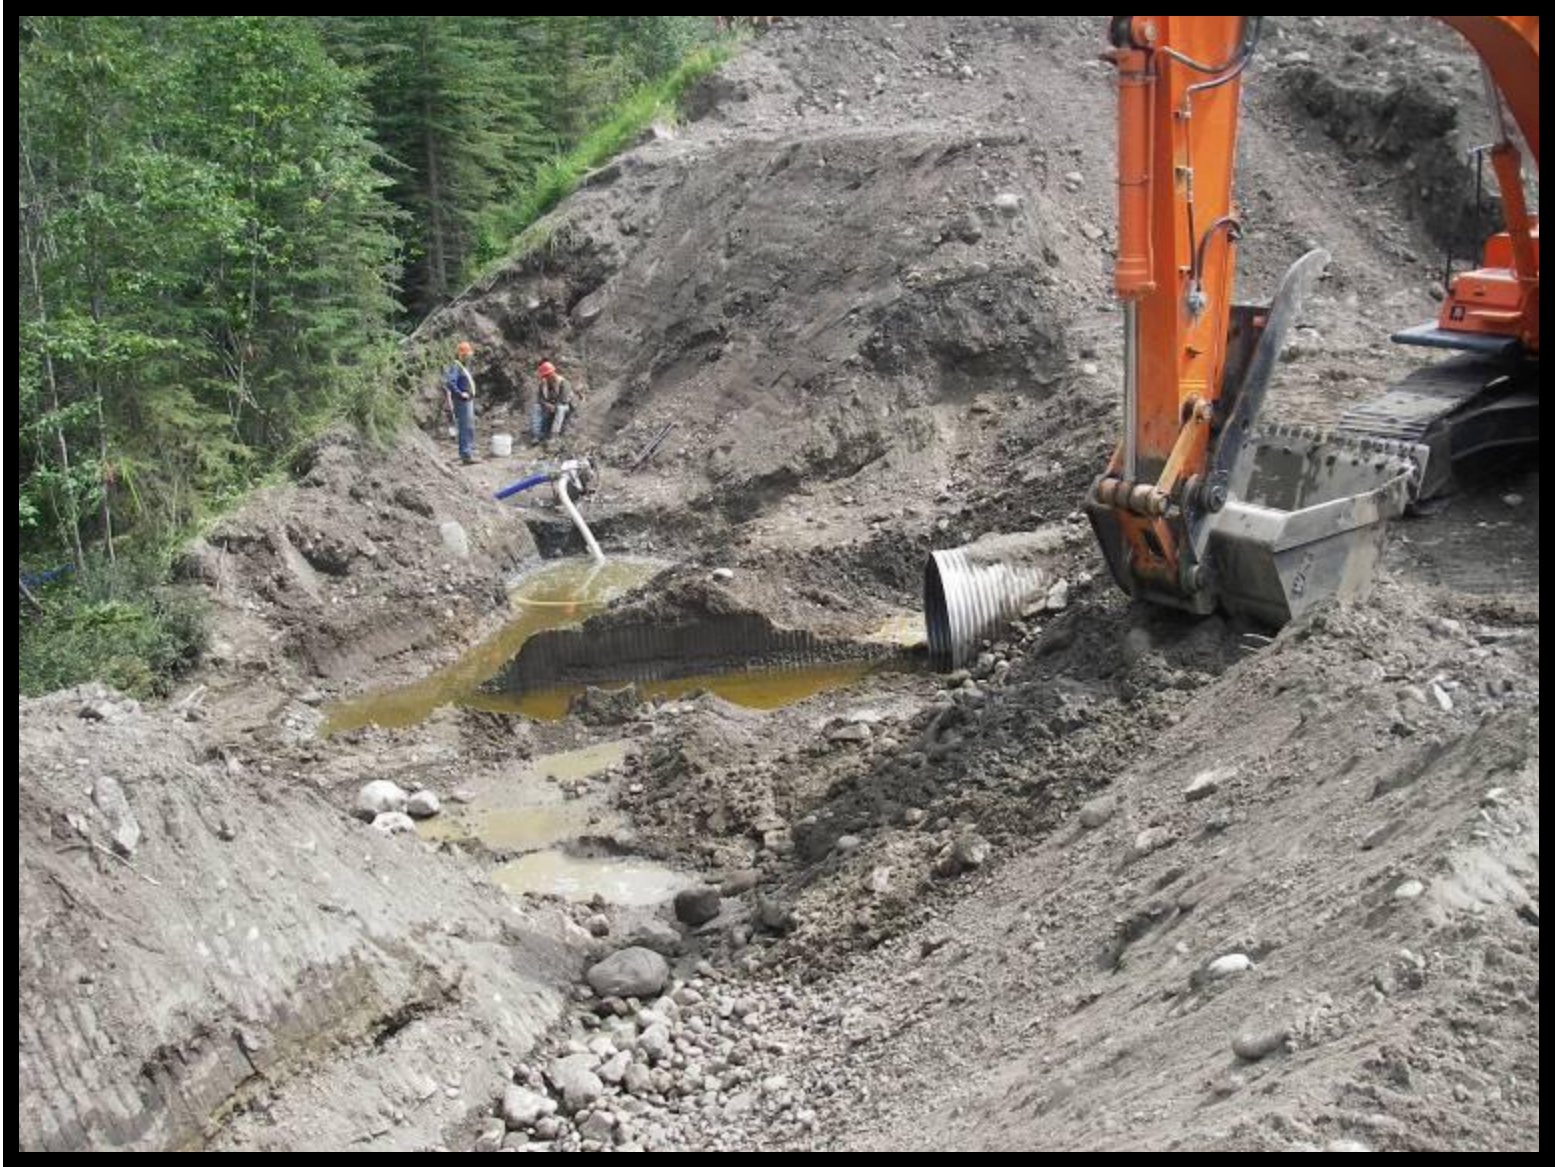
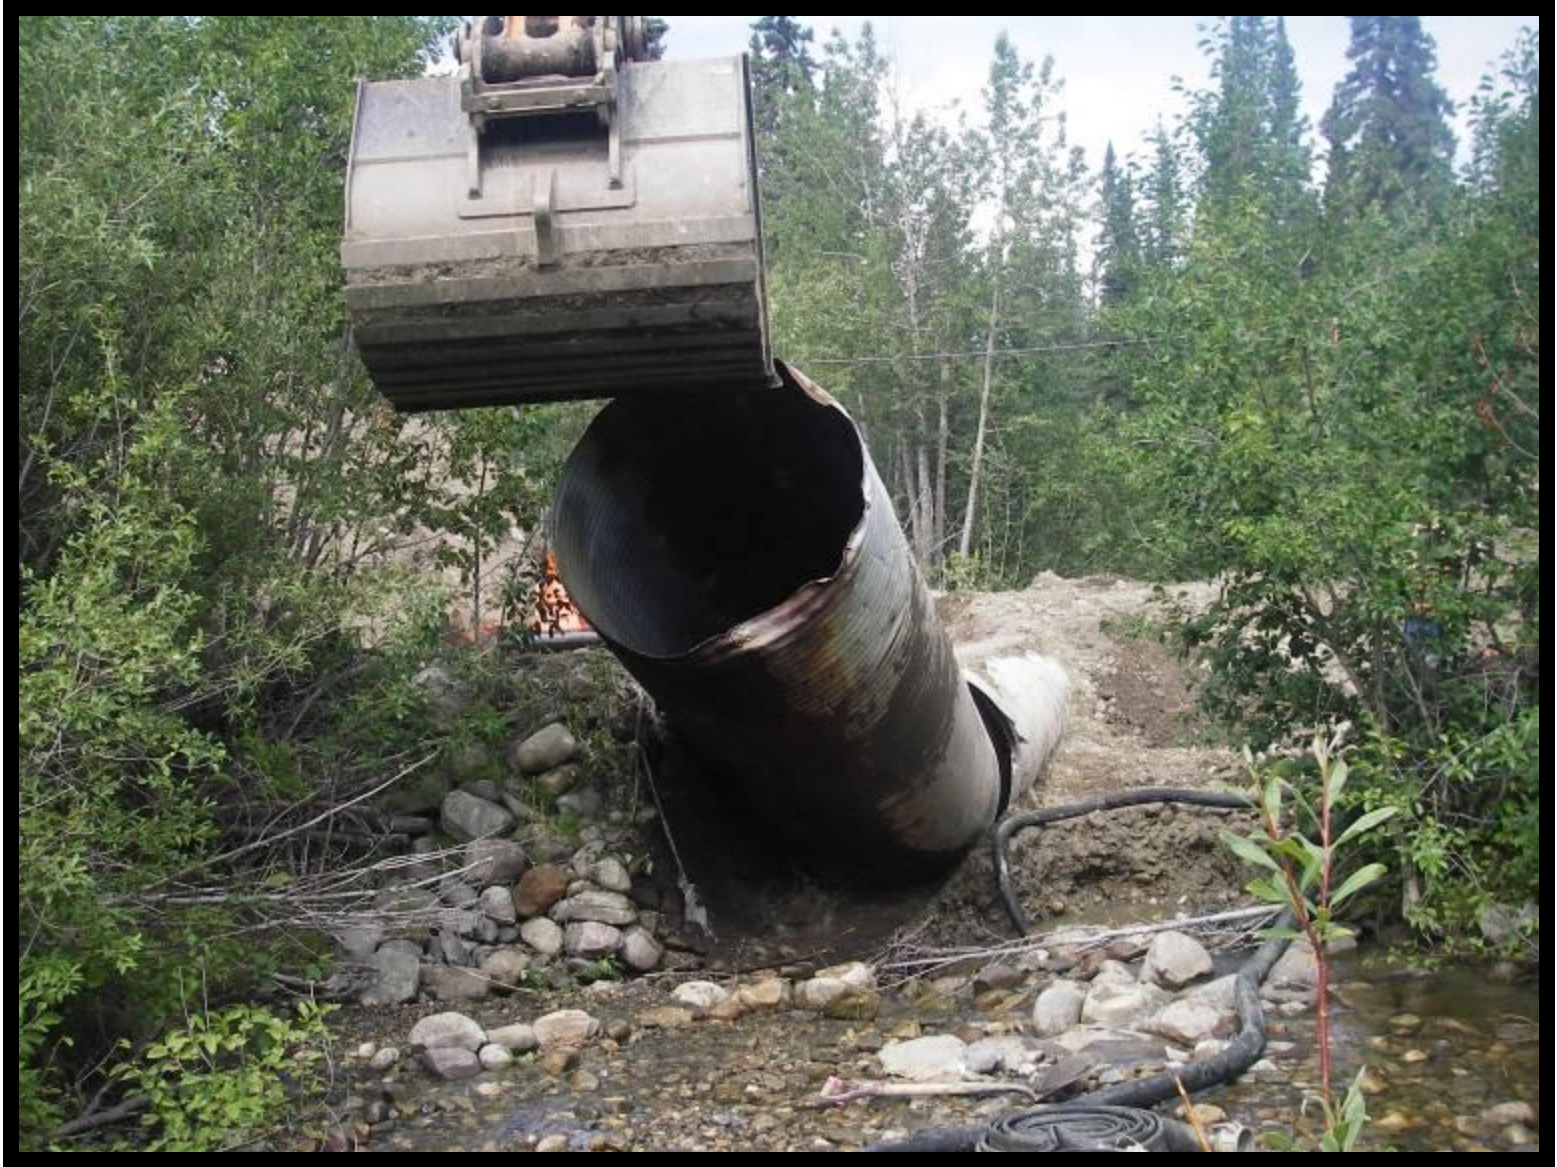
Removal of the culvert

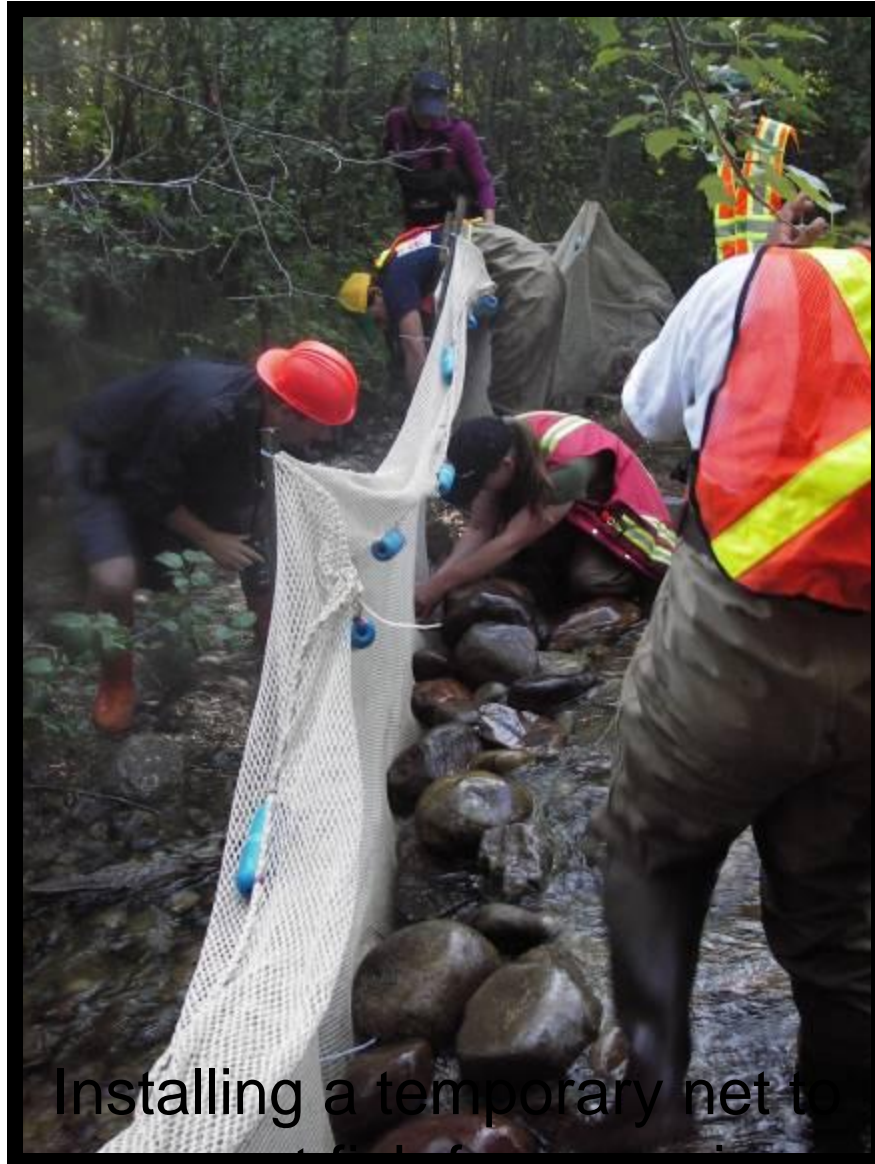
Installing a temporary net to  
prevent fish from moving  
upstream during

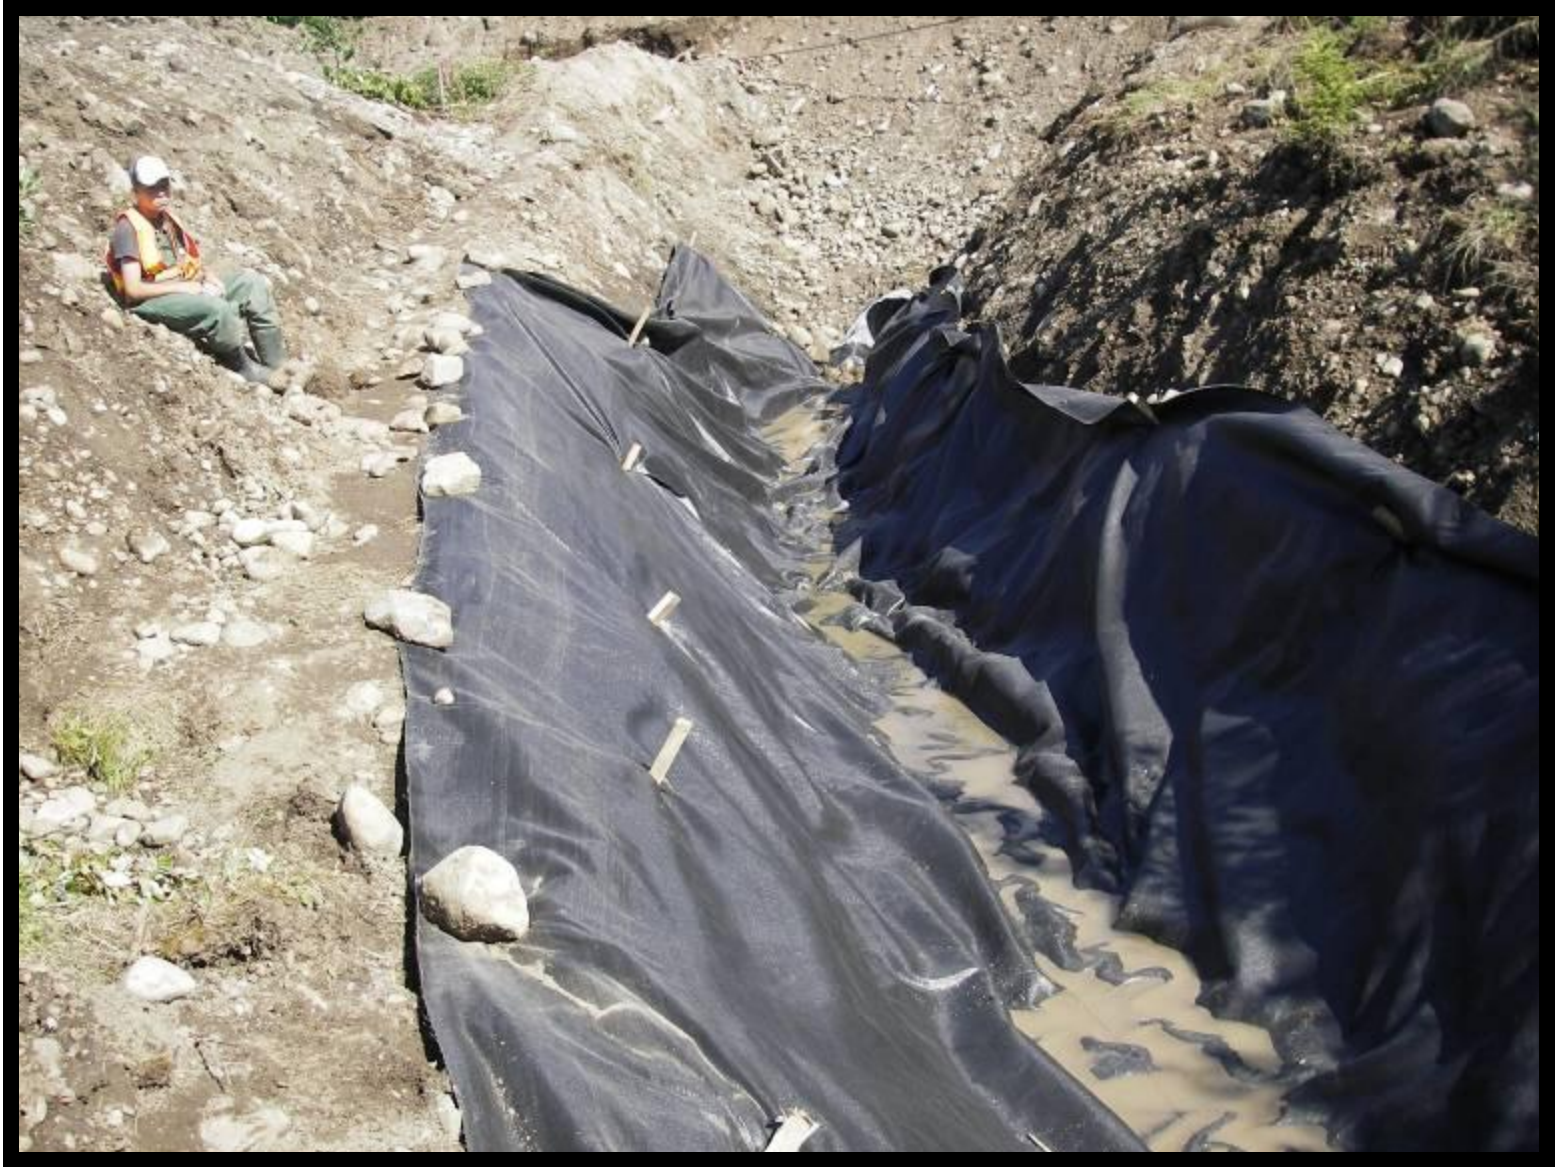
Stream diversion ditch upstream

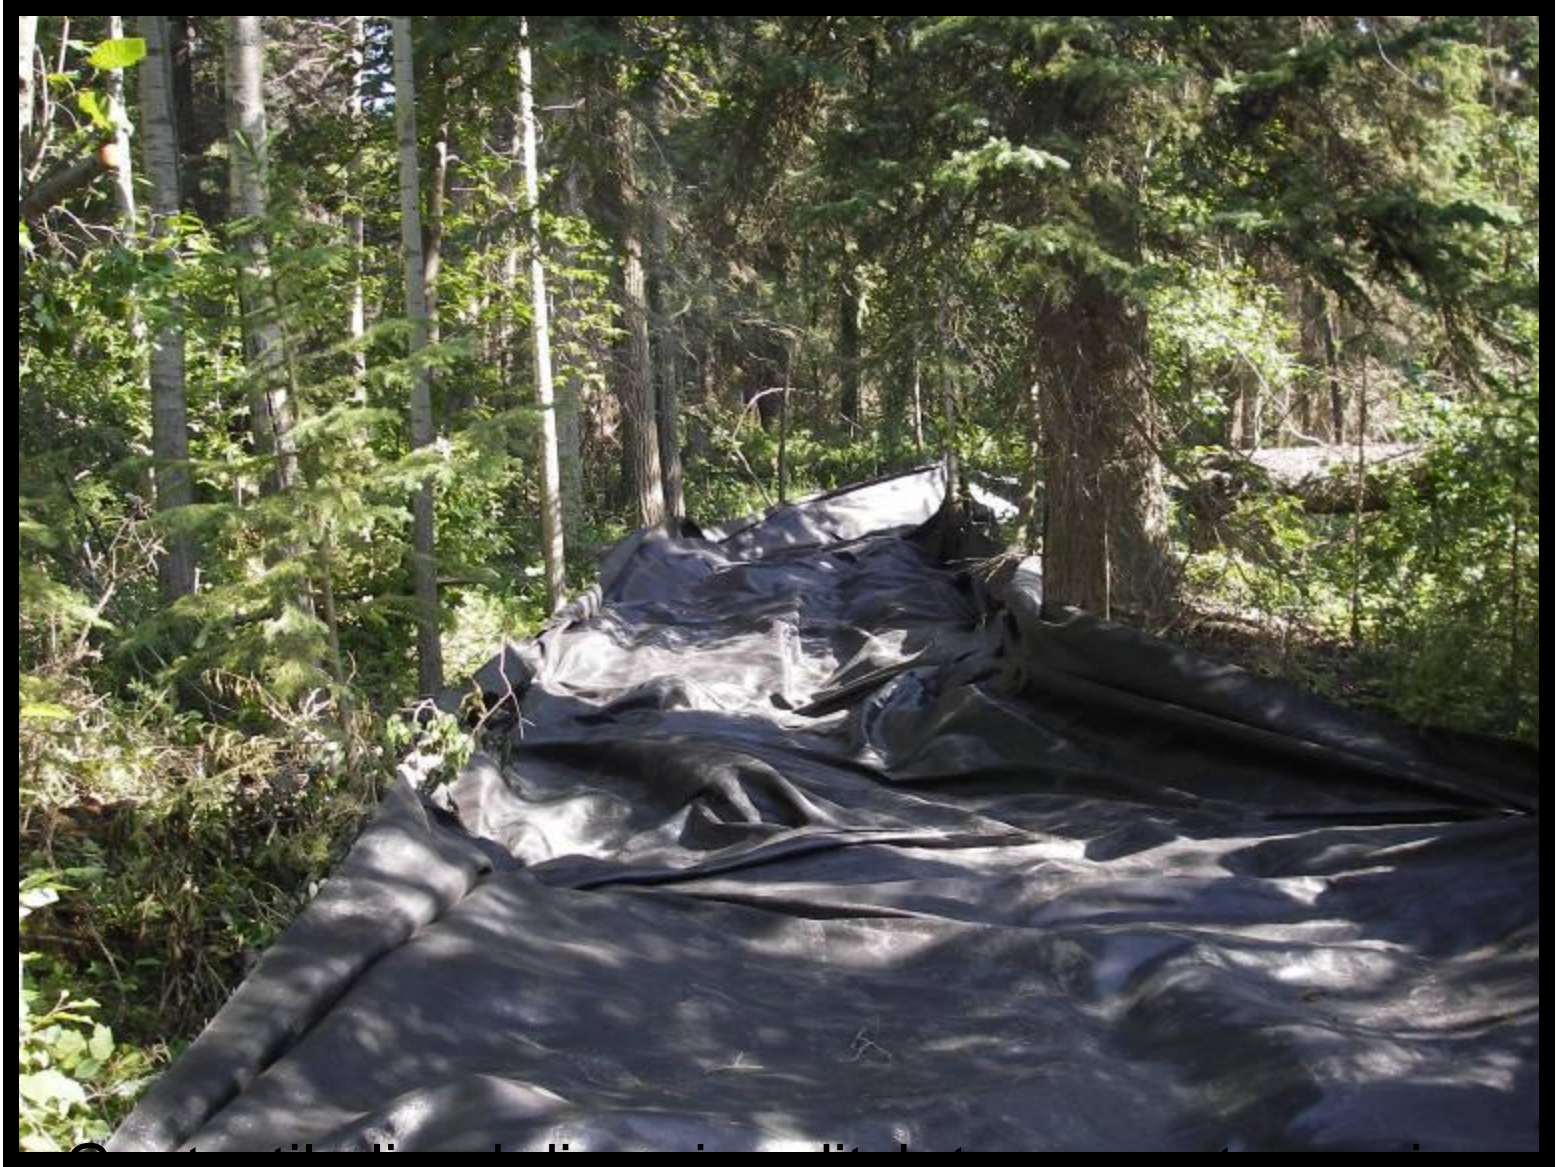
Geotextile lined diversion ditch to prevent scouring of forest floor

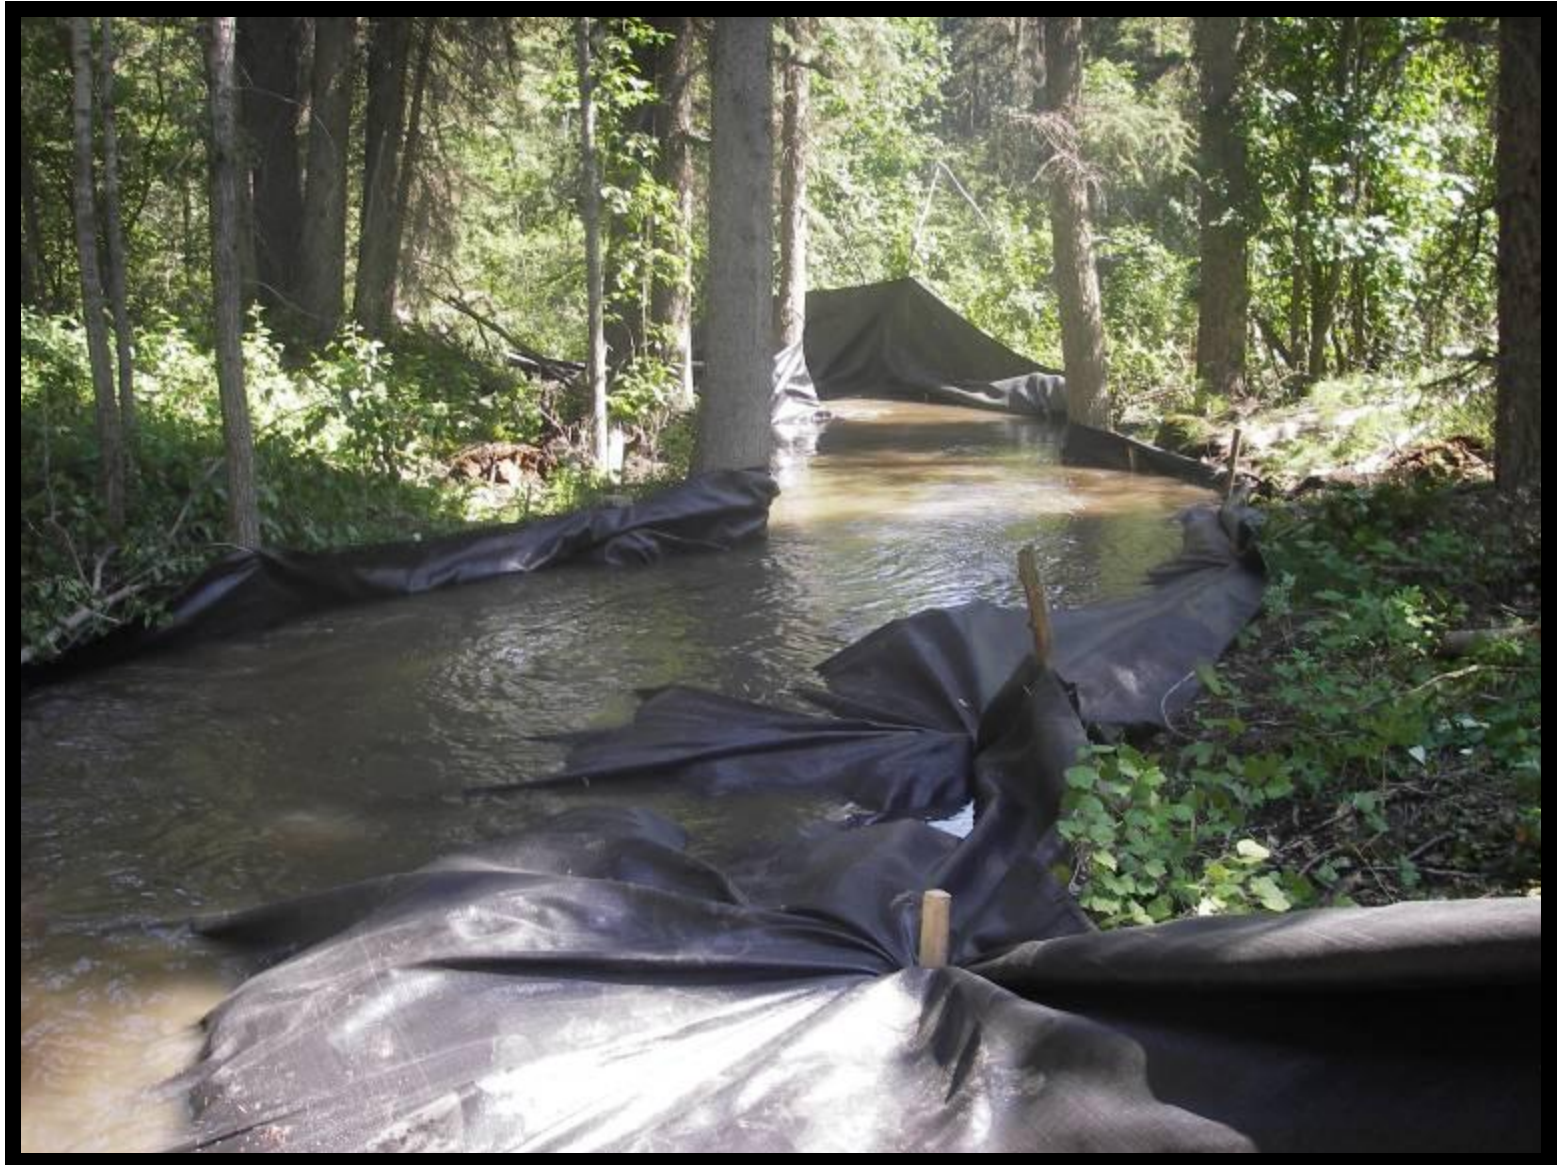
Downstream diversion ditch in action

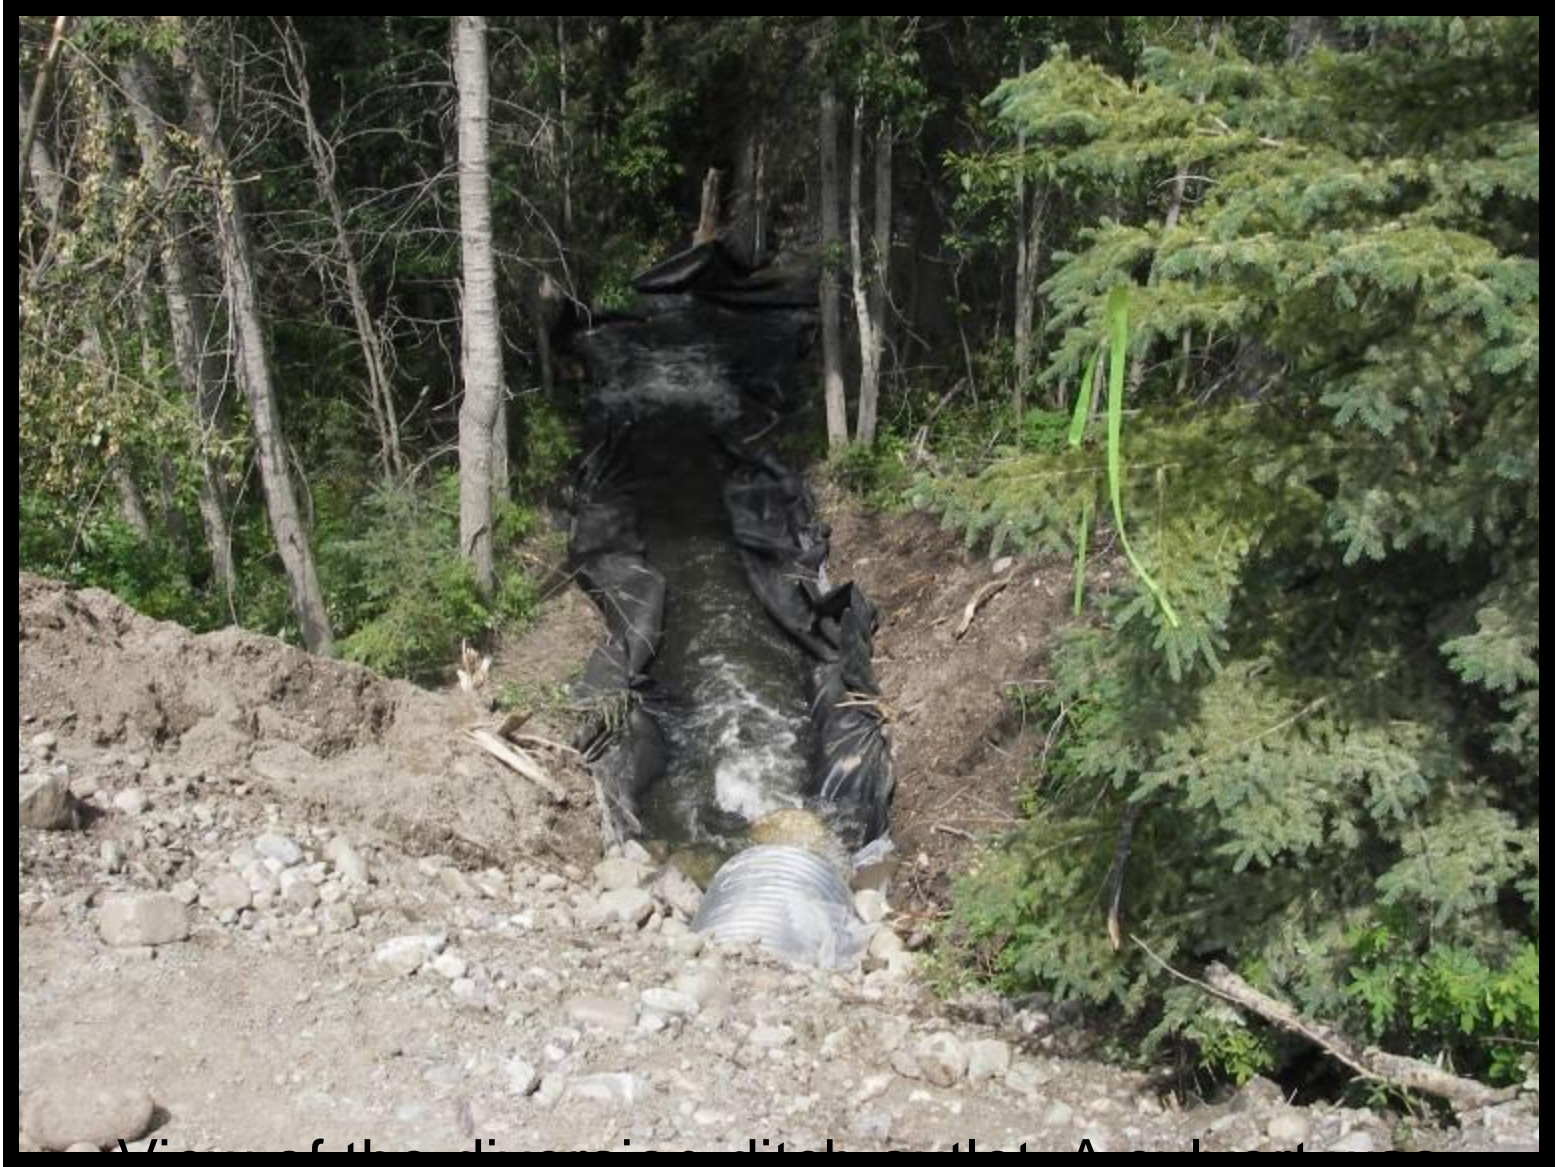
View of the diversion ditch outlet. A culvert was placed under the road and upon construction

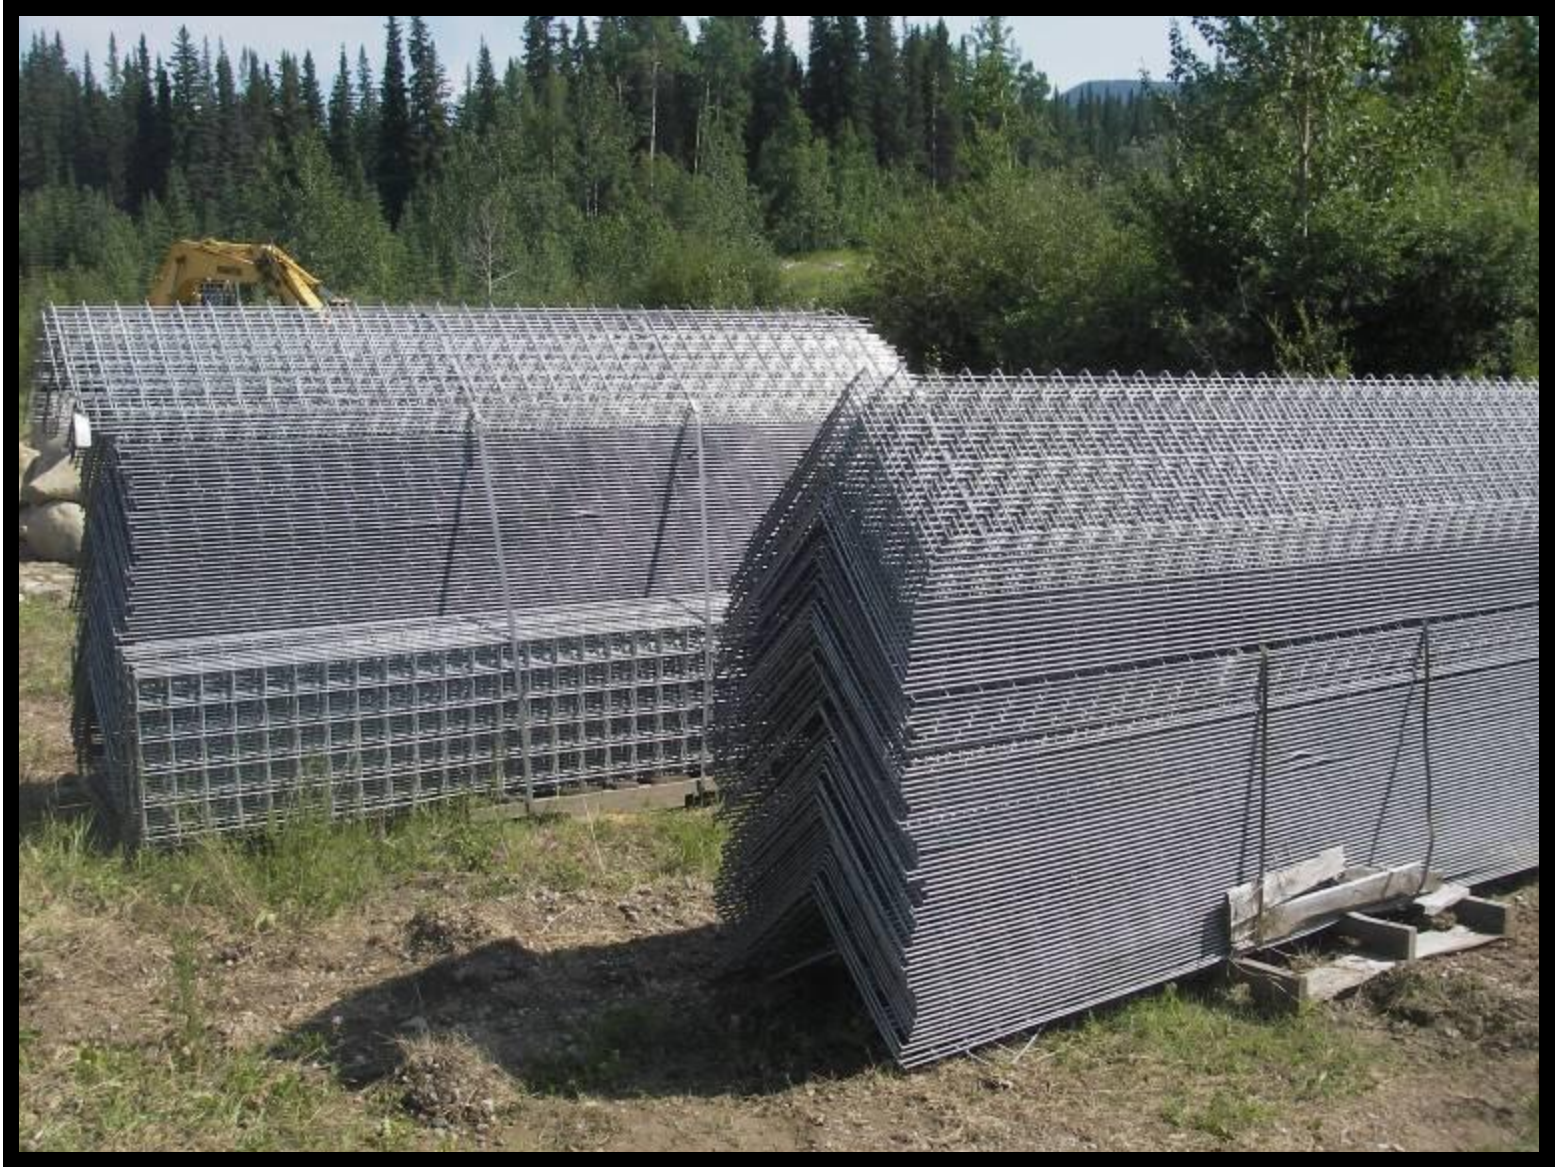
Metal Cages

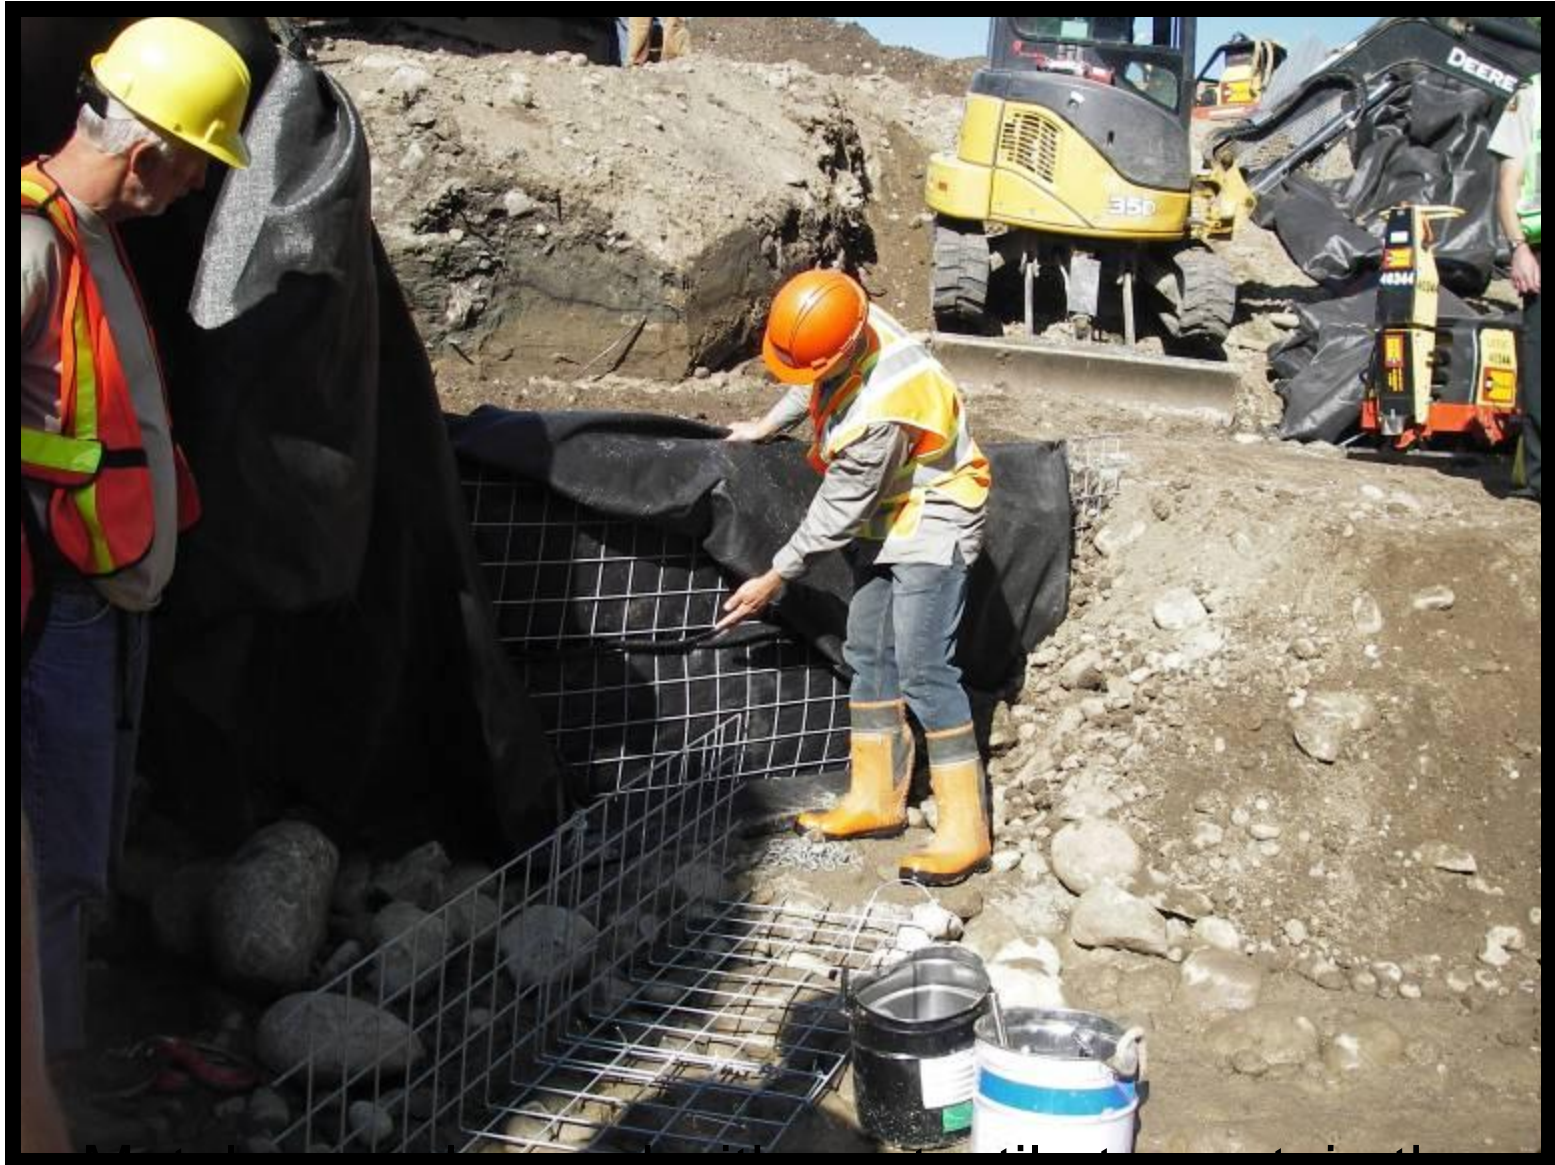
Metal cages layered with geotextile to contain the compacted soil

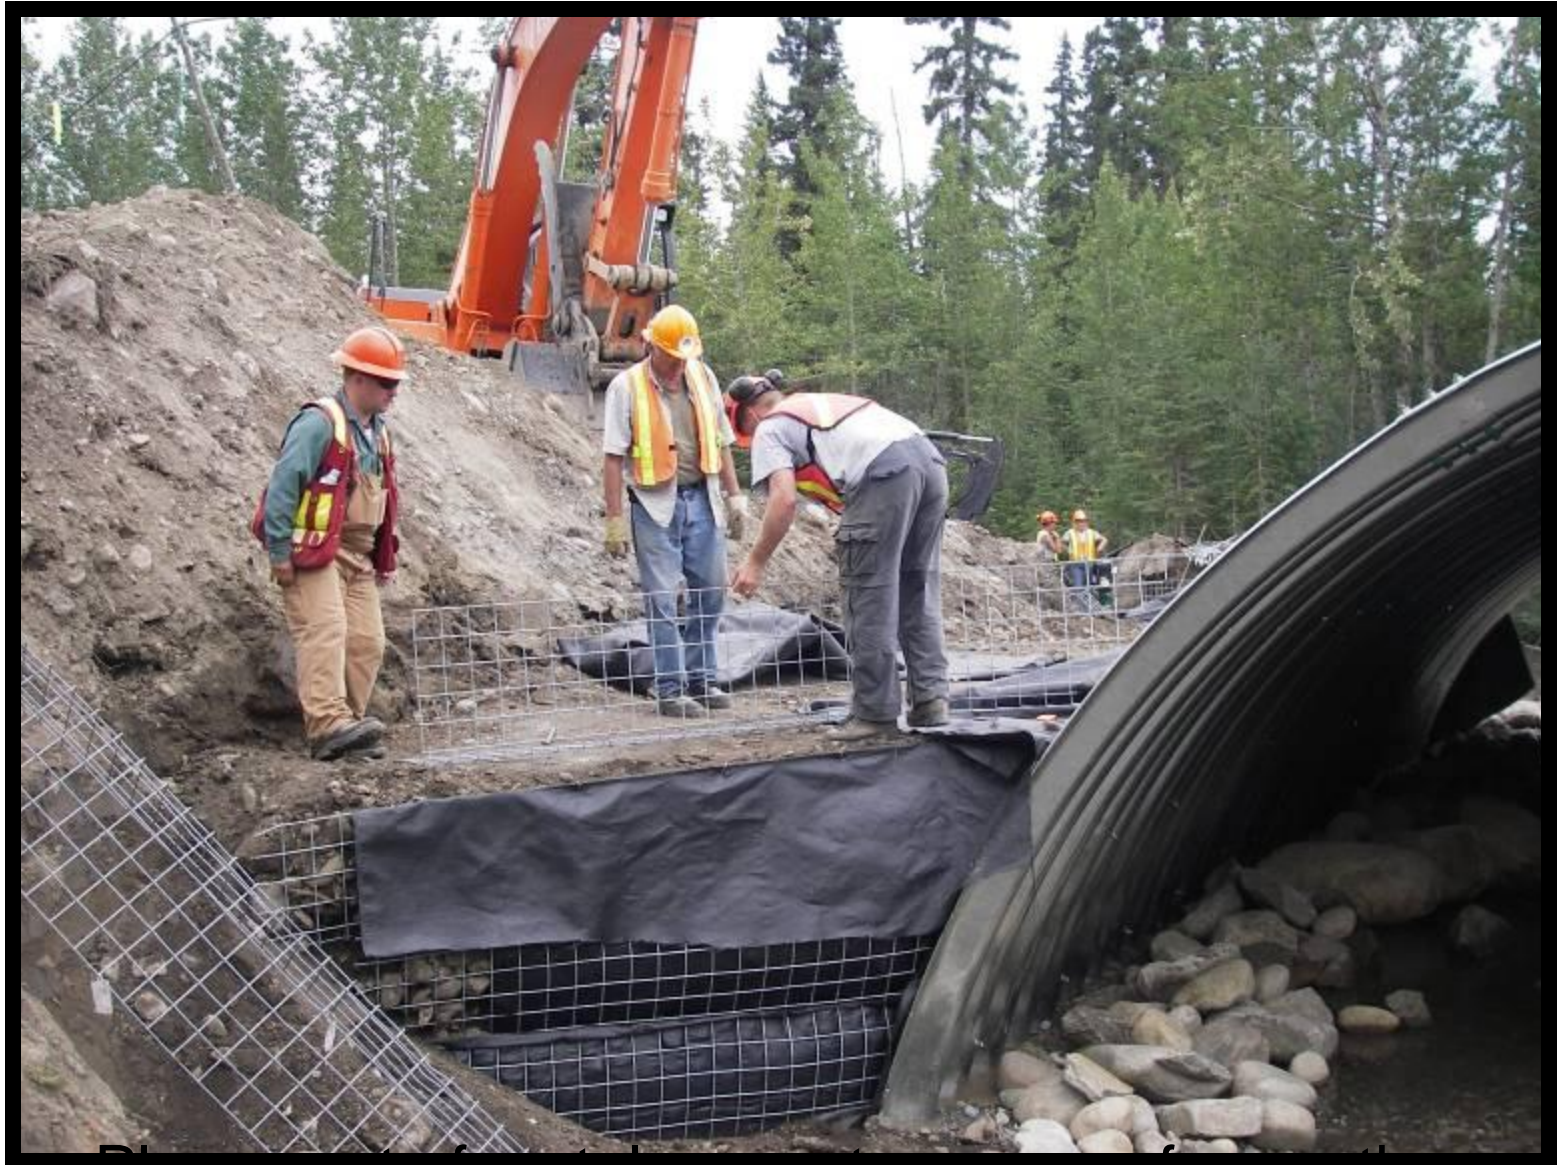
Placement of metal cages to prepare for another layer of soil

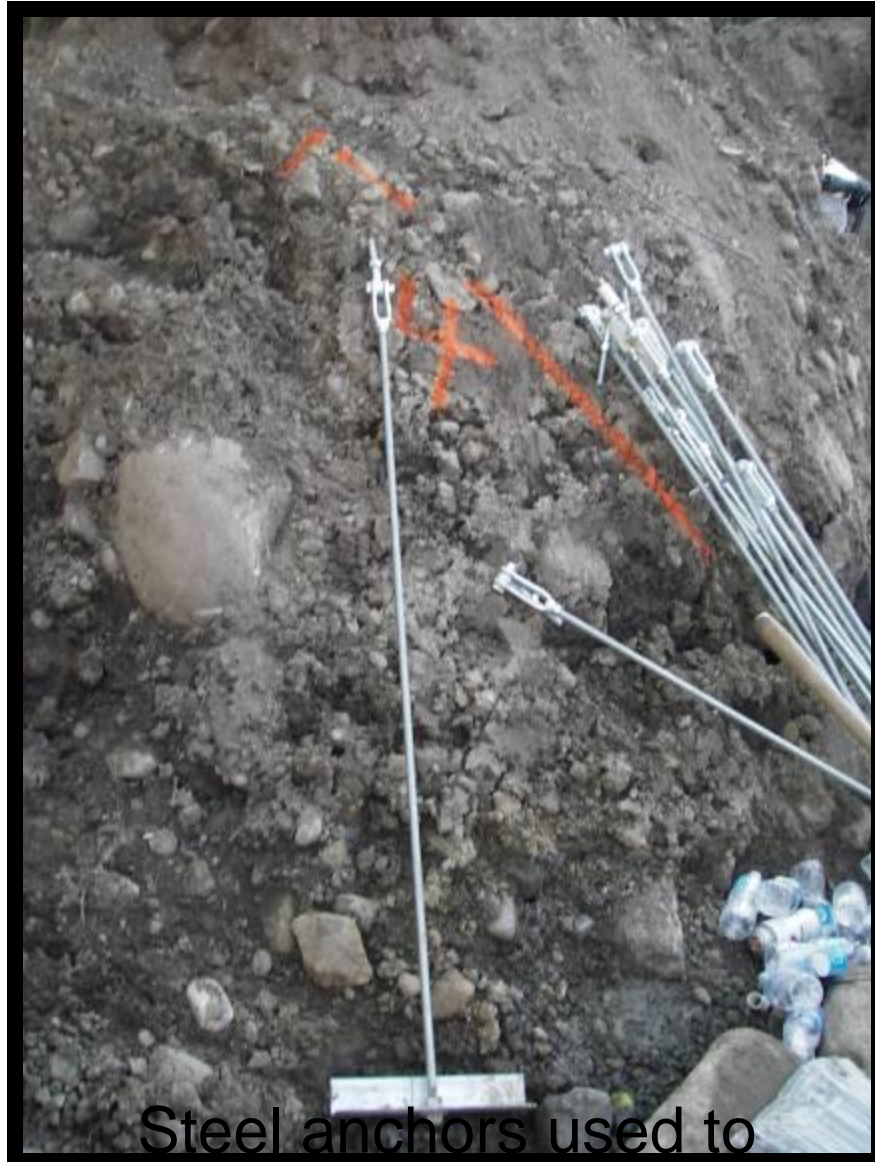
Steel anchors used to secure the arch once in the streambed

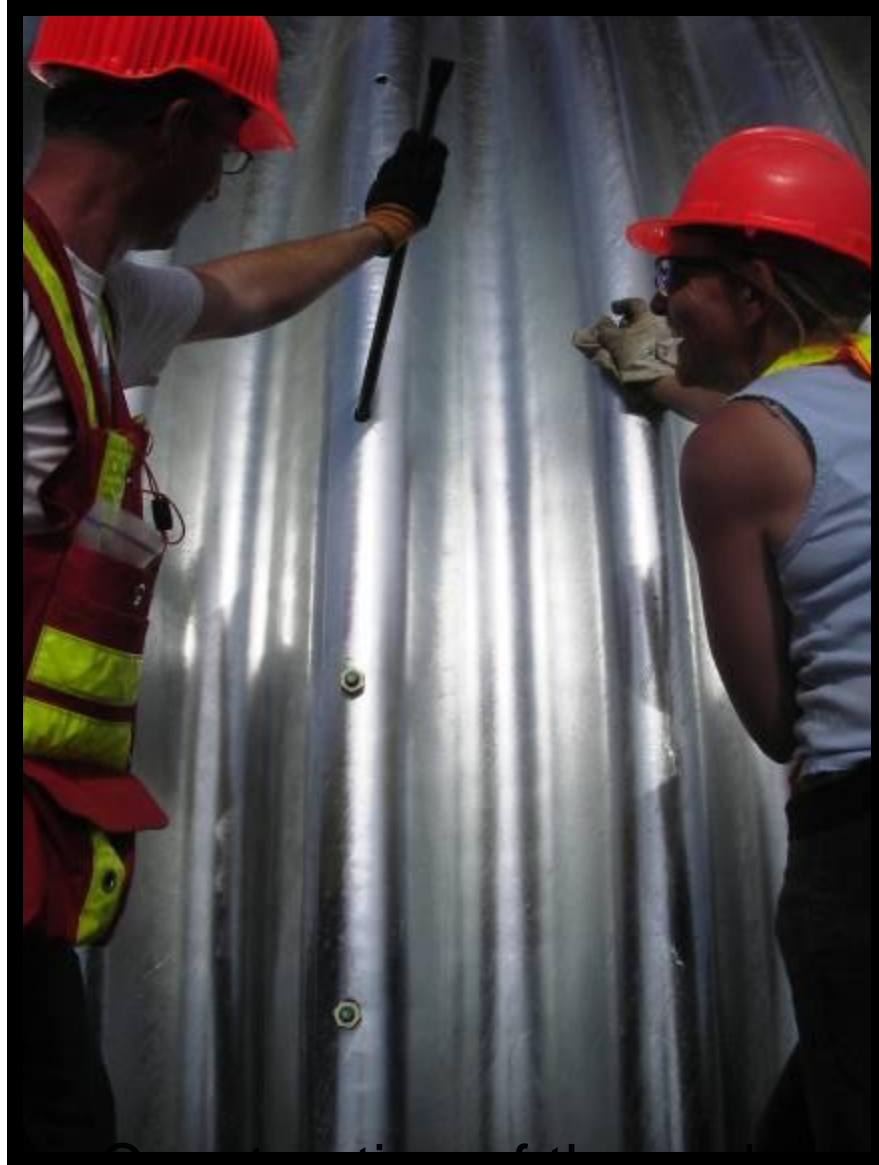
Construction of the arch,  
pieces must be aligned
