## **Foothills Stream Crossing Partnership**

### **Geotextile Reinforced Soil Arch Photo Gallery**

Hardisty Creek – July 2009

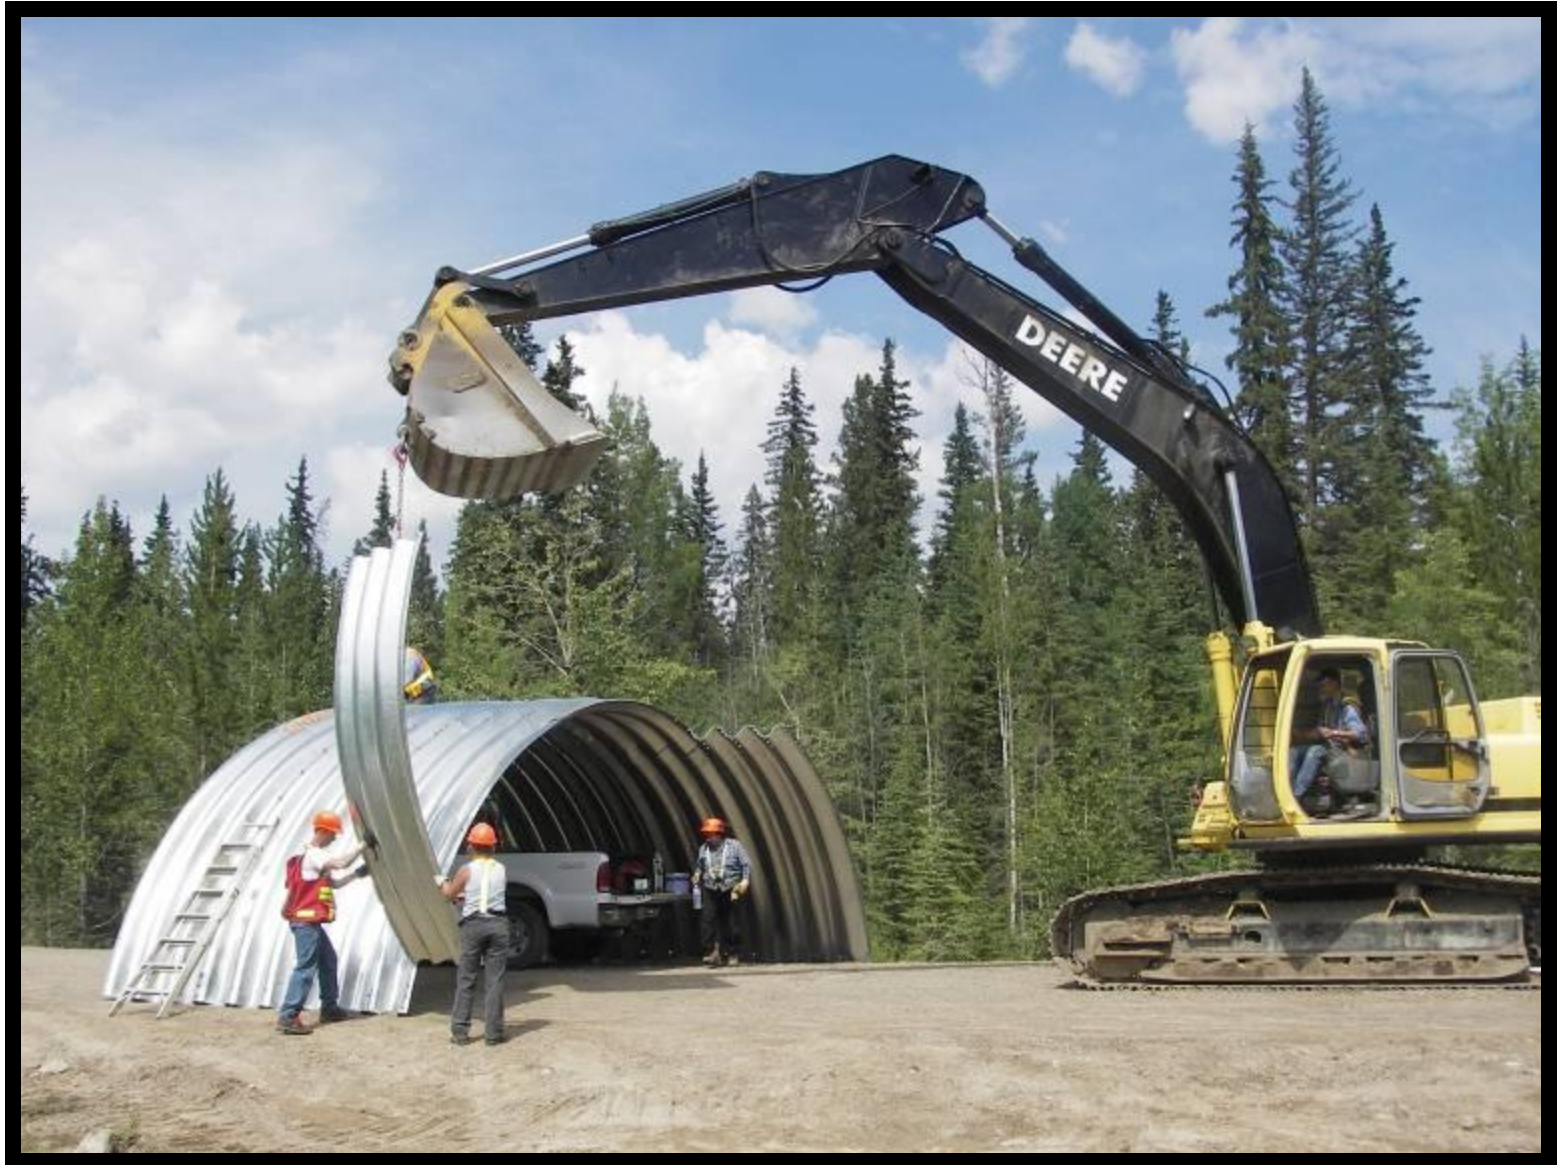
Construction of the metal arch

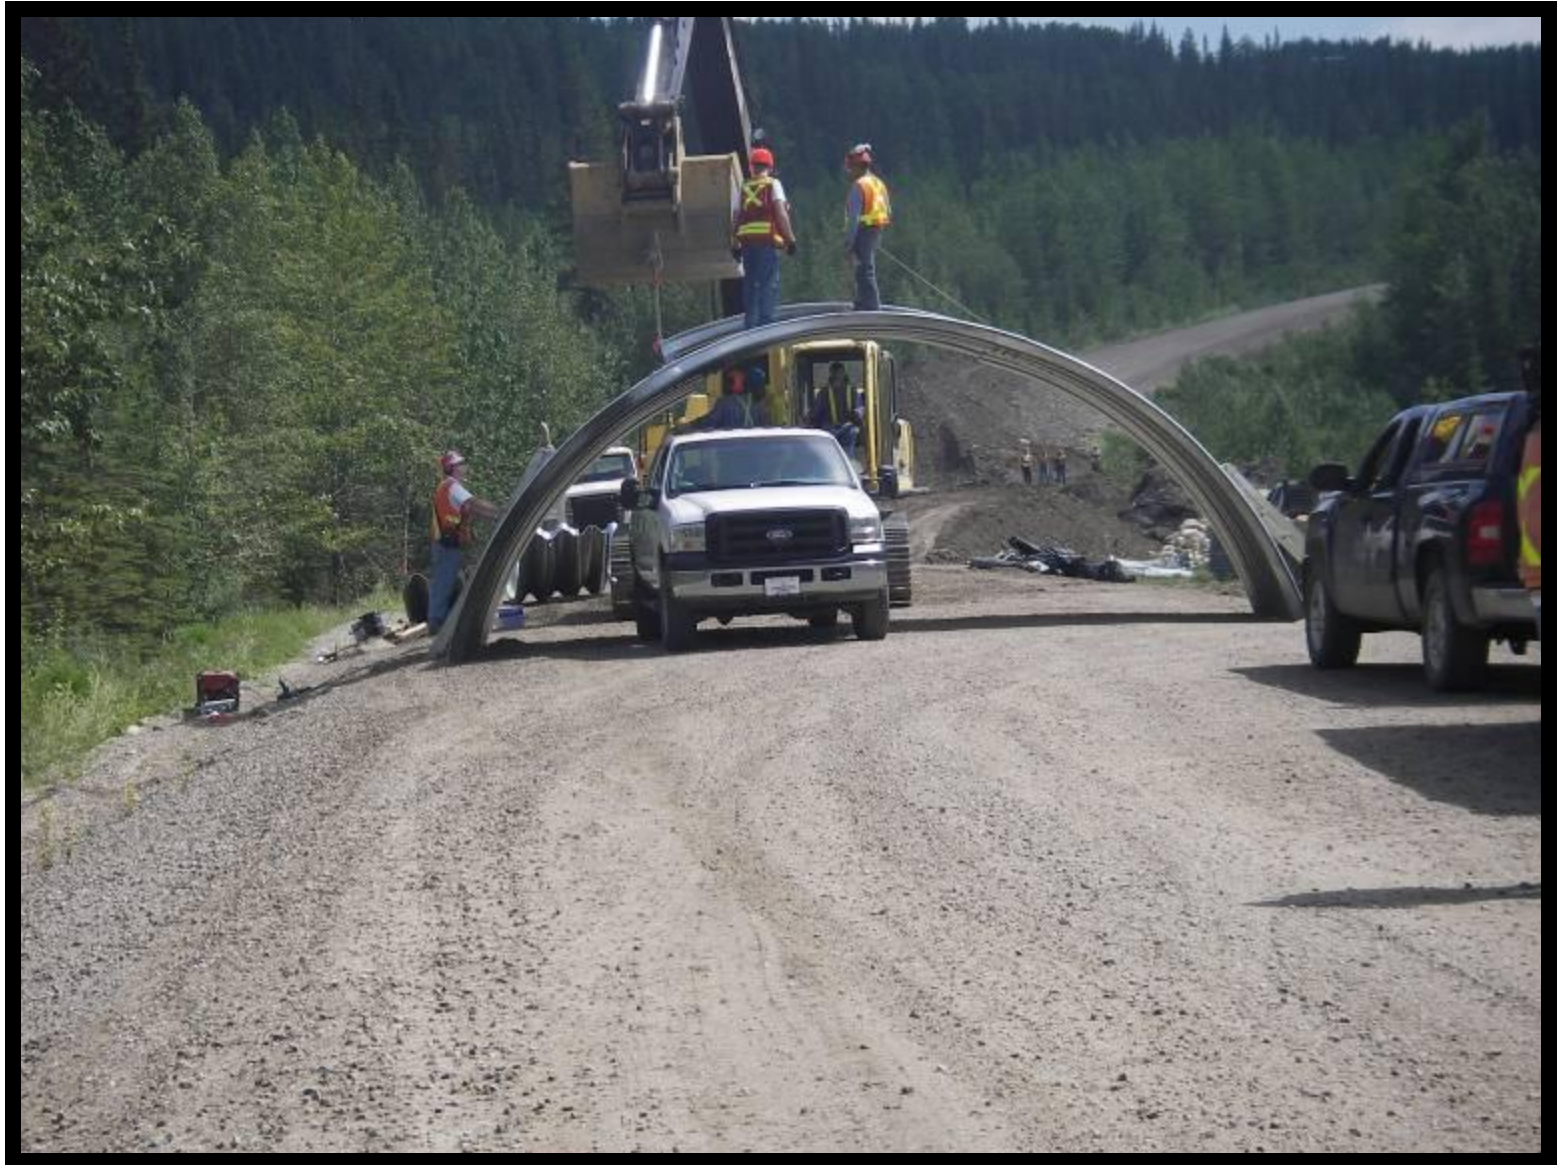
Construction of the metal arch before installation

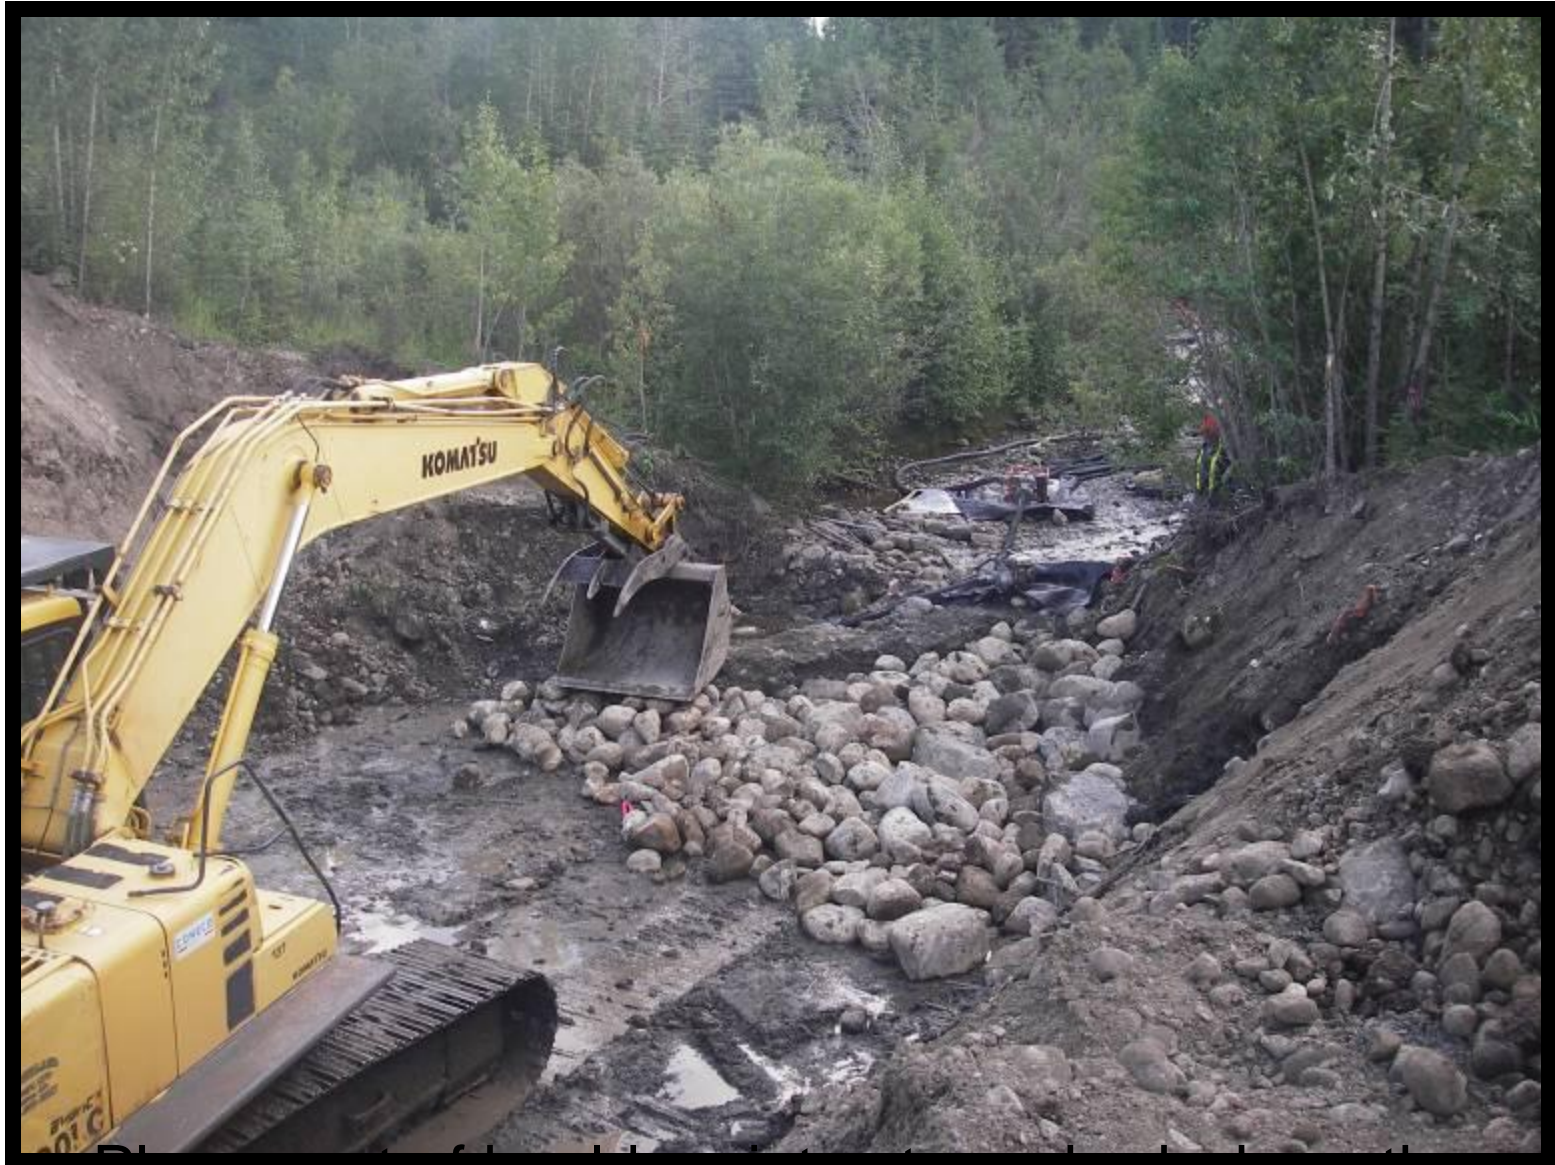
Placement of boulders into streambed where the culvert was previously

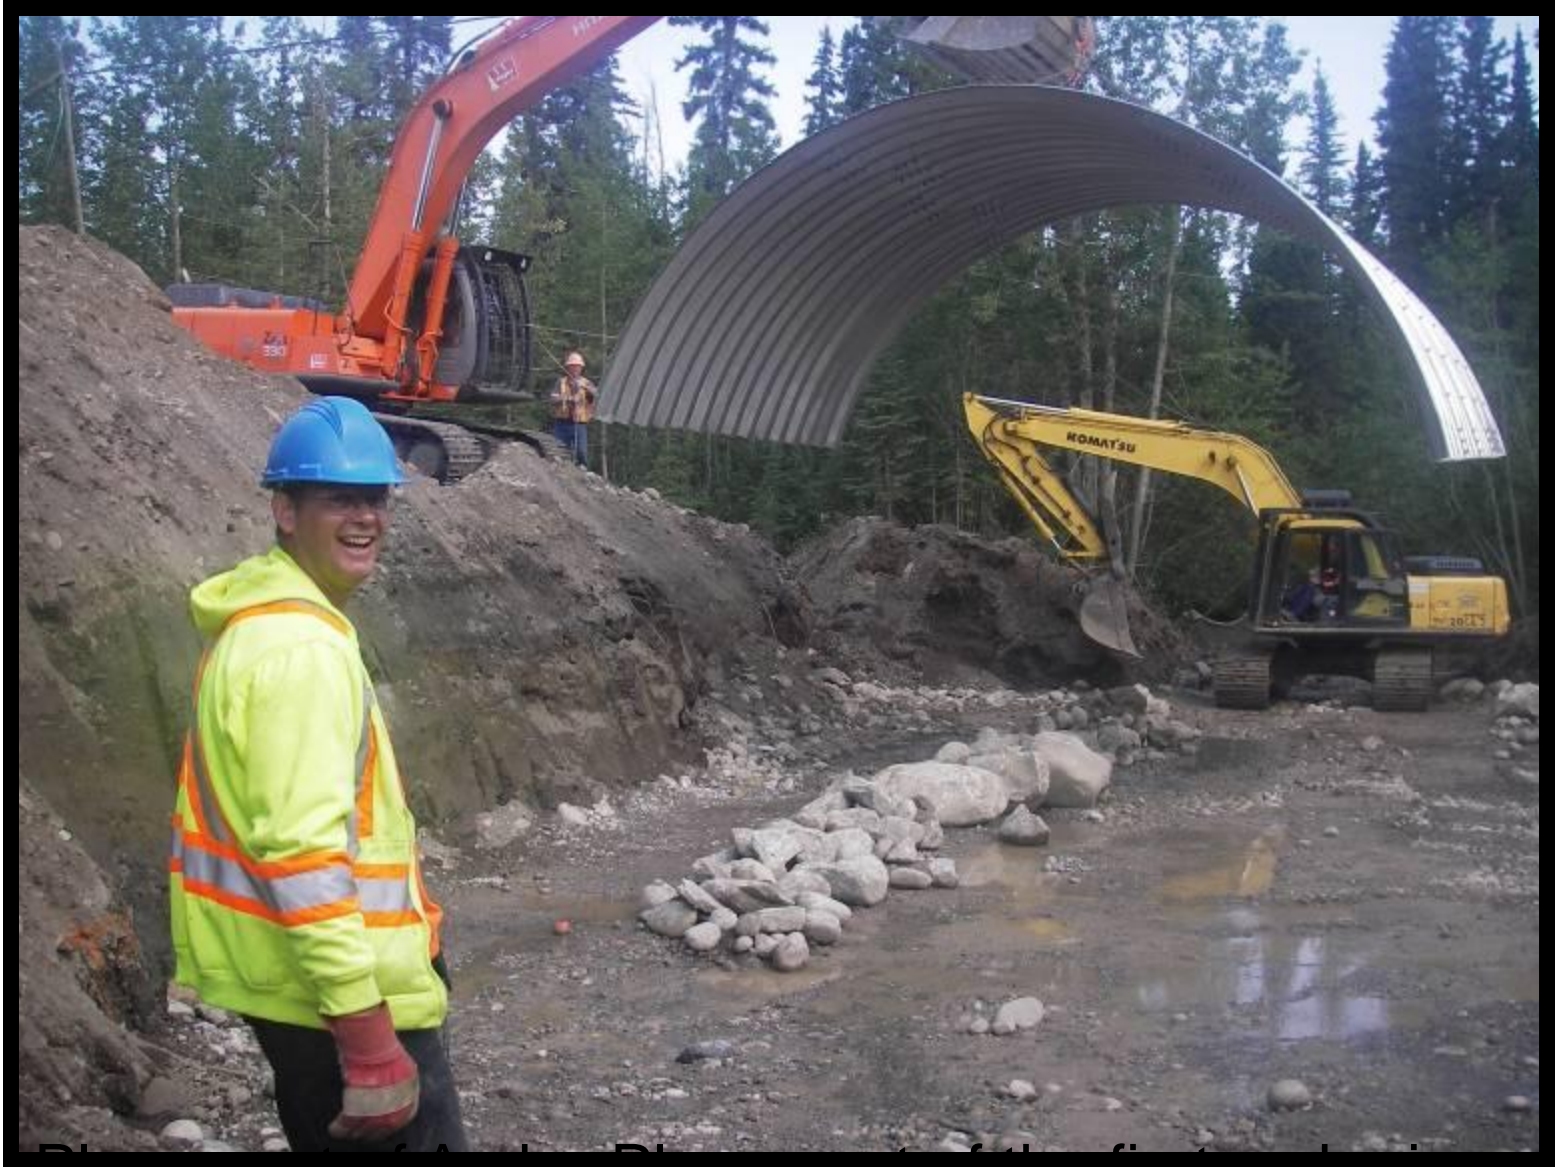
Placement of Arch - Placement of the first arch piece into the streambed

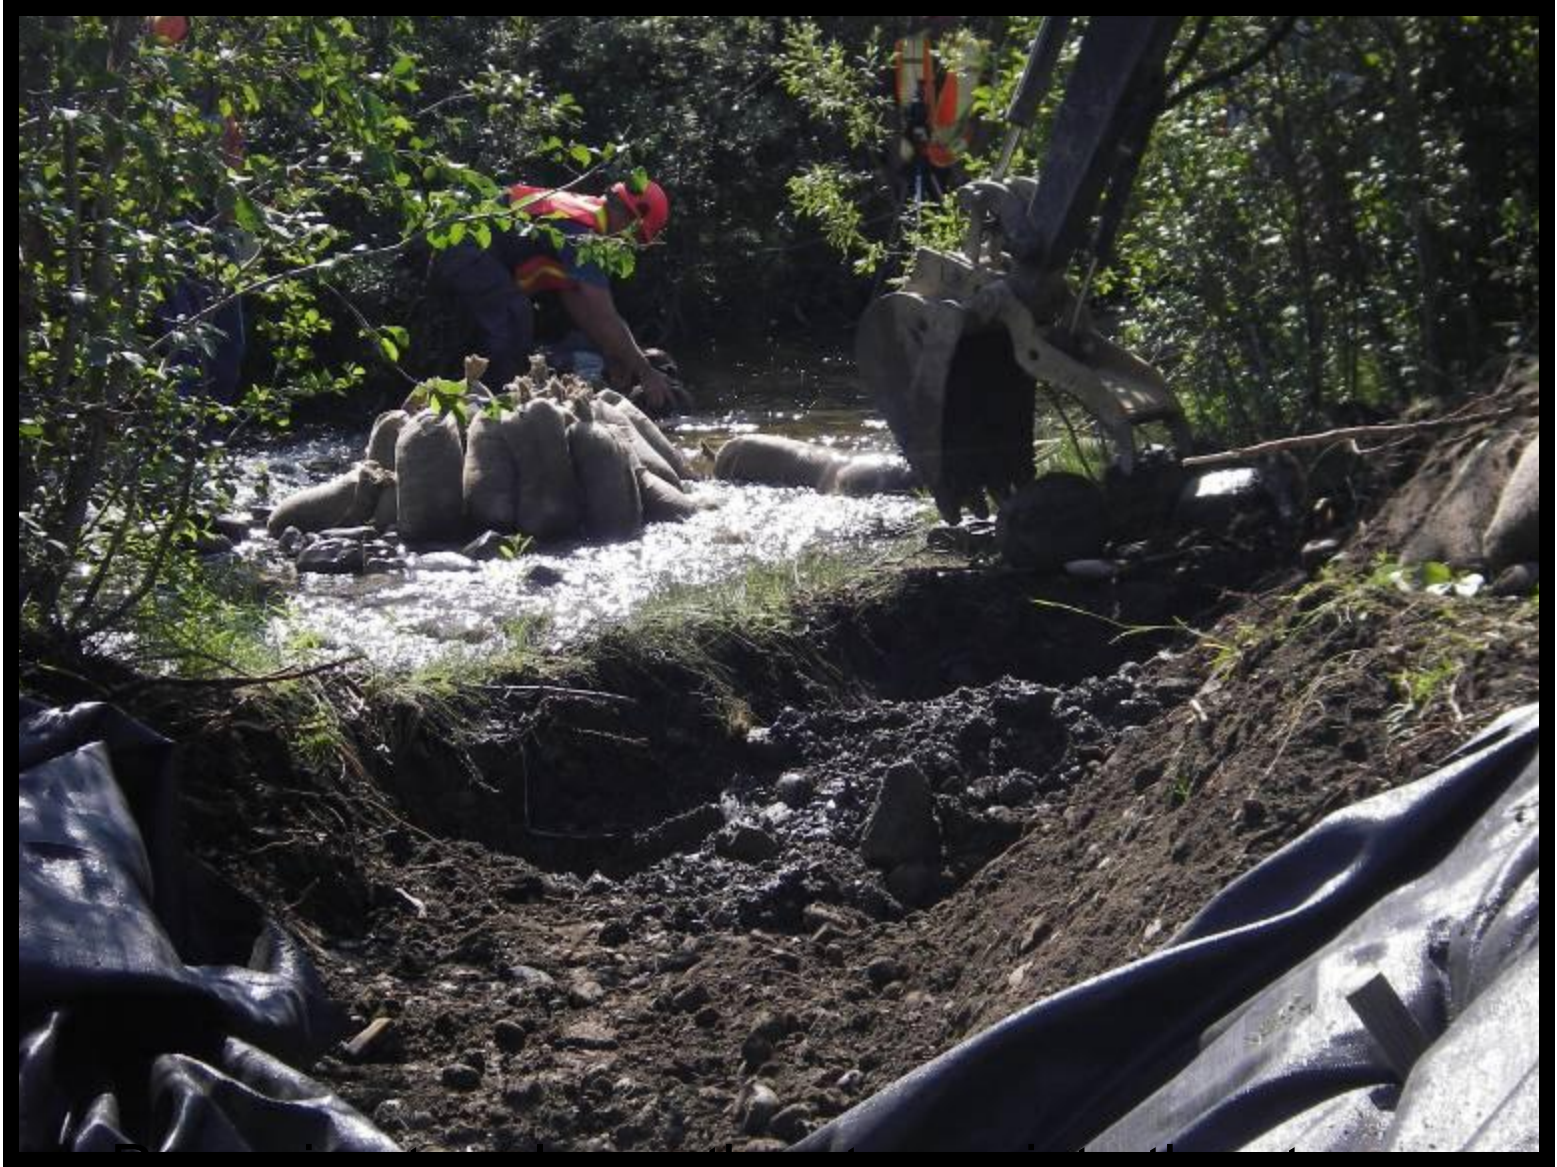
Preparing to release the stream into the stream diversion ditch

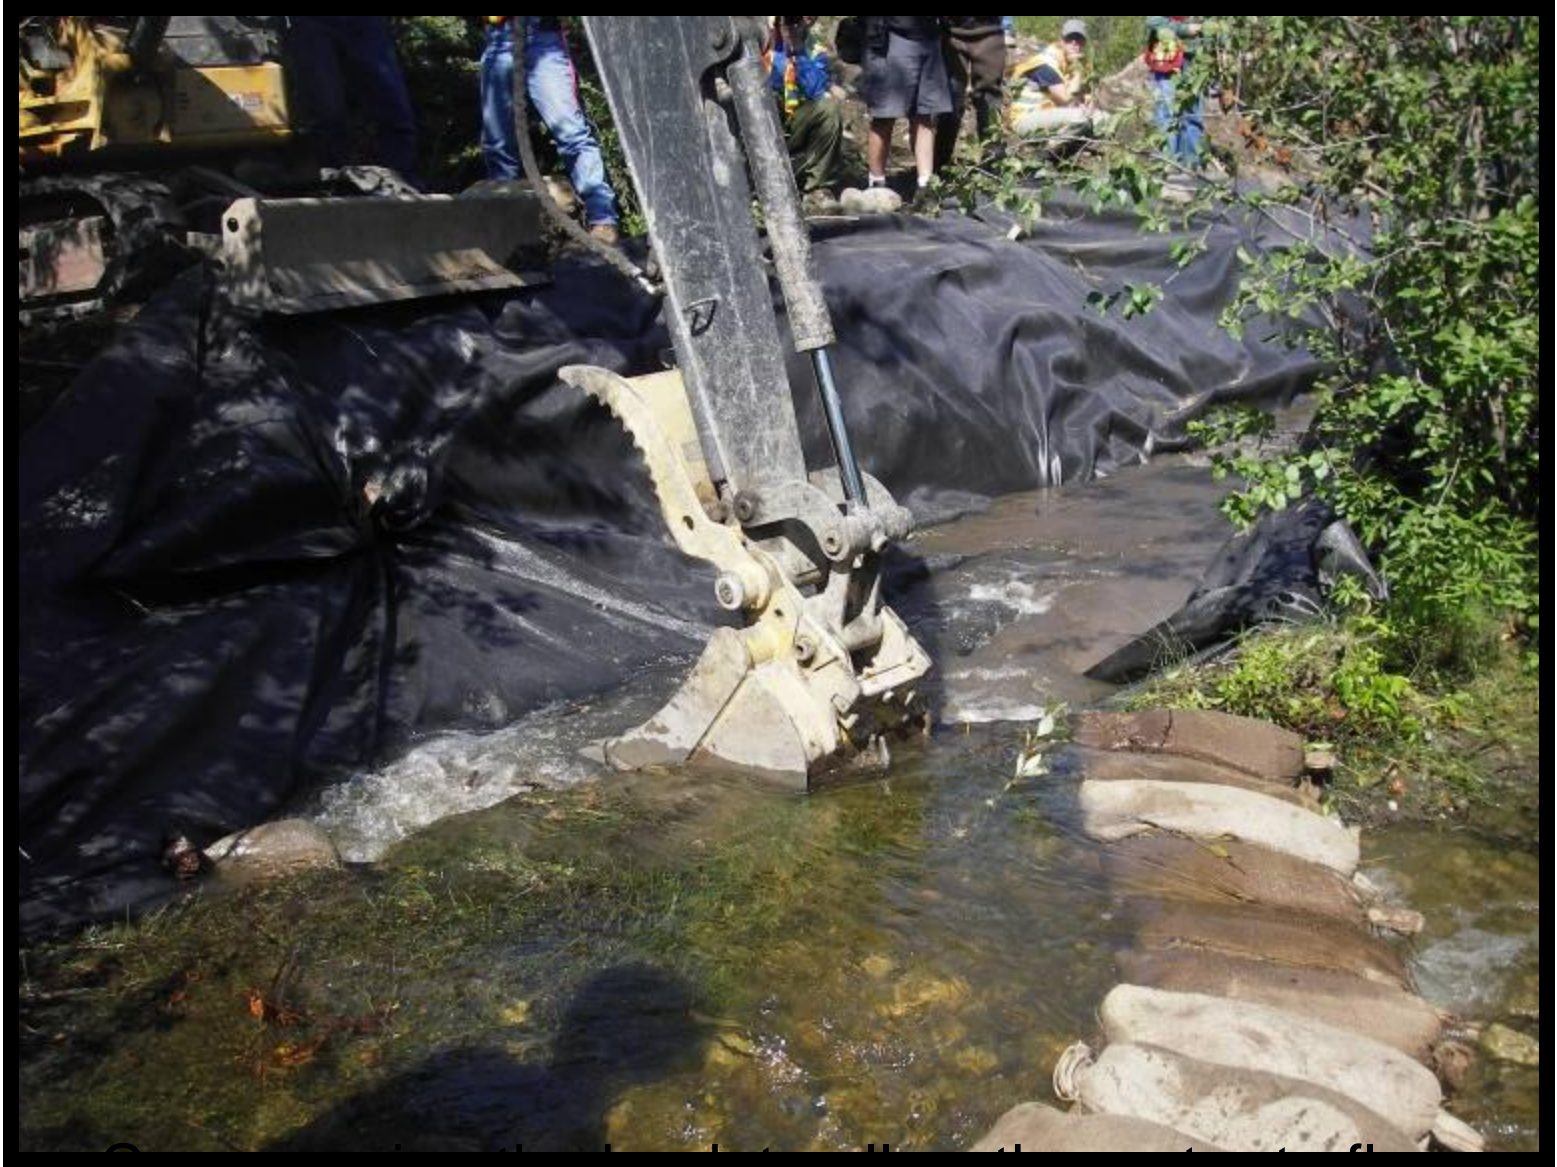
Compressing the bank to allow the water to flow through the diversion ditch

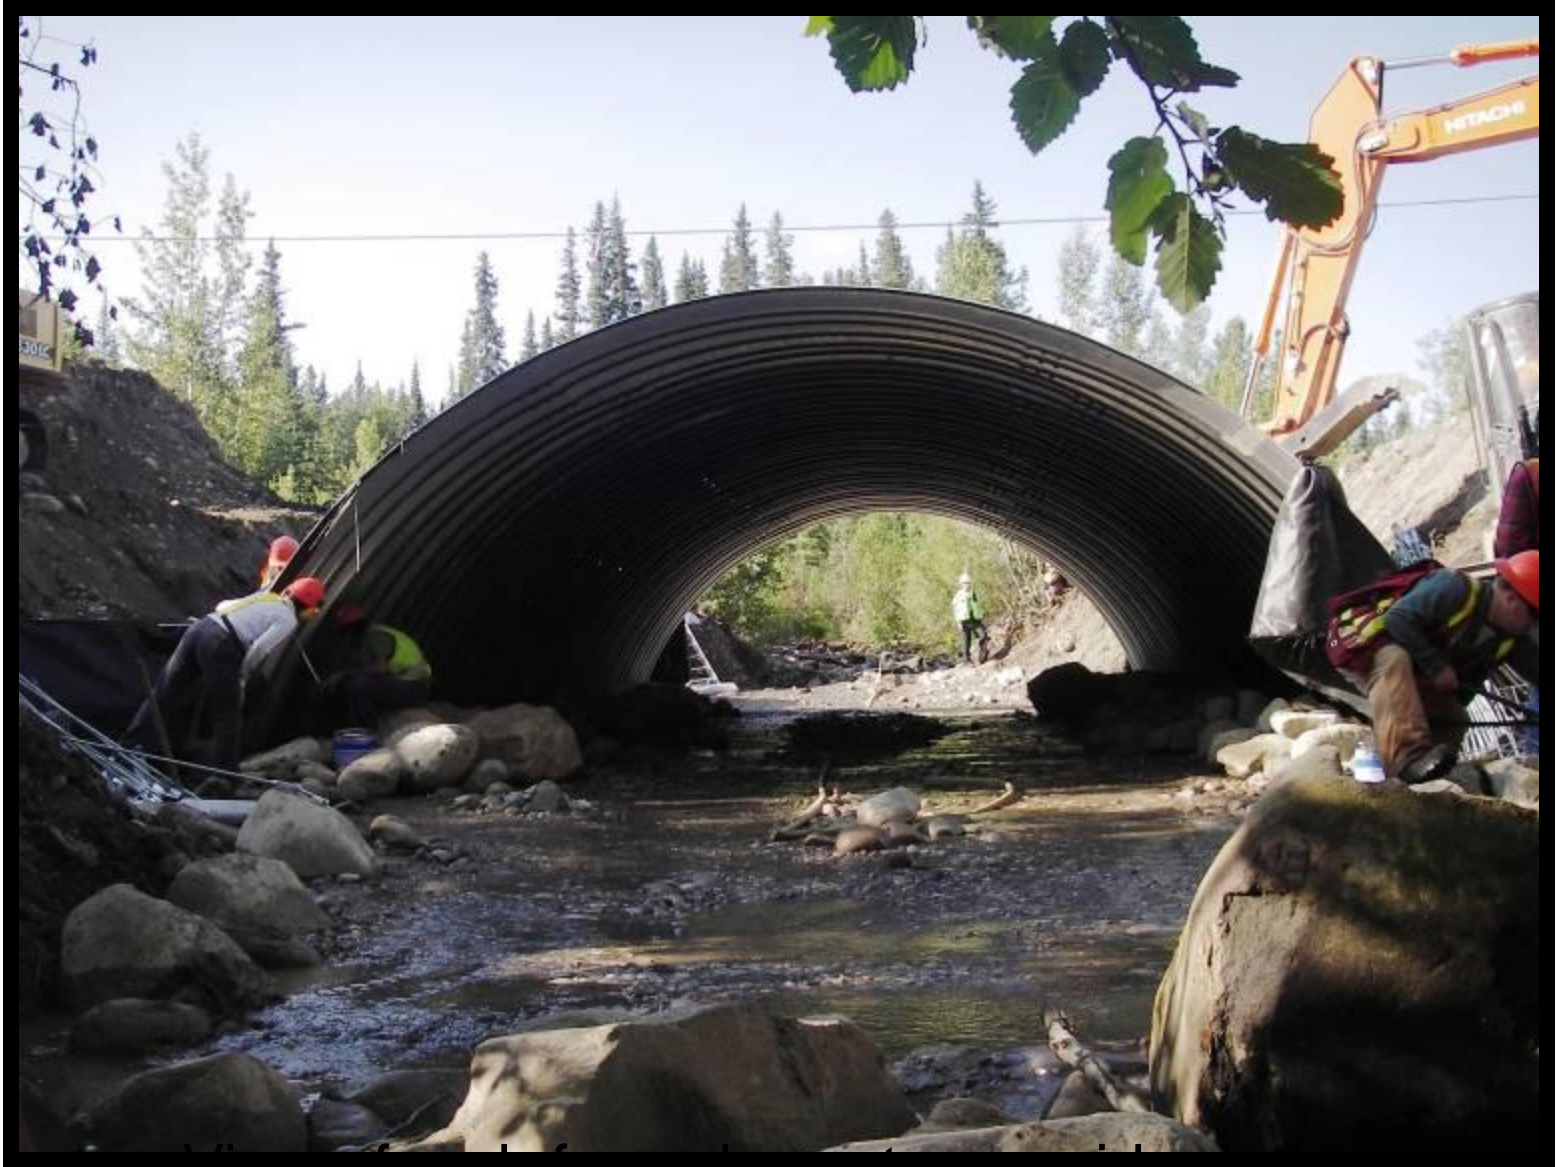
view of arch from downstream side during construction

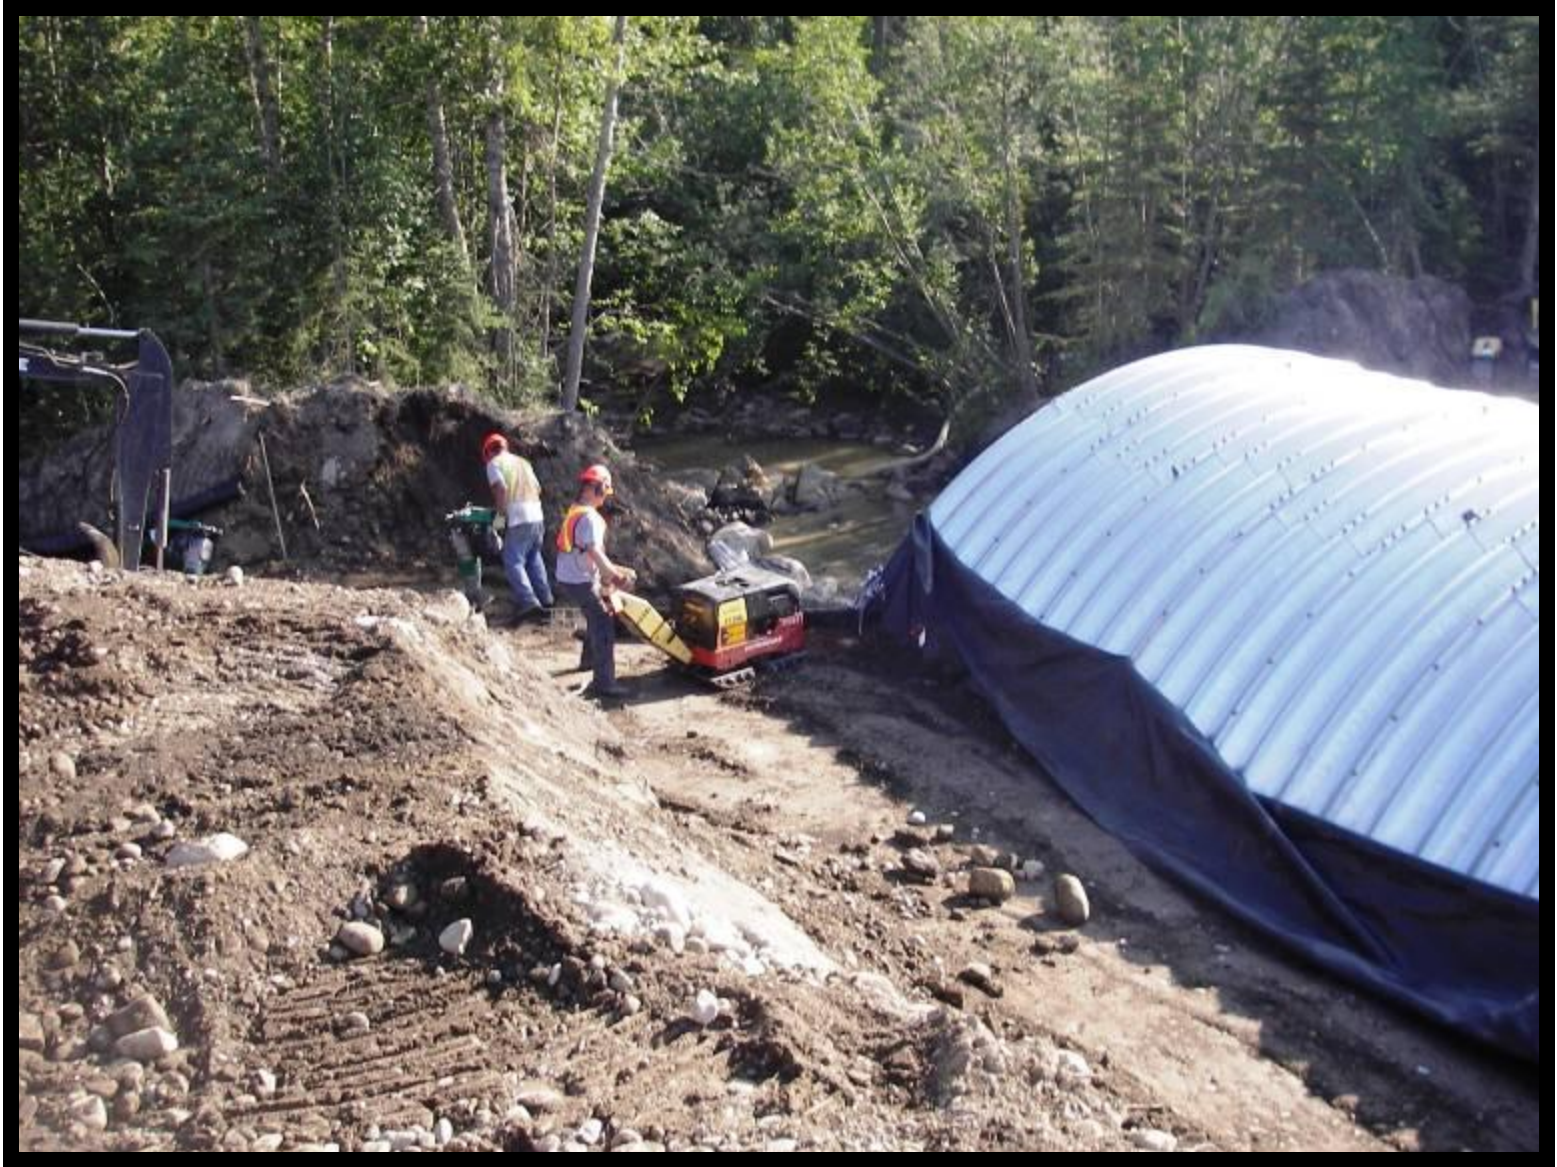
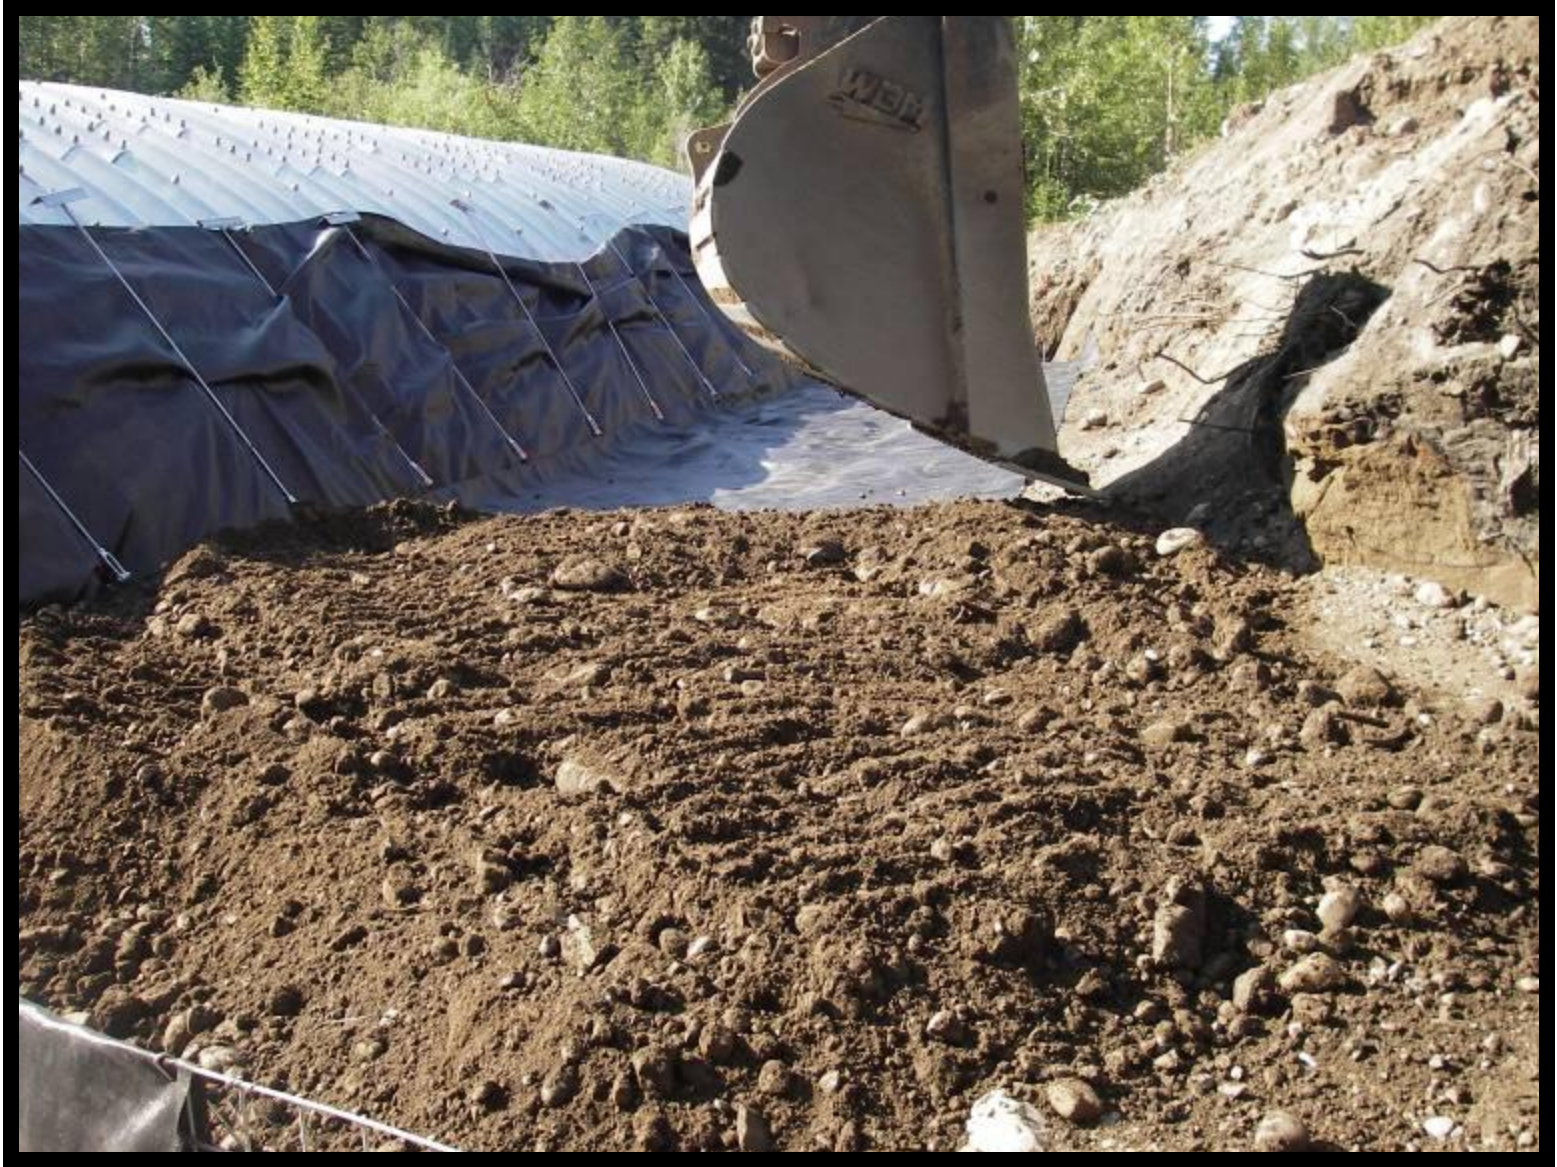
Compaction of soil around the arch

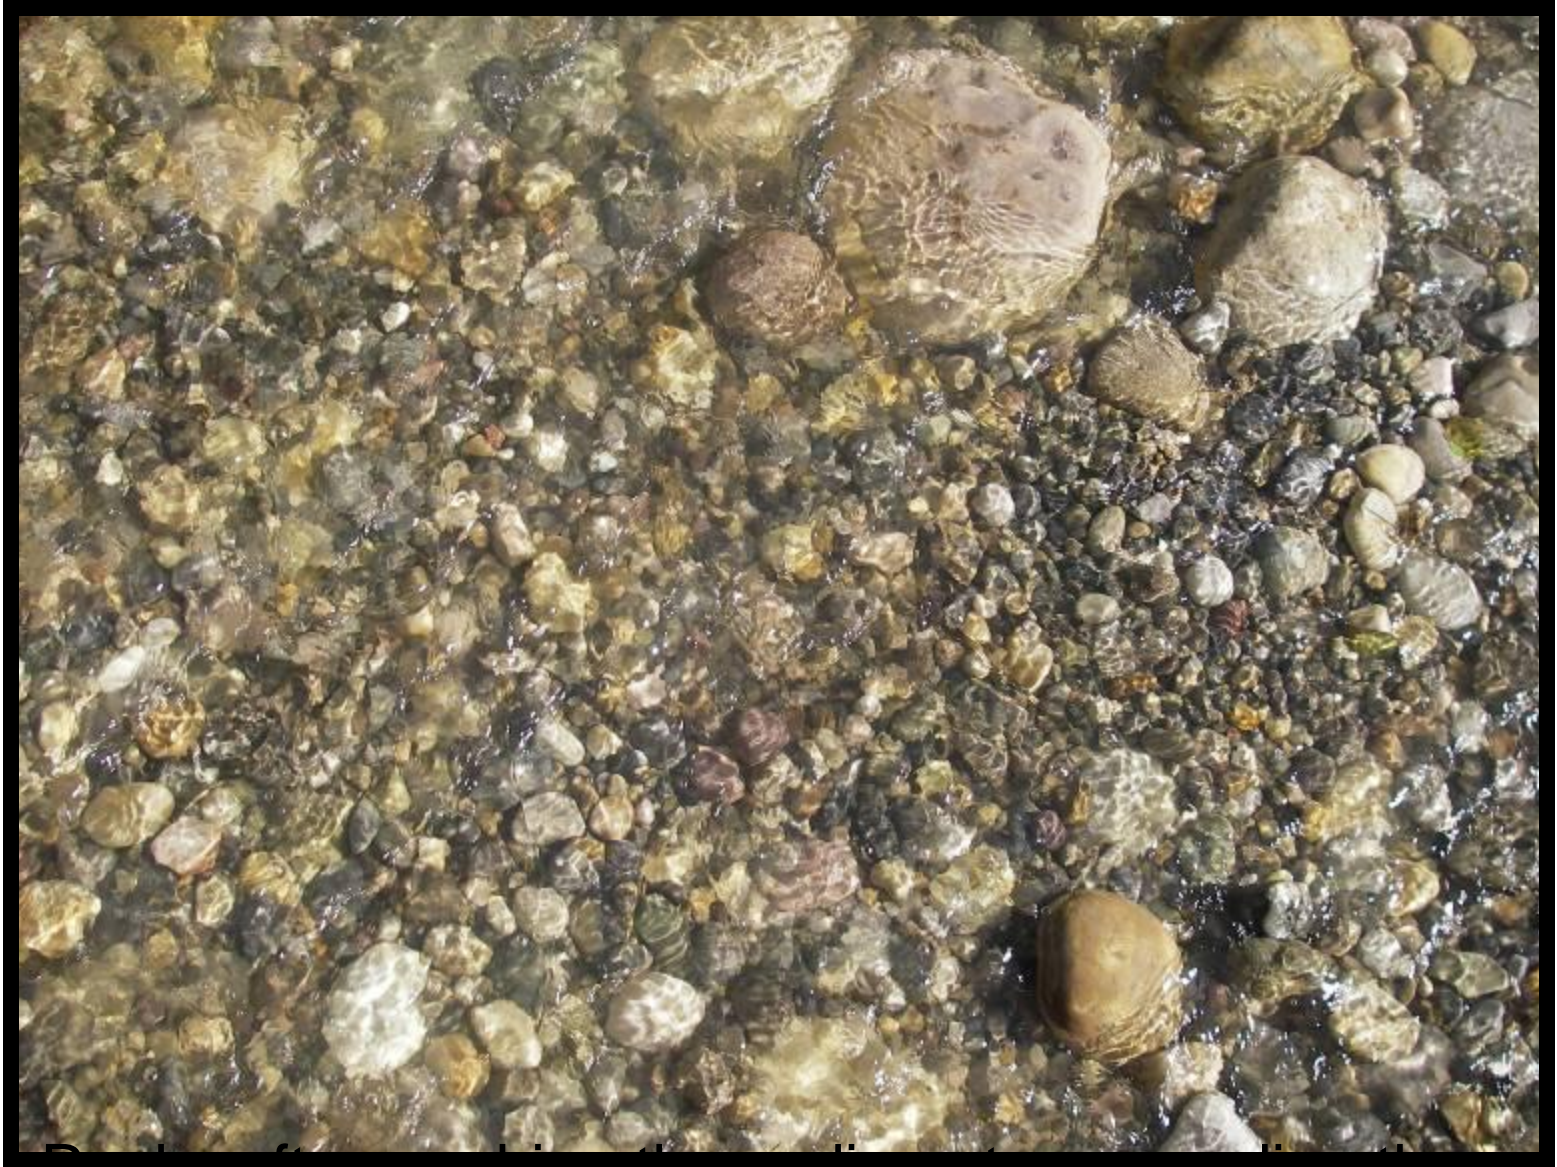
Rocks after washing the sediment surrounding them to prevent sediment from entering the creek

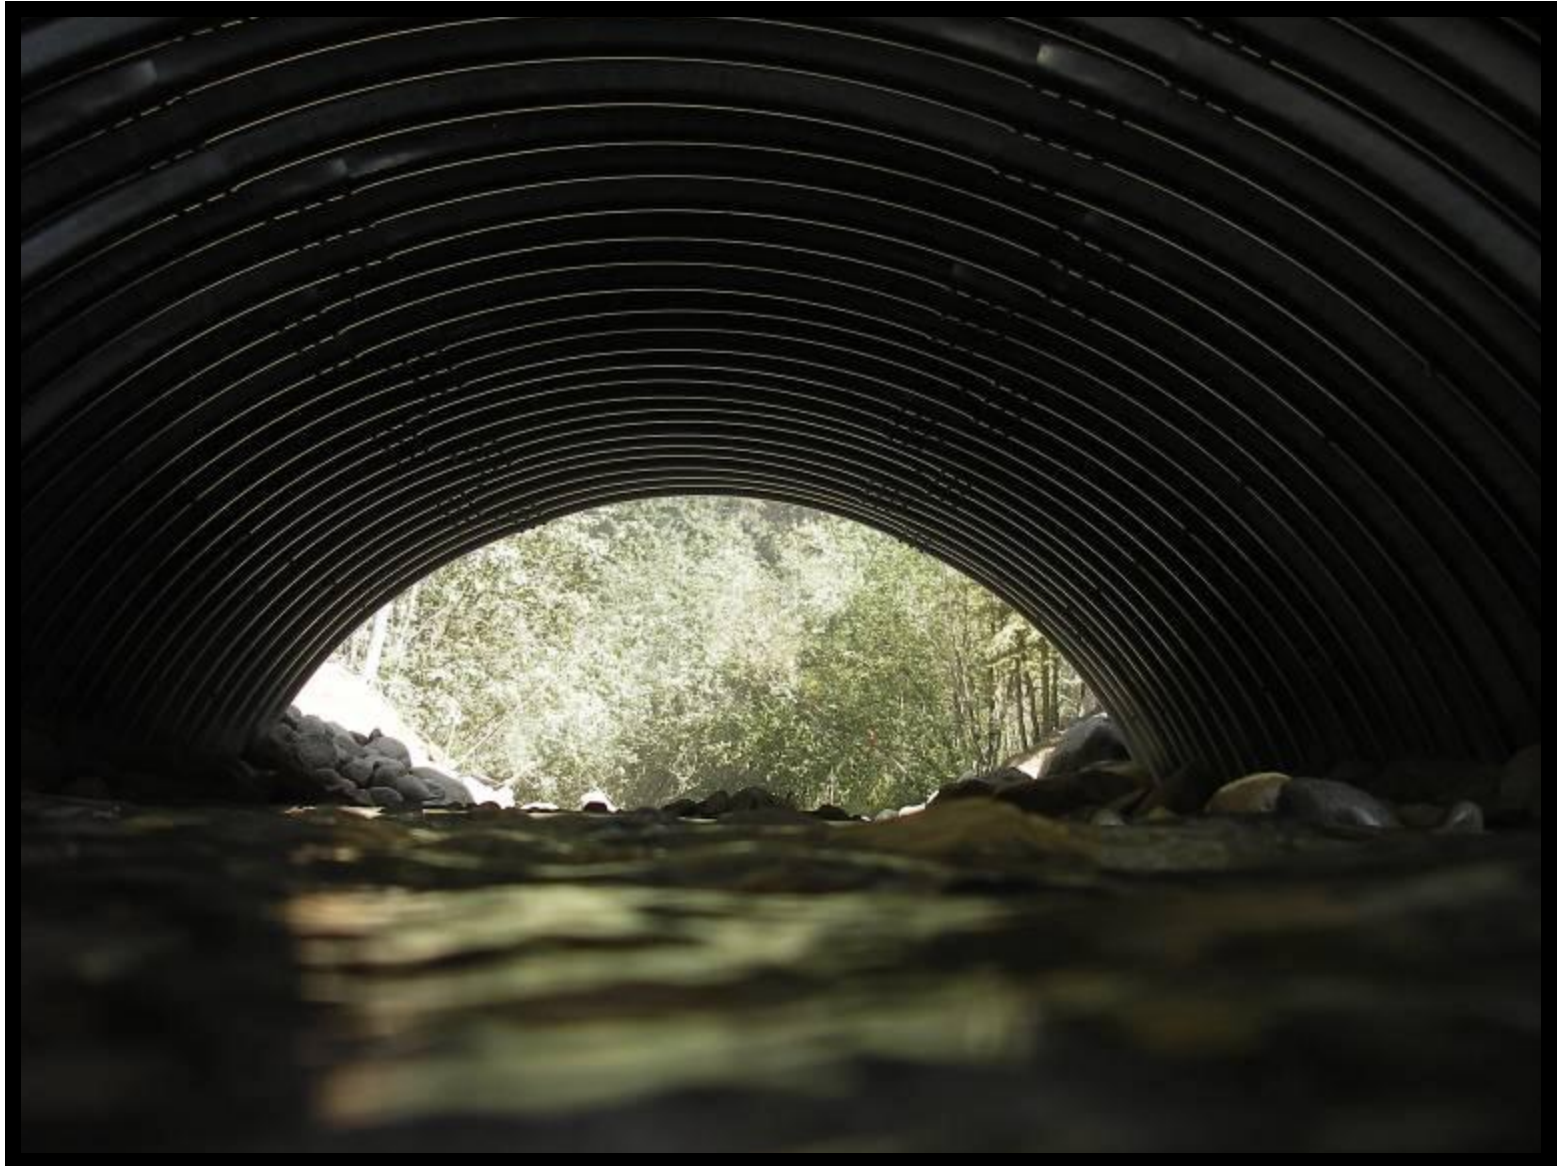
View of arch from water level facing downstream

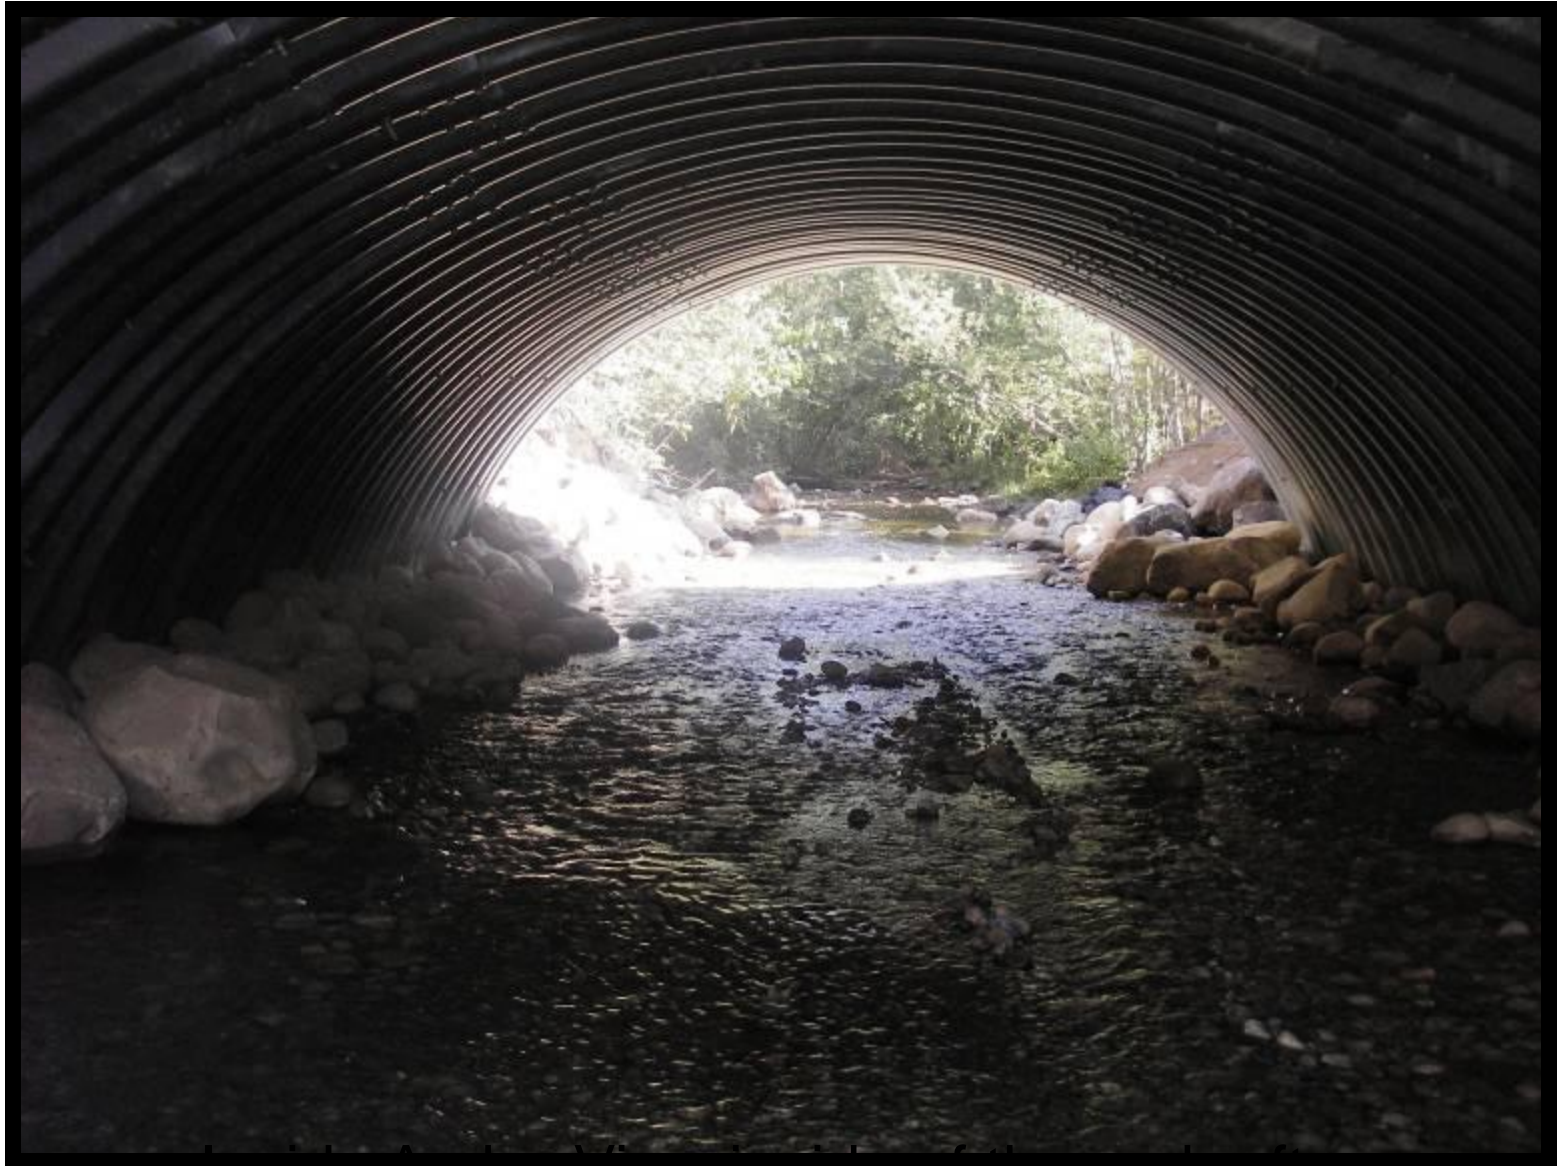
Inside Arch - View inside of the arch after construction
