## **Foothills Stream Crossing Partnership**

### **Geotextile Reinforced Soil Arch Photo Gallery**

Hardisty Creek – July 2009

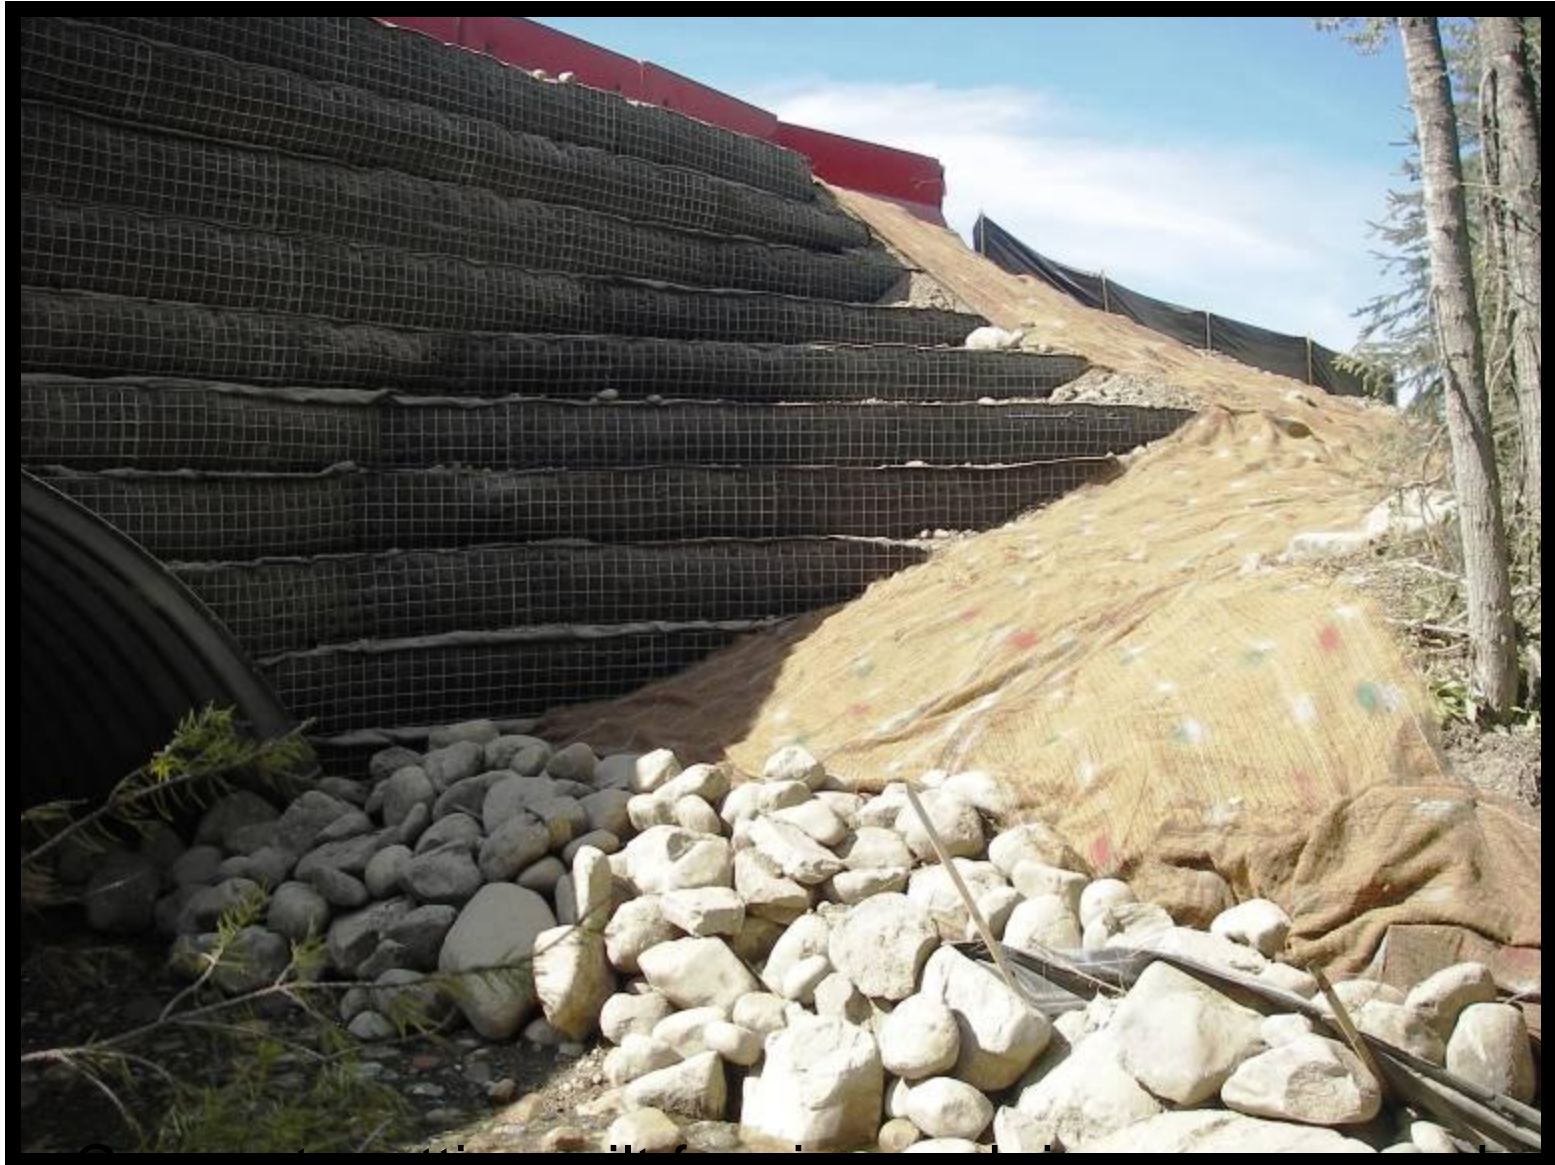
Coconut matting, silt fencing and rip rap was used as sediment control at the outlet

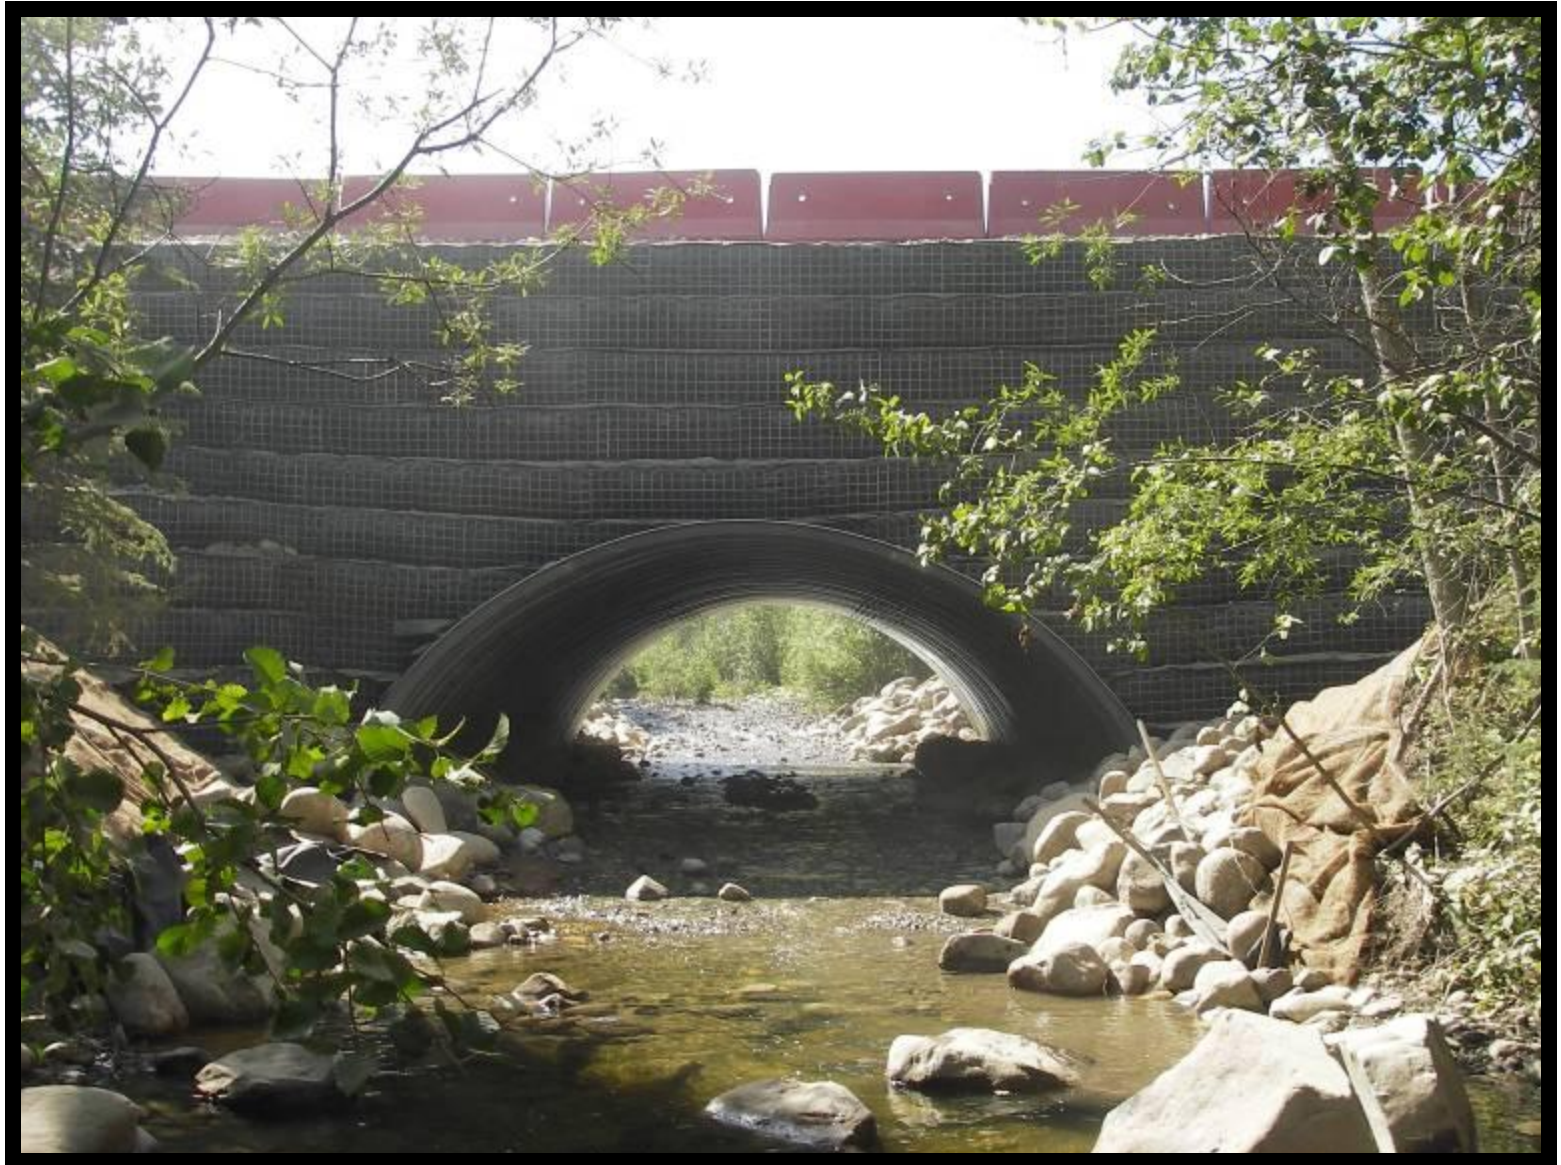
Outlet - View of outlet after construction

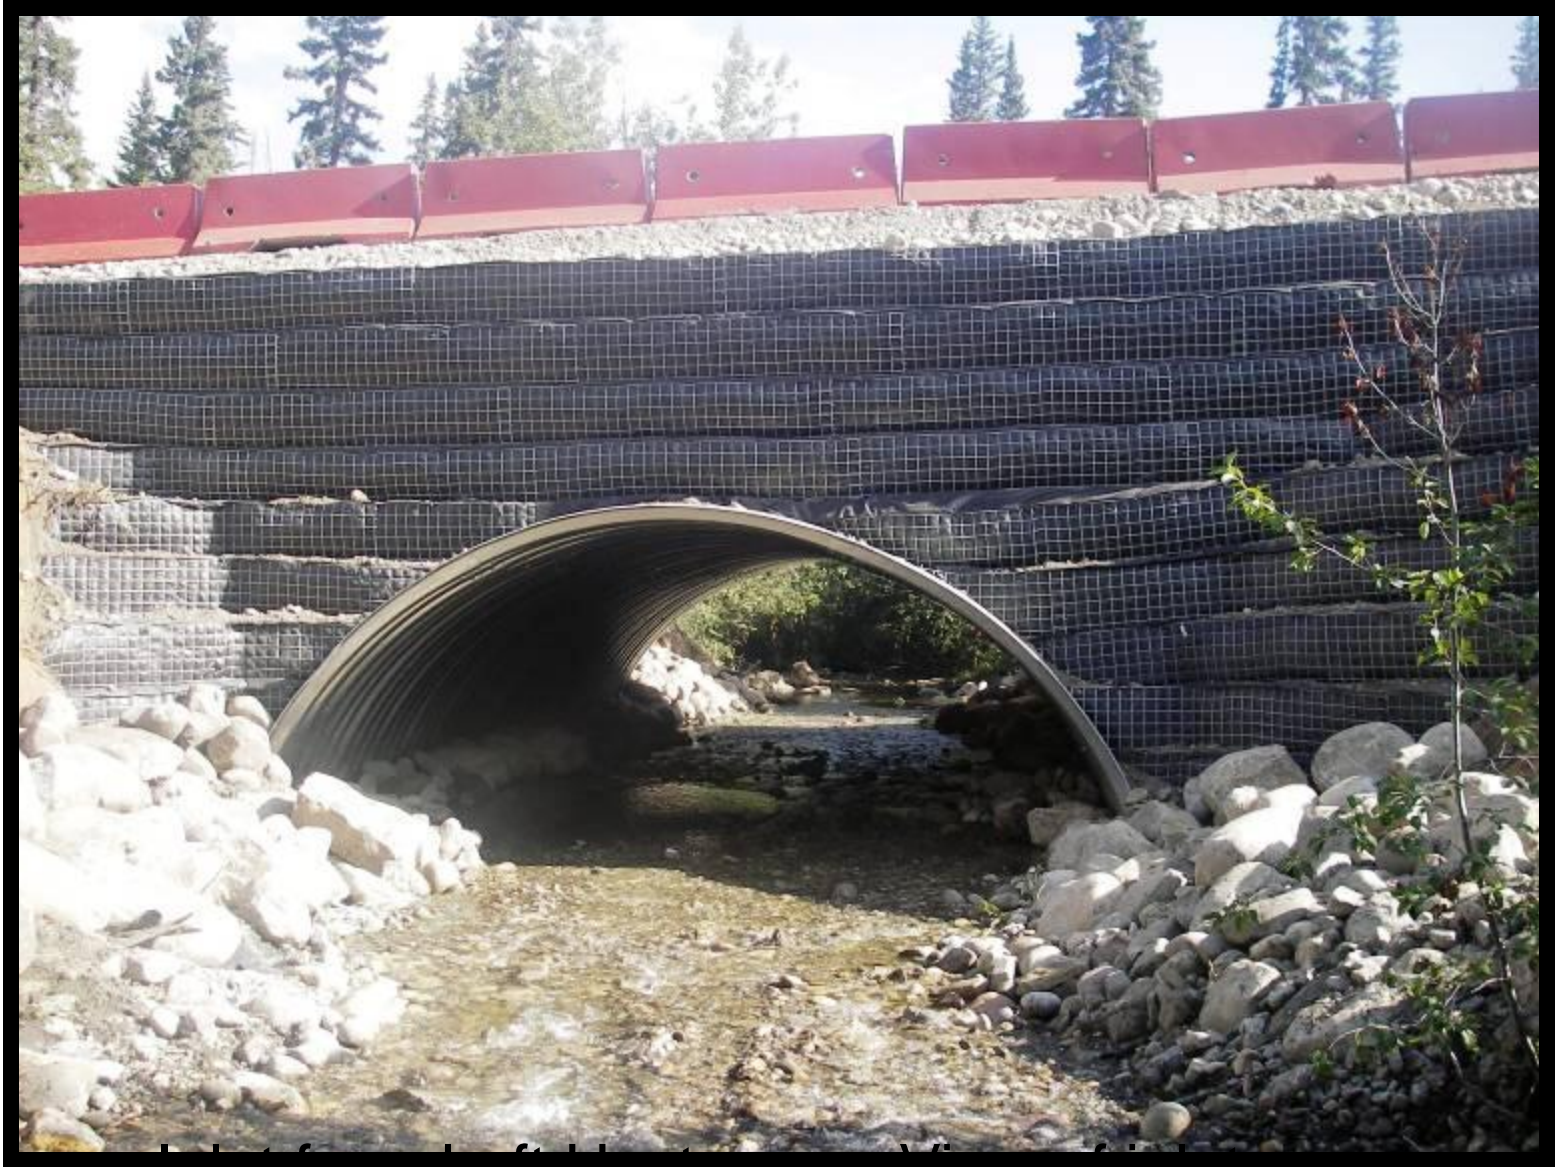
Inlet from Left Upstream - View of inlet upon completion of construction

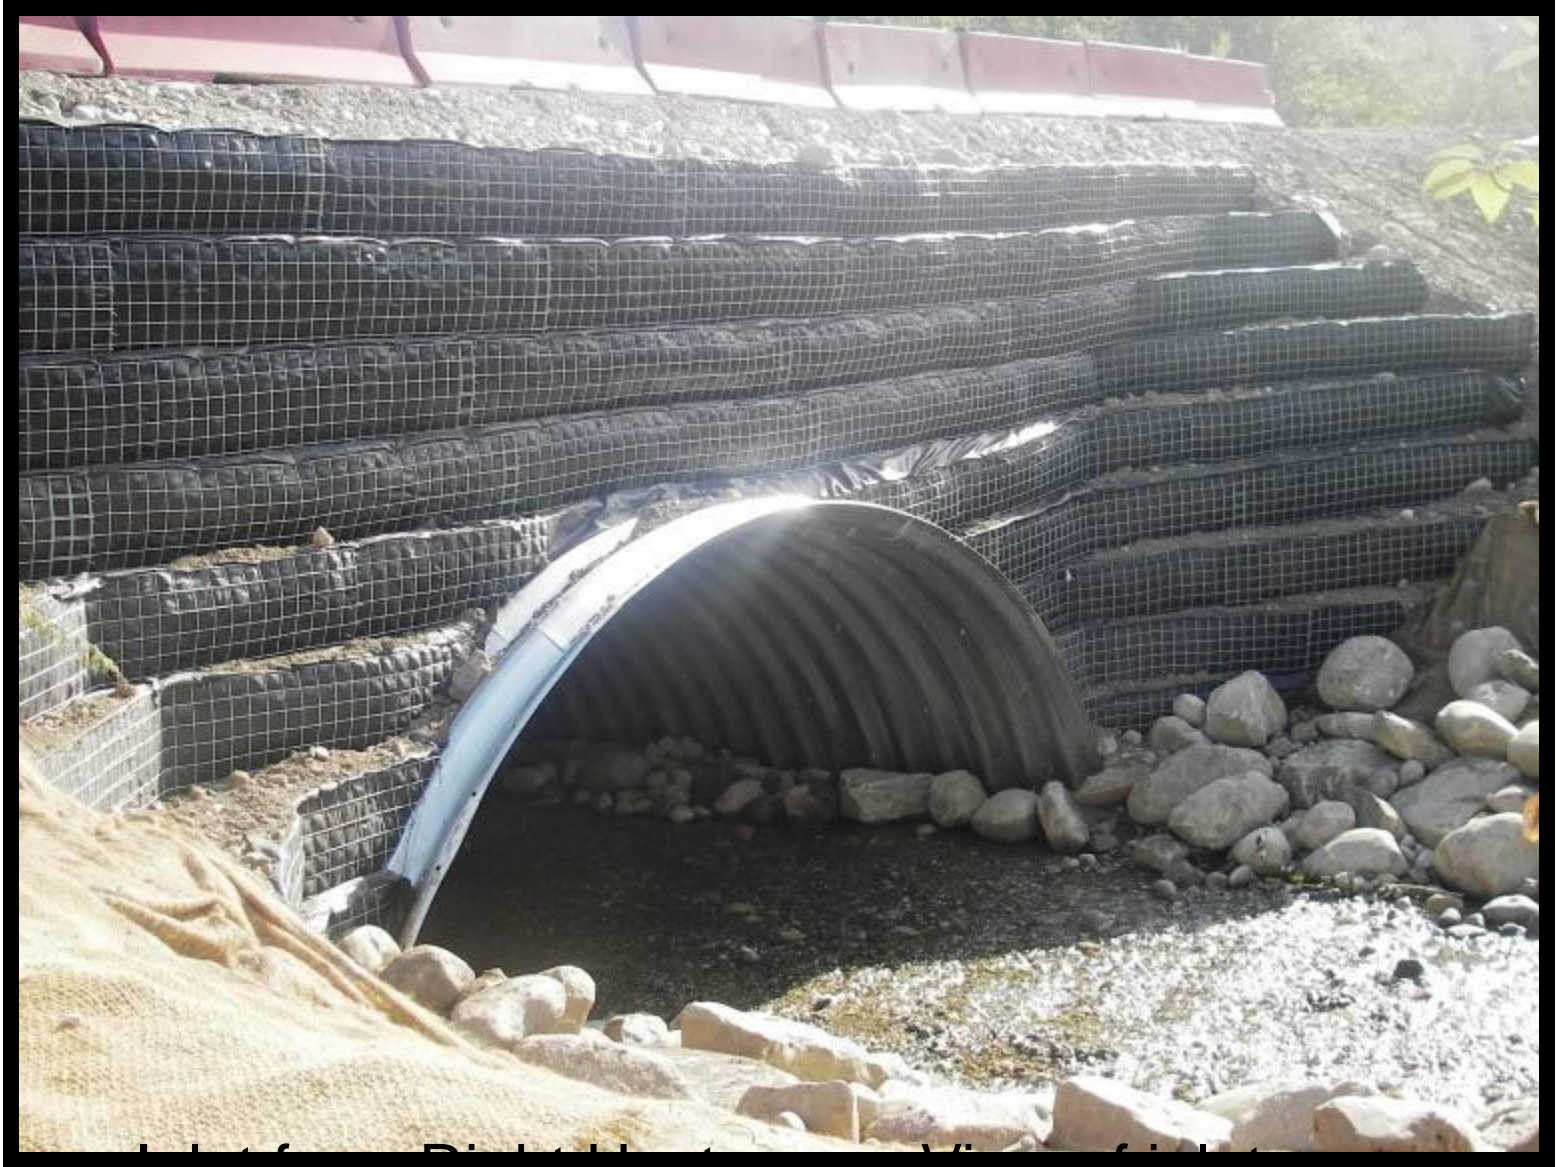
Inlet from Right Upstream - View of inlet upon completion of construction

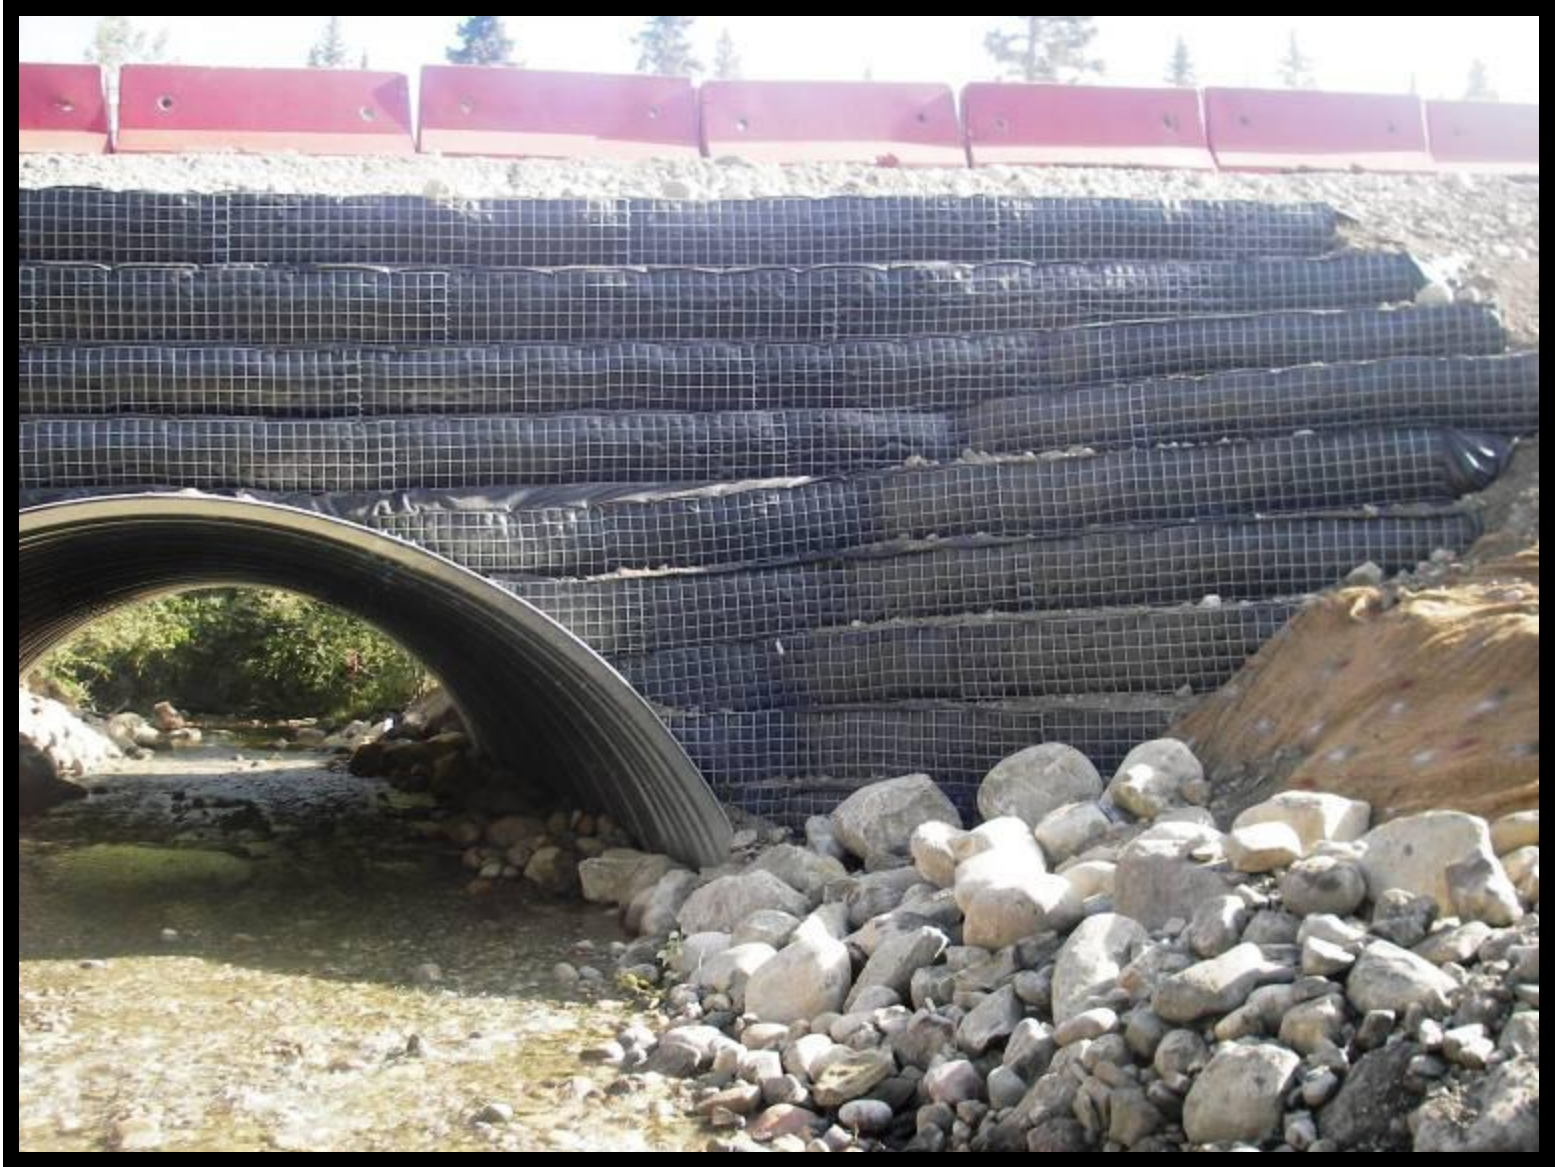
Inlet - View of inlet

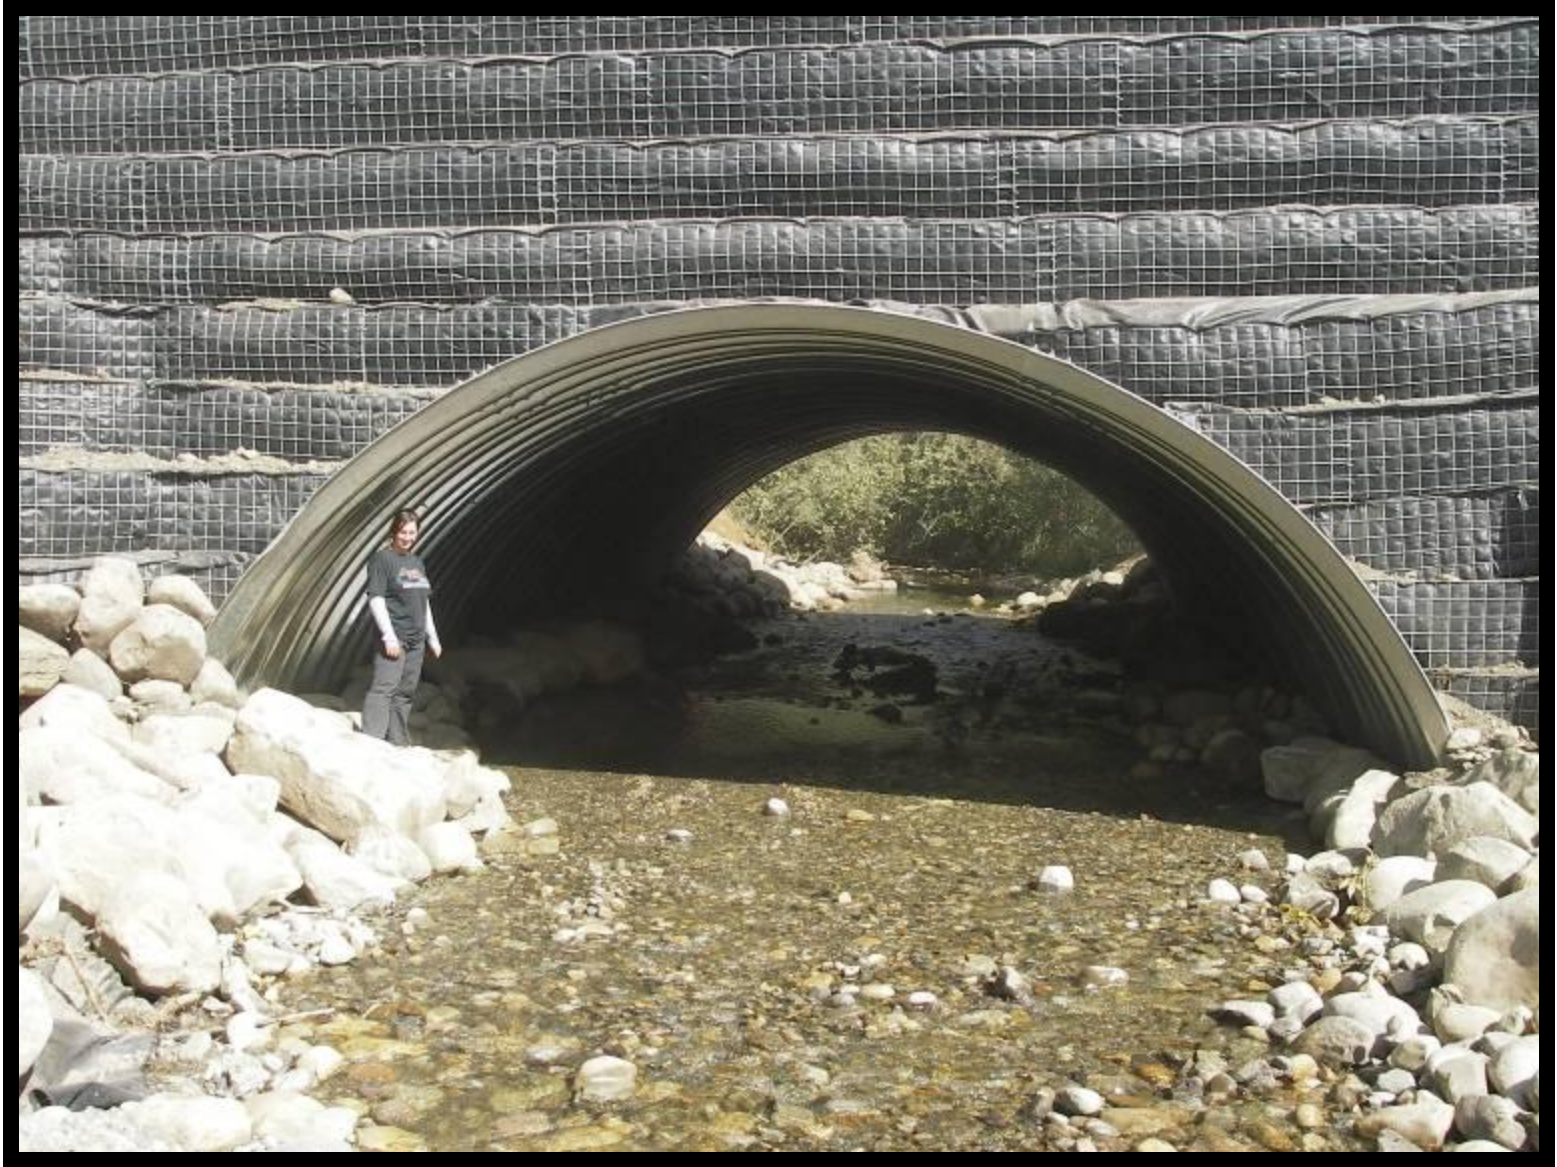
Inlet - Arch inlet after completion of construction

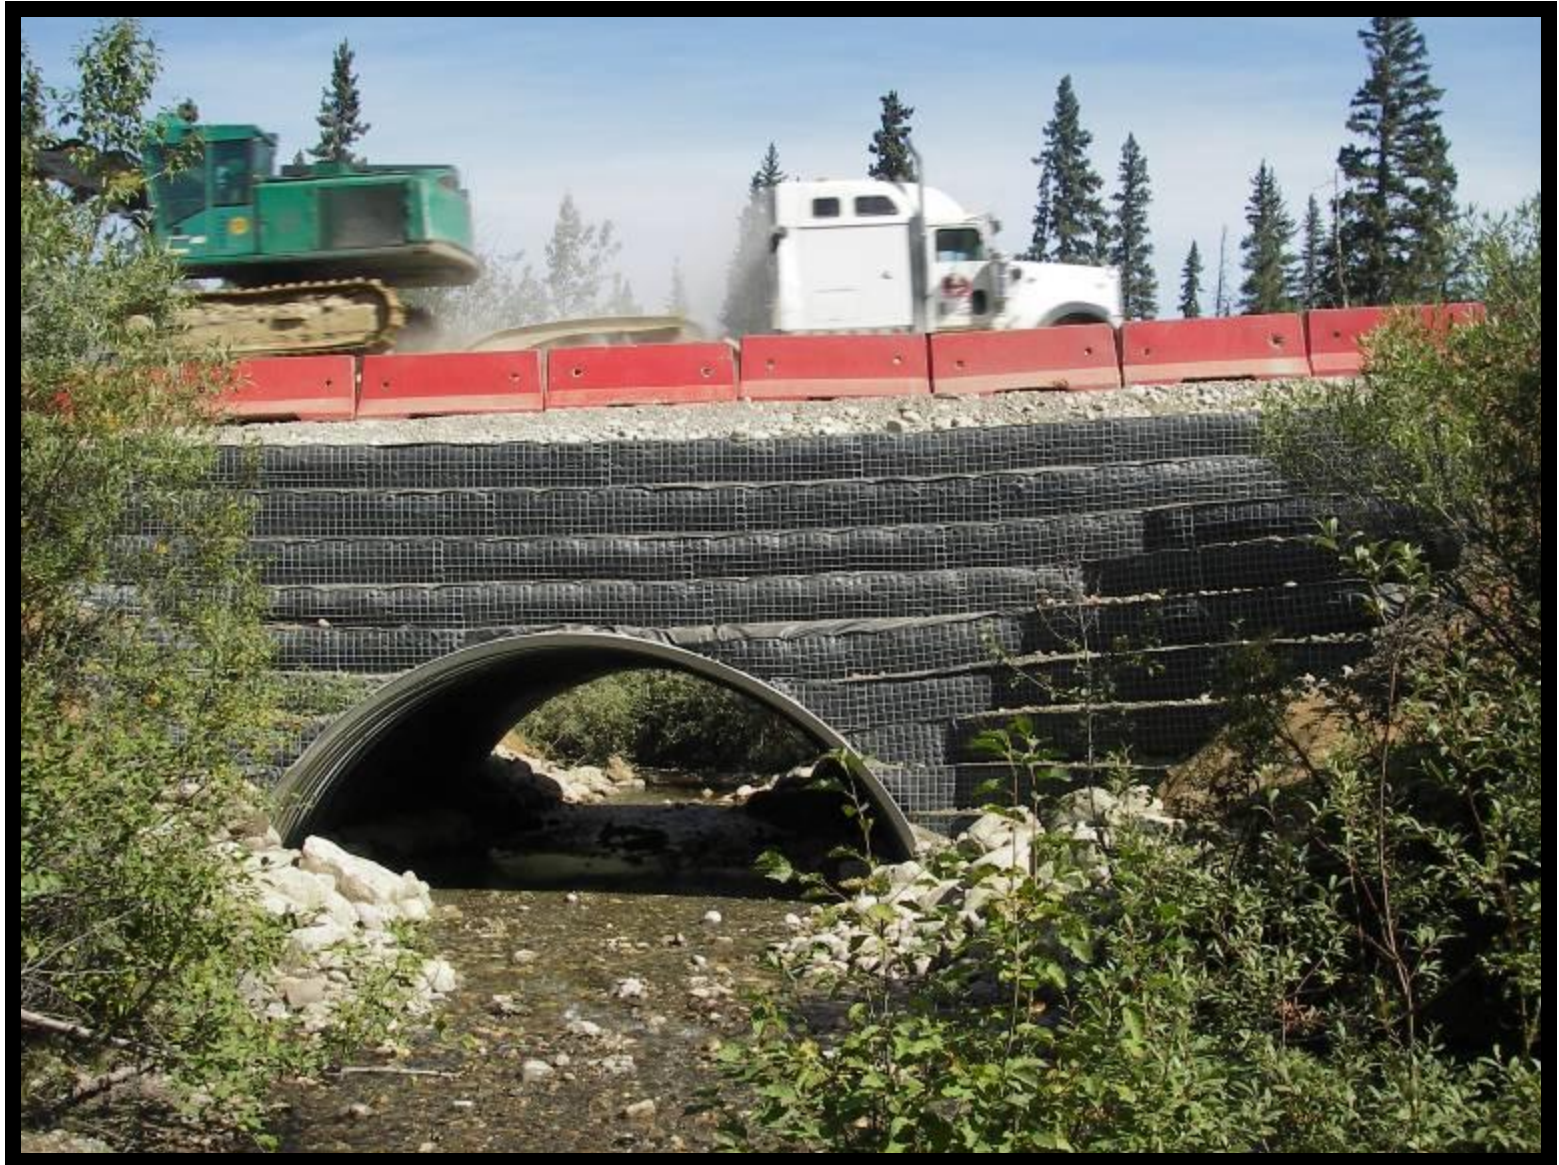
View of inlet as a semi-truck passes over

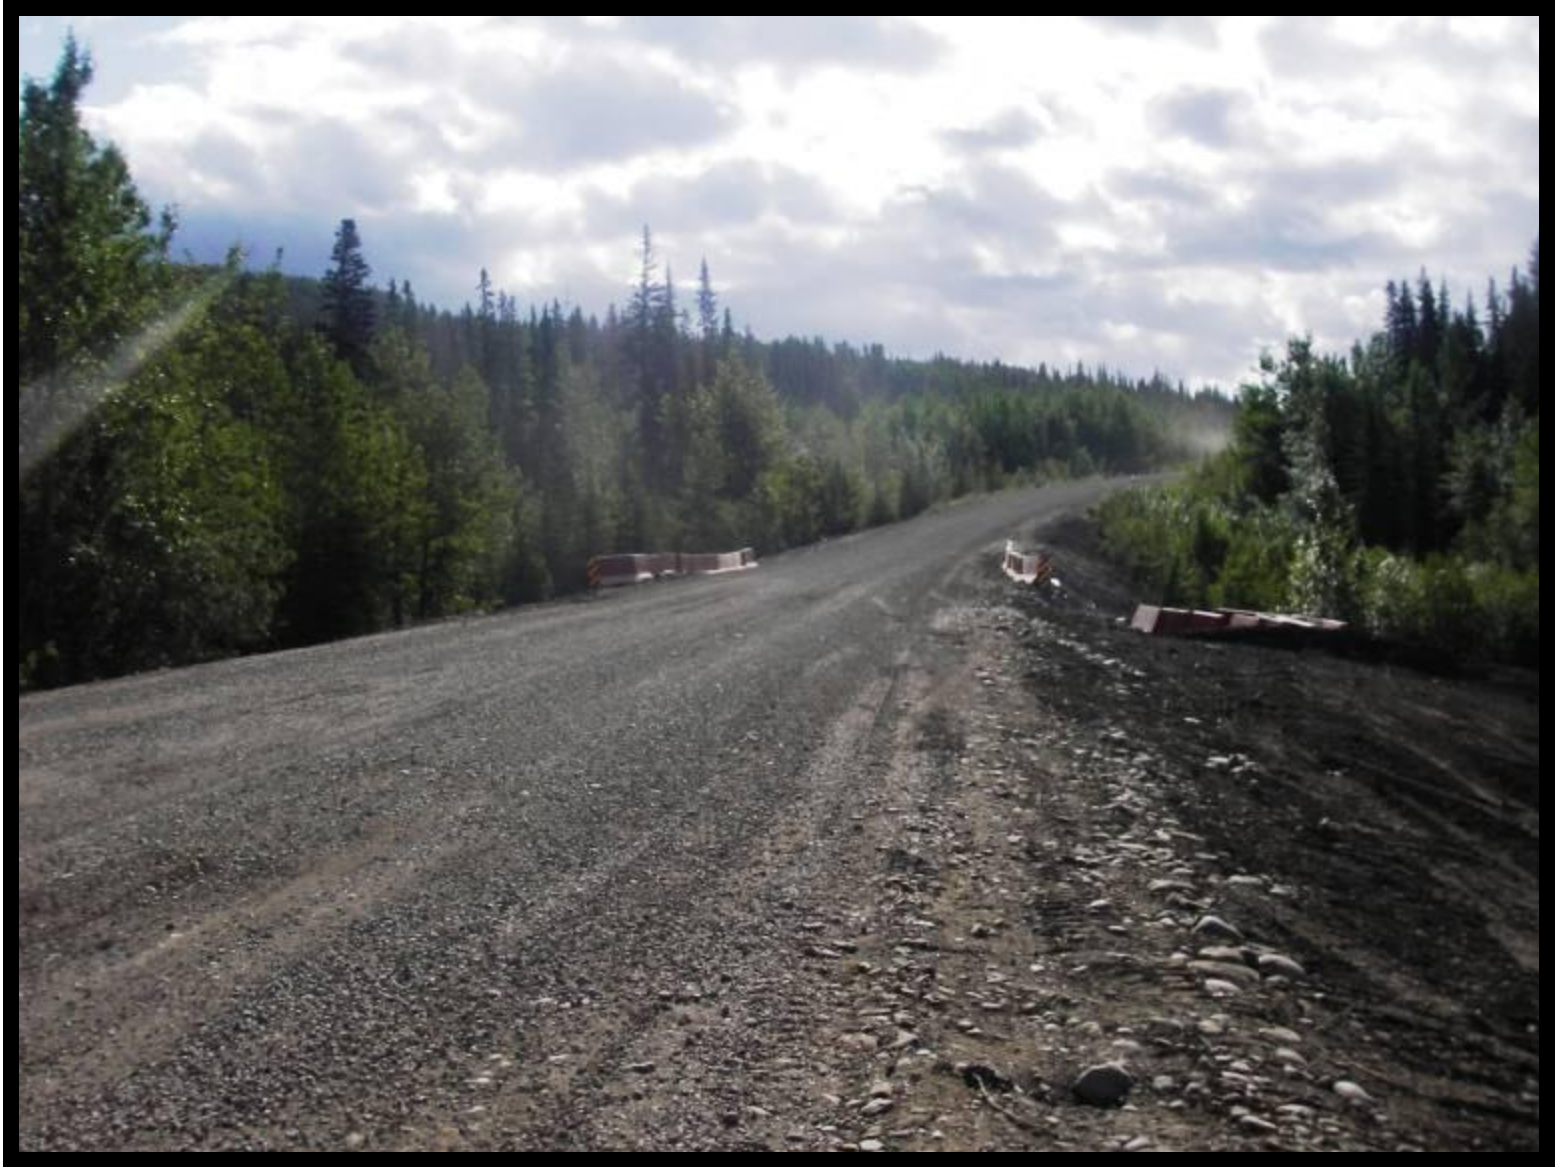
View of the road after construction
