A STREAM CROSSINGS REMEDIATION PLANNING PROCESS AND EXAMPLE APPLICATION IN THE FOOTHILLS MODEL FOREST, ALBERTA.

AUTHORS: Richard McCleary, Foothills Model Forest, Hinton, Alberta
Scott Wilson, Foothills Model Forest, Hinton, Alberta
Christopher Spytz, Weldwood of Canada Ltd. – Hinton Division, Hinton, Alberta

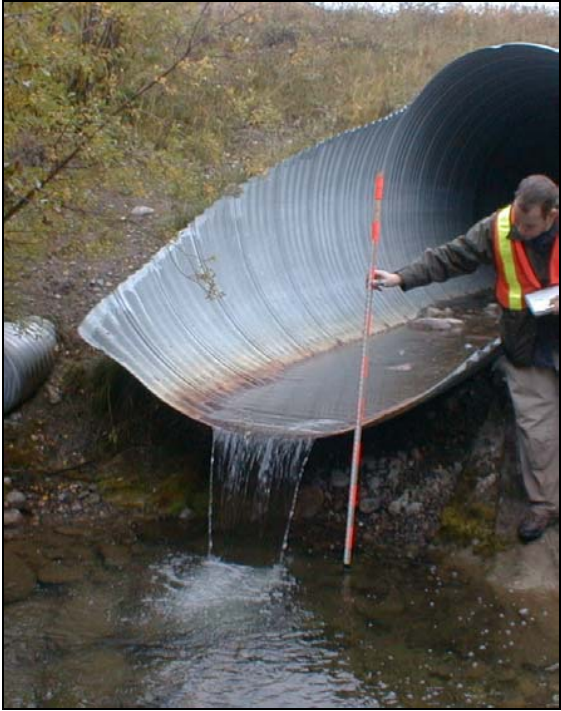
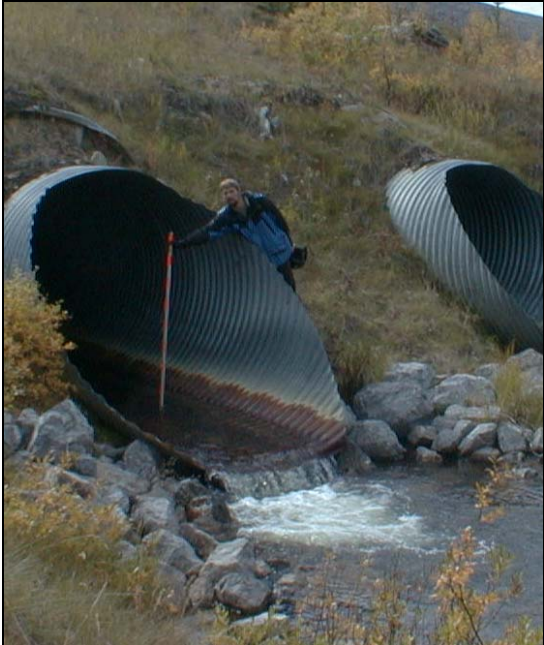
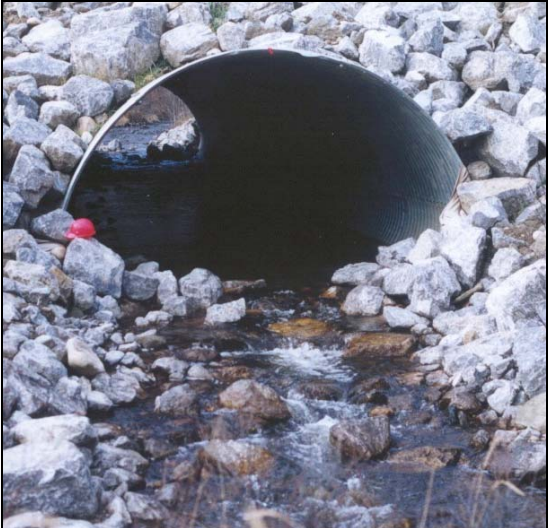
Figure 1. Assessment of stream crossing barrier status.

Full Barrier	Potential Partial Barrier	No Barrier

<ul style="list-style-type: none"> • Hang height greater than 0.6 m • Outfall pool depth less than 1.25 x hang height • Debris at inlet or outlet 	<ul style="list-style-type: none"> • Outlet hang height less than 0.6 m • Outfall pool depth > 1.25 x hang height • Water velocity in culvert greater than upstream water velocity 	<ul style="list-style-type: none"> • All bridges, fords, or engineered culverts with baffles or a natural stream-bed • Outlet not hanging and culvert backwatered by grade control downstream of outlet • Water velocity in culvert comparable to upstream

An overview assessment of fish passage was an important first step in the remediation process. This assessment served to identify crossings suited to more detailed evaluations. Candidate crossings were identified using GIS, and included all road-stream intersections and railroad-stream intersections within the study area watershed. During a field visit, a determination of barrier status was made (Figure 1). The procedure for determining barrier status was based upon Love and Firor (2001) and Parker (2000).
