Overview Assessment of Fish Passage at Stream Crossings in the Hardisty Creek Watershed

Prepared by: S. Wilson, Fish Biologist Intern
and R. McCleary, P. Biologist
Fish and Watershed Research Program
Foothills Model Forest
February 19, 2003

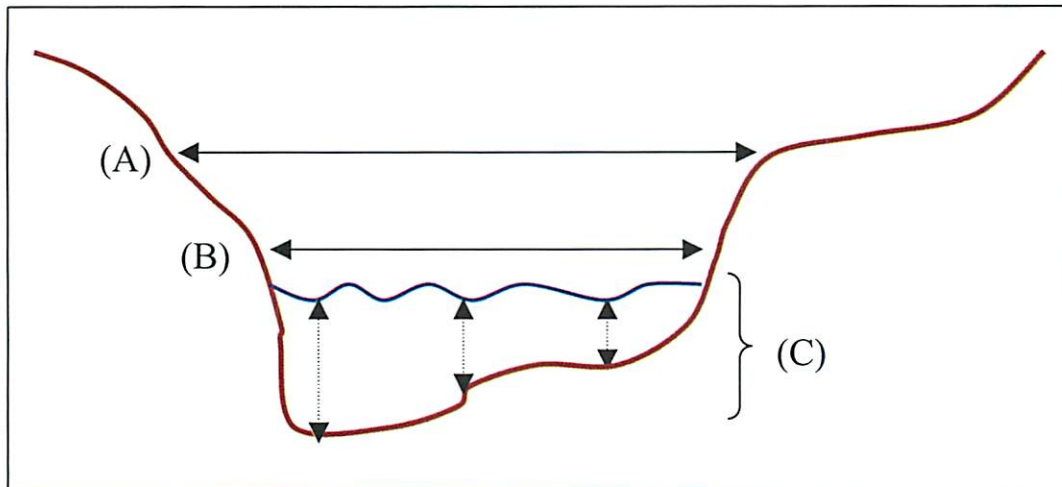
Figure 2. Stream channel measurements taken upstream of each crossing included; rooted width (A), wetted width (B), and three water depths across the channel (C).

Field assessments were completed during the fall of 2002. Each crossing was identified as a bridge, a culvert, or a ford. At all sites, stream channel measurements were taken at a location upstream of the crossing's influence. Measurements included wetted stream width, rooted/bank-full width, and three representative depths across the channel (Figure 2).

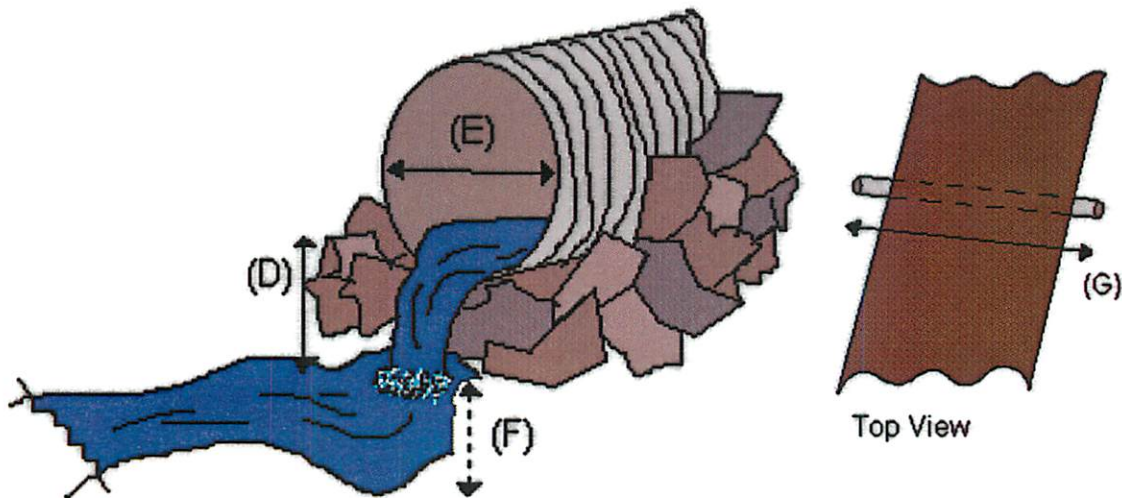
Figure 3. Typical measurements taken from a culvert-type stream crossing, where; (D) hang height, (E) culvert diameter, (F) pool depth, and (G) culvert length.

For stream crossings with a culvert, field measurements included hang height, culvert diameter, plunge pool presence and depth, and the total length of the culvert (Figure 3). In addition, presence of substrate within the culvert was noted.

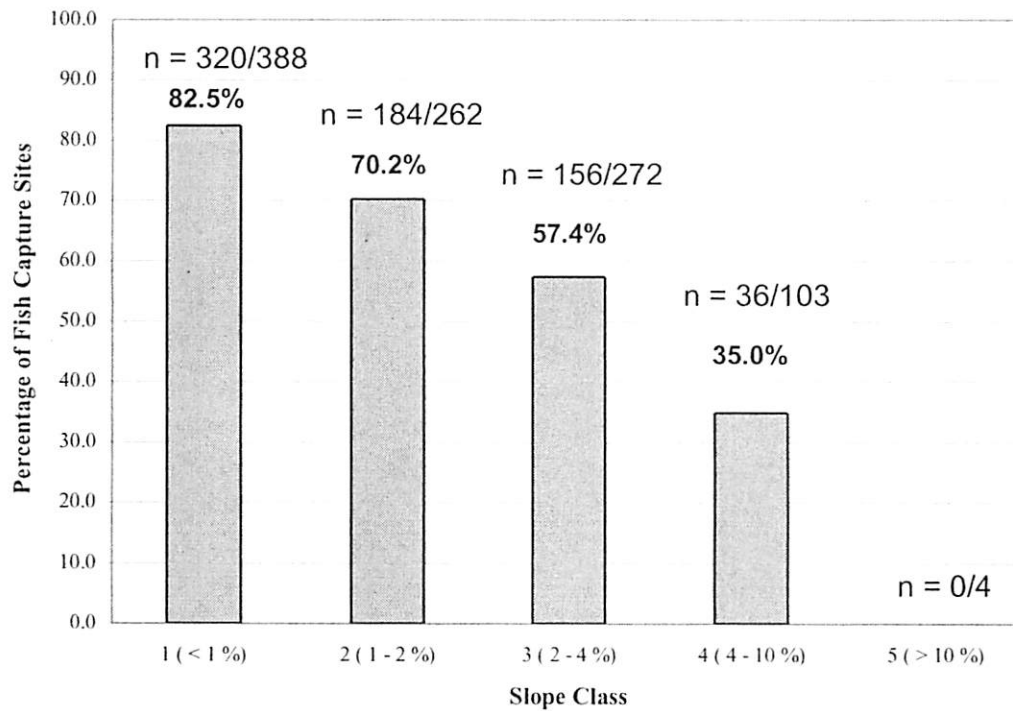
Figure 4. Percentage of sites where fish were captured within the Foothills Model Forest according to stream reach slope class.

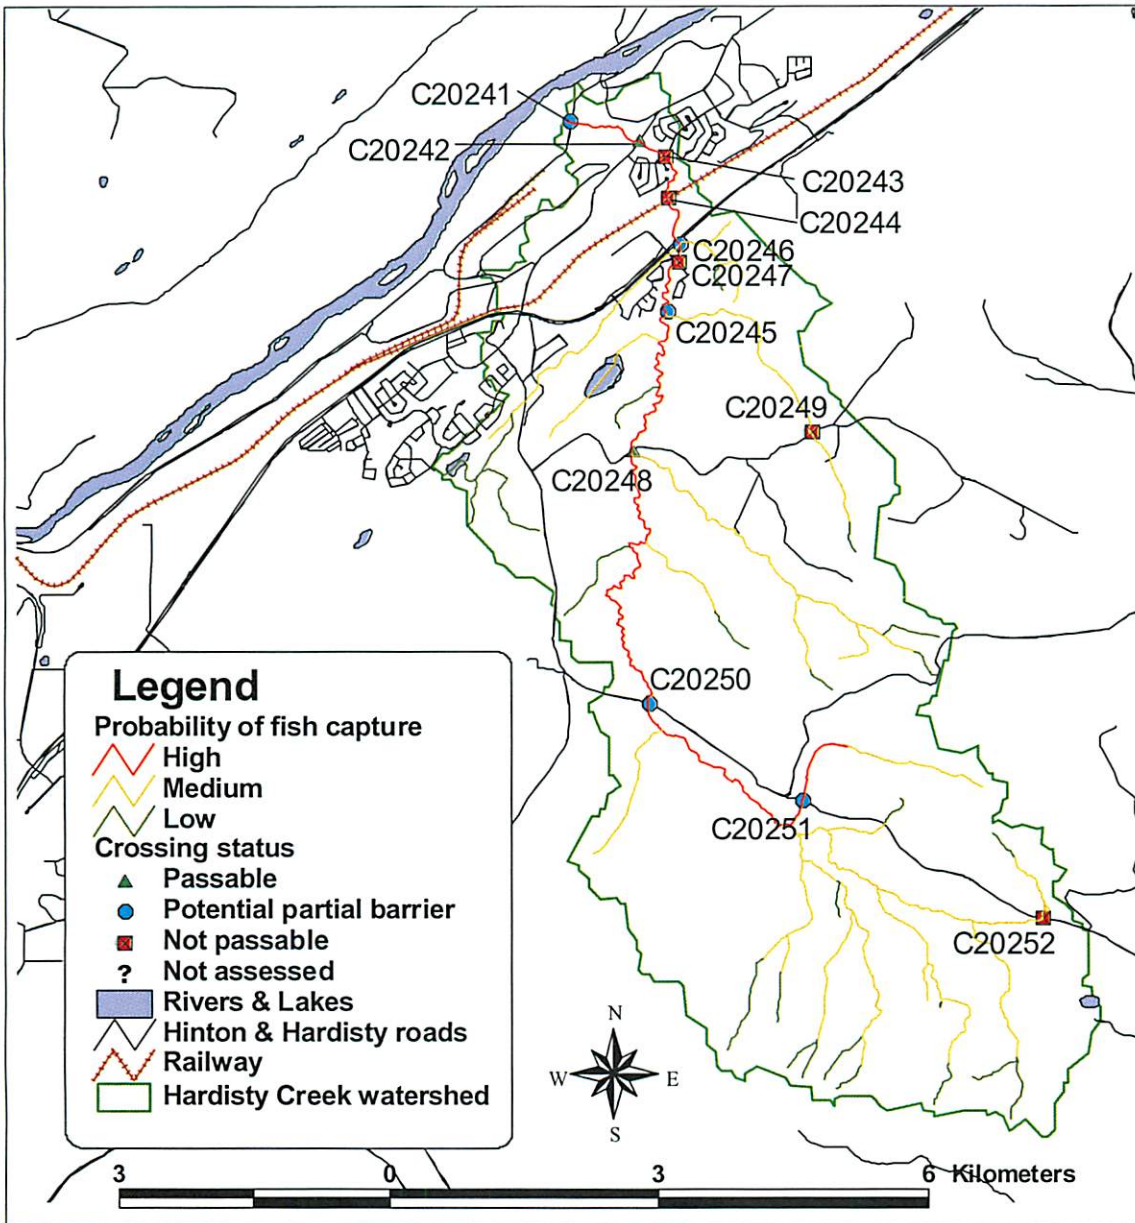
Results for Hardisty watershed were summarized into one figure and three tables. The figure is a map showing roads, streams and crossings (Figure 5). The status of each crossing was represented by a symbol and the fish capture probability was represented by one of three different colors.

Figure 5. Stream crossings in Hardisty watershed.

Three crossings that were located in high probability of fish capture streams presented full barriers to fish migration (Table 3). These sites would be candidates for detailed restoration prescriptions.

Five crossings that were located within high probability streams were found to present a potential partial barrier to fish migration (Table 4). These sites would be candidates for more detailed crossing assessments.

Two crossings that were located within medium probability of fish capture streams were found to present either a full or potential partial barrier to fish migration (Table 5). These sites would be candidates for additional inventory of fish and fish habitat to confirm the fish habitat status.

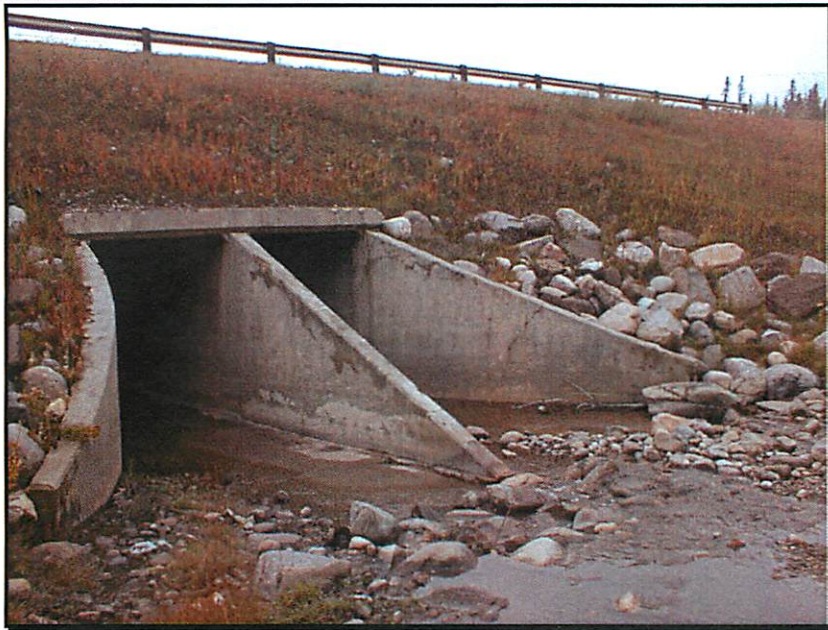
Inlet

FMF culvert ID	C20246
Weldwood ID	
Date	9/30/2002
Stream	Hardisty Creek
Tributary to	Athabasca River
Watershed	Hardisty
Easting	463 518
Northing	5 917 970
Structure type	Concrete slab

Culvert 1 diameter	2.4m concrete slab
Hang height	0.28m
Substrate	Yes
Outlet backwatered	No
Pool description	Present
Culvert 2 diameter	2.4m concrete slab
Hang height	0.28m
Substrate	Yes
Outlet backwatered	No
Pool description	Present
Culvert 3 diameter	
Hang height	
Substrate	
Outlet backwatered	
Pool description

Barrier class*	3
Reason	Outfall barrier
