Final Report:

**Fish Population and Water Quality Monitoring
Hardisty Creek Restoration Project**

Richard McCleary, M.Sc., P.Bio.

Foothills Research Institute

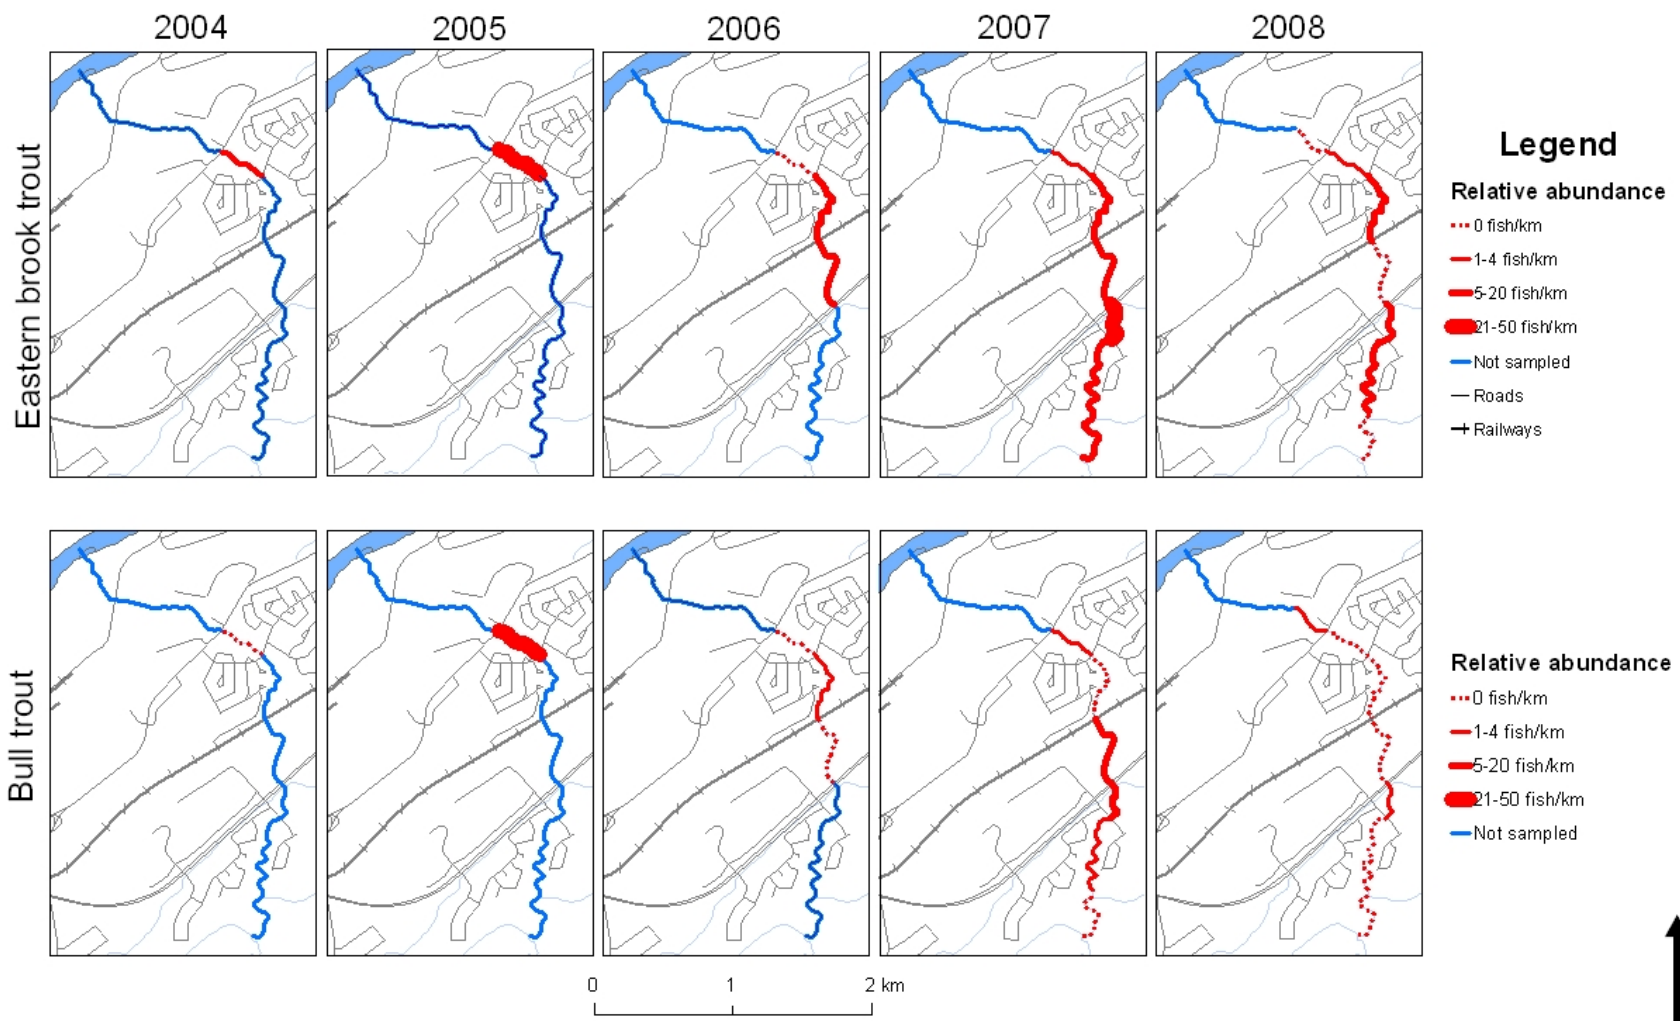
Figure 5. Relative abundance of brook trout and bull trout from 2004 to 2008 in Hardisty Creek within Town of Hinton.

The reach with the highest bull trout abundance was Reach 3 in 2005 (45 fish/km) (Figure 5). This survey was completed in the late fall following the replacement of the culverts nearest the mouth of Hardisty Creek by HWP. Overall relative abundance decreased from 2007 to 2008. Factors that could have contributed to the change may include erosion at the #2 fish passage remediation site at Hardisty Ave. The erosion may have reduced the effectiveness of the fish passage remedial measures. The material that was eroded from the site was deposited in downstream areas where it reduced pool depth and access to stream side large woody debris – both important bull trout cover features. In 2008, the Town of Hinton initiated plans to complete necessary maintenance activities at the site in 2009. In 2007, bull trout were captured upstream from two of the culverts that were rated as impassible to fish and a large char (>30cm) was observed during electro fishing in the most upstream reach – suggesting that bull trout may have also been able to negotiate the highest culvert, which was rated as a migration barrier.

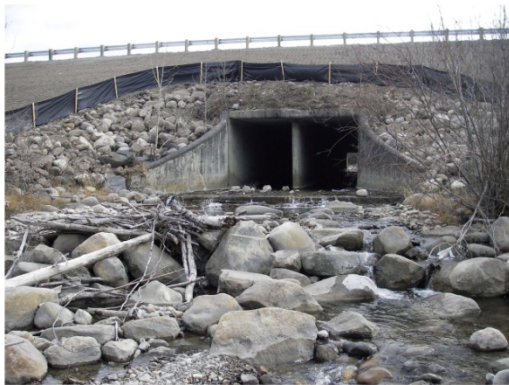
Hanging culverts at reach end.

Type	Location	Height
HangCulvrt	Distance = 238 m	0.59 m

The Highway 16 crossing was rated as a complete barrier to fish migration. Unfortunately the proposed repair plan was determined to be cost prohibitive (personal communication 2008, Dana Becker – Alberta Transportation). However, bull trout and juvenile mountain whitefish have been captured upstream of this structure. This indicates that the environmental performance of the existing structure is better than our evaluations indicated. Projects that improve fish passage at the culvert outfall may provide further benefits.

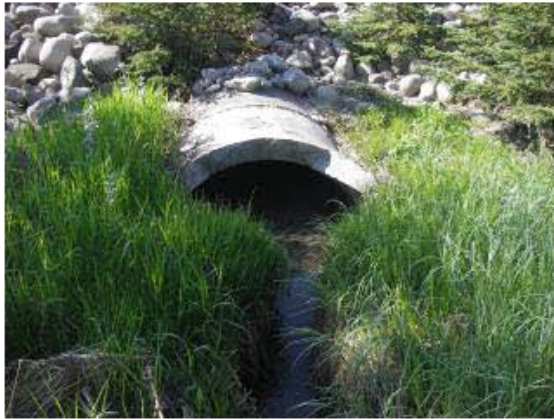
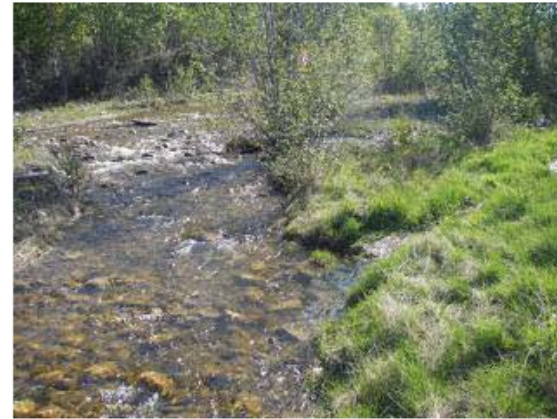
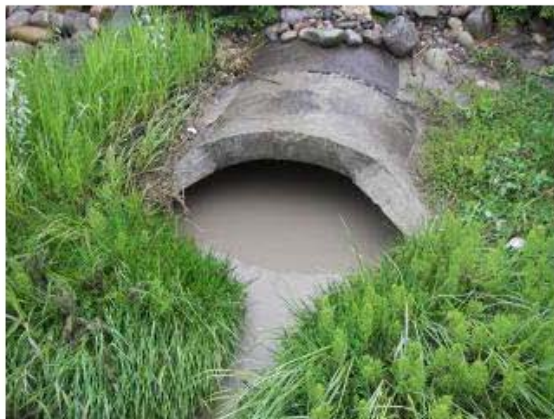
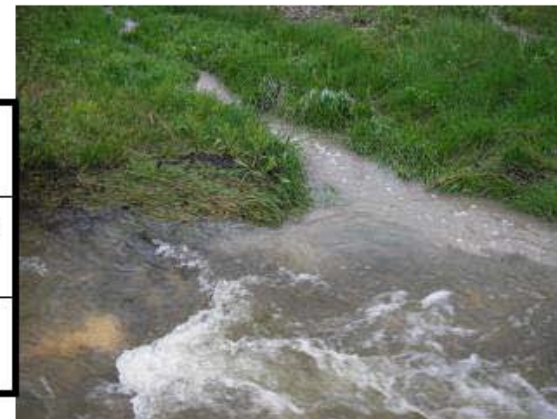
Site #2 is located behind the industrial park off Switzer Dr., NW of The Brick. Source water was clear when the site was first visited (pre-event), with all T-tube readings being 120+ cm's. The source water sampled post-storm event was substantially more turbid, as can be seen in the chart below

Section	Turbidity	
	cm	Ntu's
a	49.8	11.24
b	2.4	1061.98
c	77.4	5.80

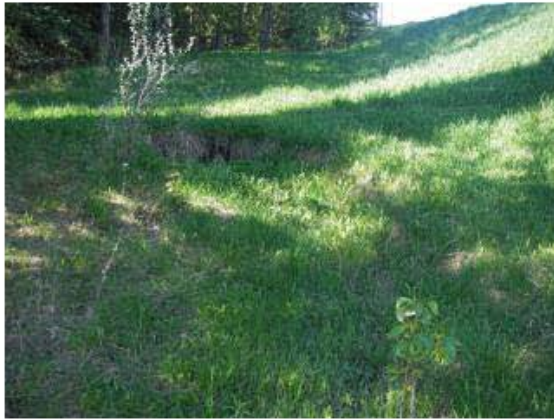
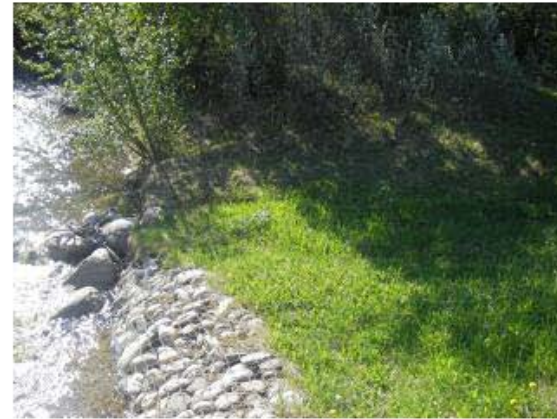
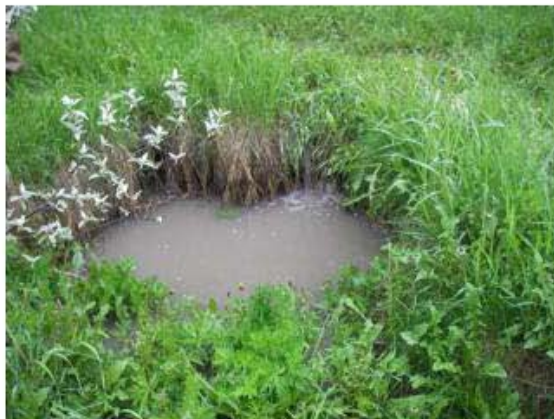
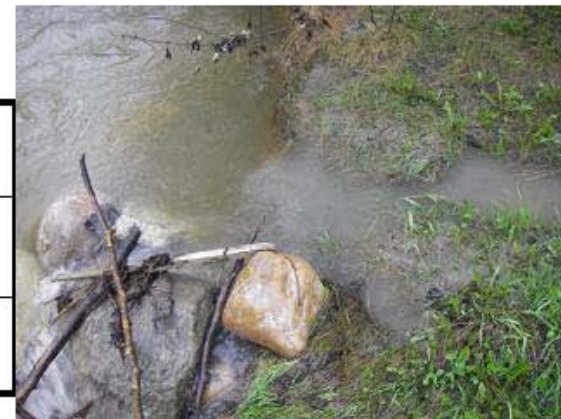
Site #3 is located immediately upstream of the bridge where Switzer Drive crosses Hardisty Creek. The input channel appears to be dry until a storm event, at which point the runoff picks up sediment from a nearby wooded area before entering the creek.

Section	Turbidity	
	cm	Ntu's
a	30	24.03
b	5	353.16
c	46.2	12.57

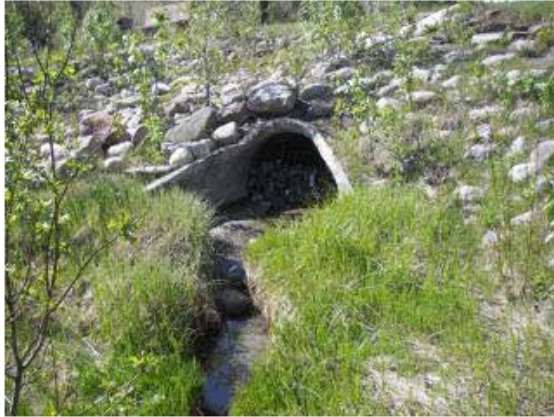
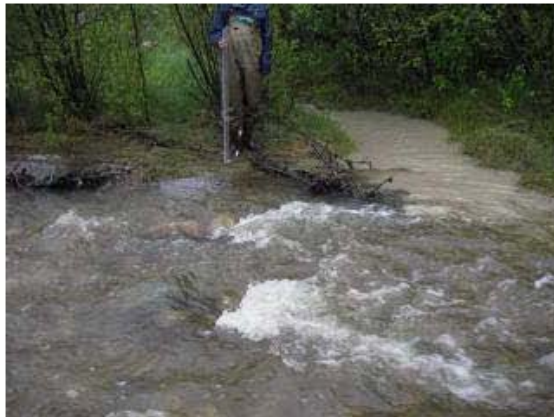
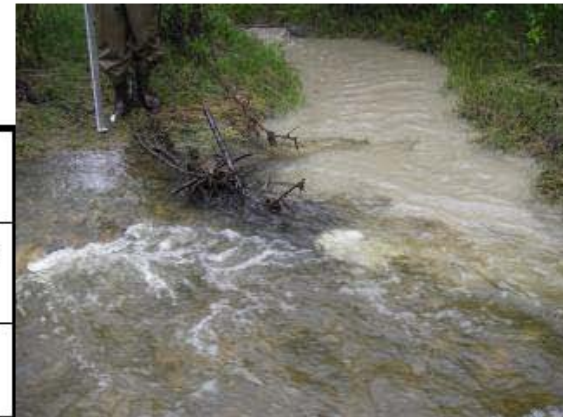
Site #6 is located beside the Lakeview Inn, just off Hwy. 16 westbound. The site proved to be one of the highest sources of sediment pollution during the storm event, likely due to runoff collected from the nearby industrial park. The turbidity was accompanied by a strong chemical odor, suggesting improper disposal of chemicals into a nearby storm drain.

Section	Turbidity	
	cm	Ntu's
a	26.2	29.44
b	1.5	2149.29
c	120	3.00

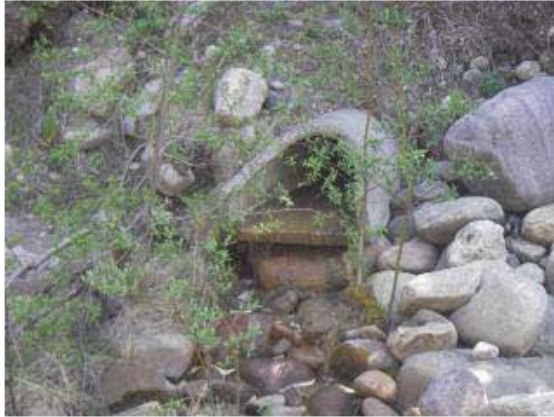
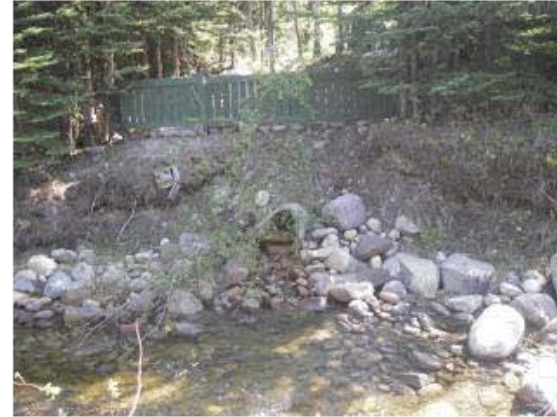
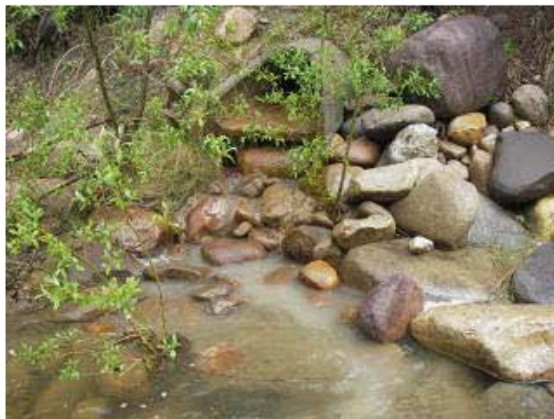
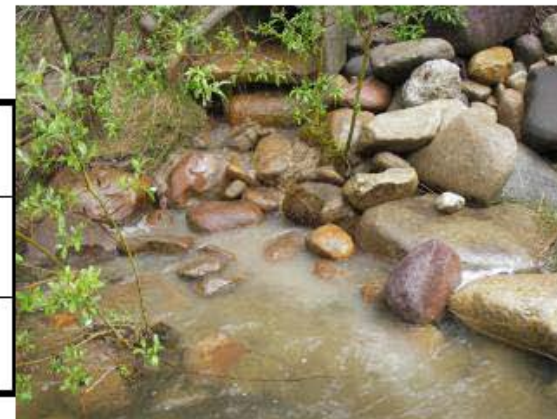
Site #9

Site #9's input rate was extremely low, being comprised of the runoff from Appleyard Cove, located just south of the culvert. The turbidity of the input water was high, but the low injection rate coupled with the high flow of the stream at that point leads to fairly rapid dilution, and thus only a small impact on overall turbidity

Section	Turbidity	
	cm	Ntu's
a	97.0	4.13
b	4.7	387.51
c	120.0	3.00
