FMF Fish and Watershed Program Quicknote #2

Sources of Instream Sediment - Observations from the Dogrib Fire

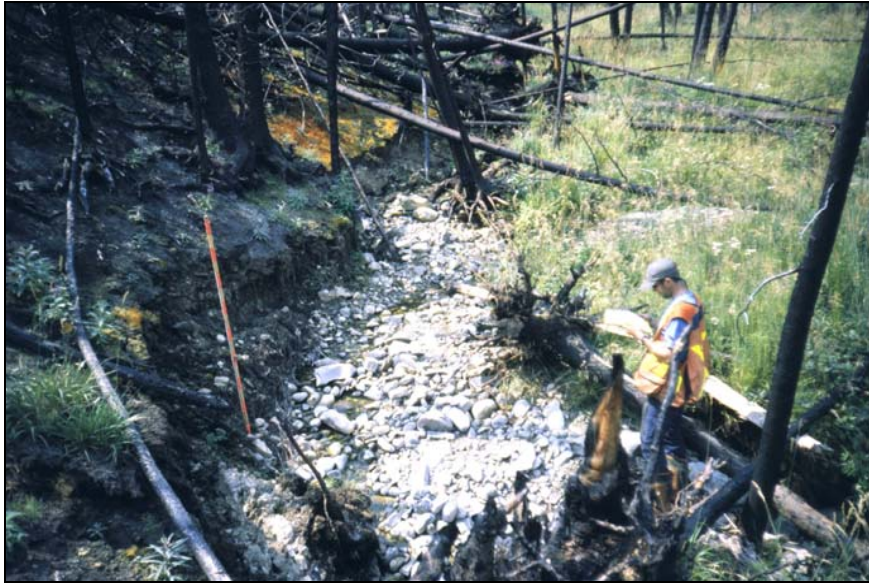
Figure 1. Extensive streambank erosion and channel-bed scour in an intermittent stream. Loss of rooting strength of vegetation along intermittent channels and increased runoff may have contributed to erosion.

1. To promote the storage of sediment within the actively eroding steep intermittent stream channels, increasing retention and minimizing harvest-related disturbance along these watercourses could be considered. Channel structure of the steep intermittent streams can include steps and pools associated with large woody debris. Considerable sediment storage was observed within these steps and maintaining them may be an important part of maximizing sediment storage within these steep channels.

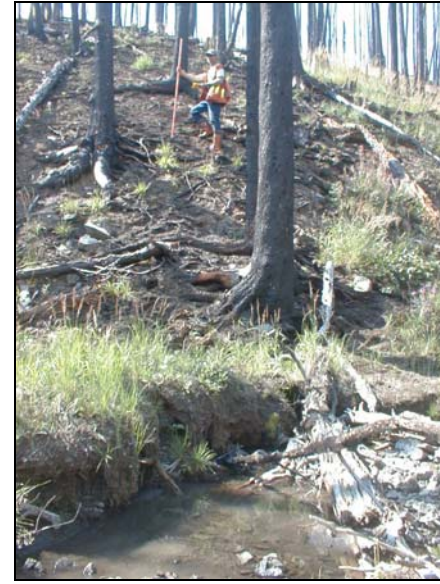
Figure 2. Steep non-vegetated hillslopes provided isolated sediment sources to stream channels. In all observed cases, soil movement was limited to sheet erosion and there was no evidence of rill or gully formation.

2. Steep slopes that are not separated from stream channels by a well-developed riparian area with sediment filtering capacity should be avoided.
3. Naturally unstable areas with any indication or history of slumping or other soil mass movements should be avoided. These areas are considered non-operational during normal forest harvest operations.

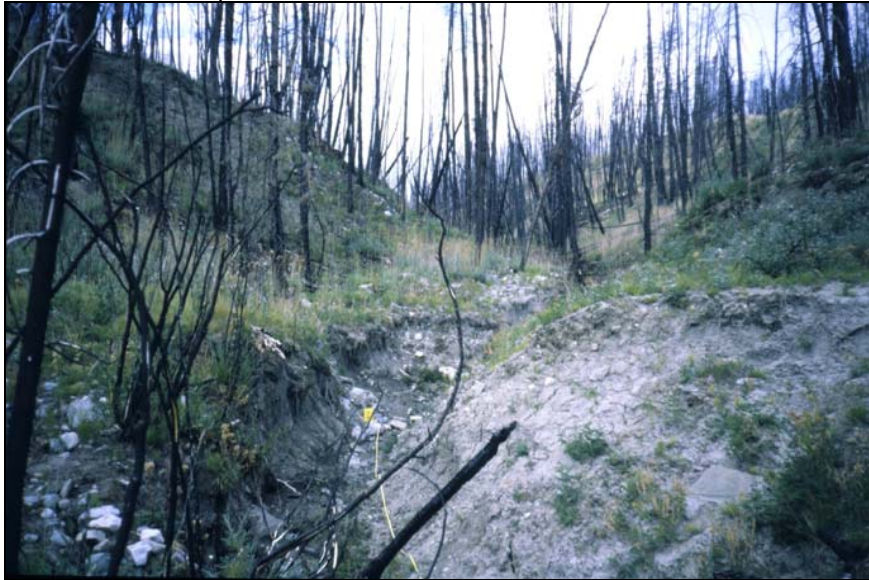
Figure 3. Extensive channel erosion occurred in steep intermittent and small permanent streams flowing through naturally unstable terrain, such as a slumping hillslopes in the Wildhorse Creek watershed.

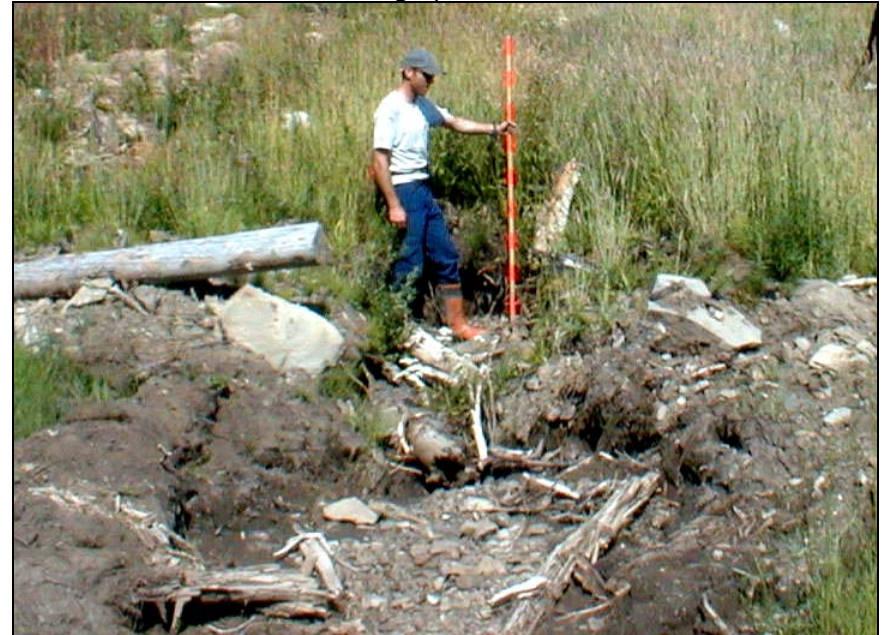
Figure 4. A reclaimed road crossing at an intermittent stream with a gully terminating in an 80cm headcut. Although intermittent streams may be so small they are unmapped, post-fire runoff can be sufficient to scour the un-vegetated portion of reclaimed road crossings.

4. Erosion control measures, such as grass seeding, planting of shrubs along watercourses and retention of structural elements, such as large woody debris, could be included as standard practice during reclamation of roads and skid trails that cross small permanent and intermittent stream channels.
