The Resilient Forest: Looking beyond the stumps

A 35-Year Examination of the Forecasts and Assertions of a 1970s Environmental Campaign

The Foothills Model Forest Adaptive Forest Management/History Program Report #6 in the Adaptive Forest Management/History Series.

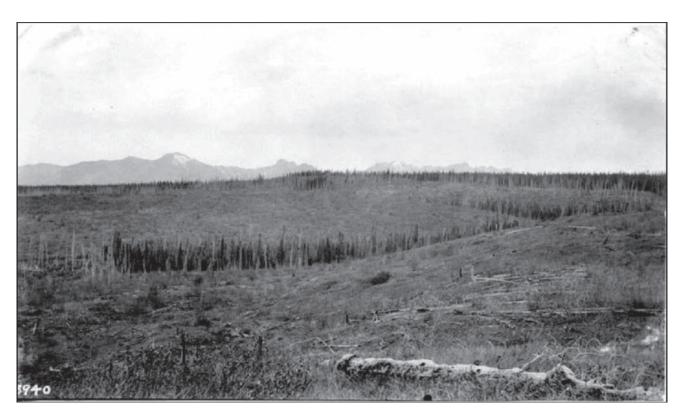
Dominion Forestry Branch 1912 photo of the north slope of the Athabasca Valley Twp. 52 Rge. 25 W 5th. Commentary on back of photo reads, "badly burned countryside, only scattered conifers left."

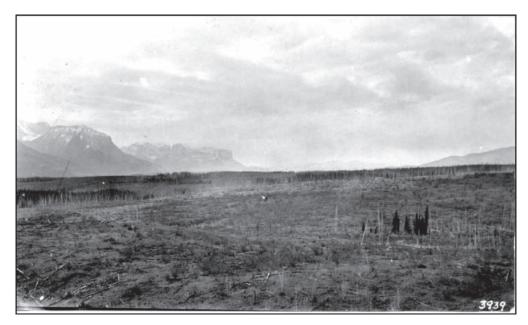
This Dominion Forestry Branch (DFB) 1912 photo shows a burned over landscape looking west between the Athabasca River and Prairie Creek Twp. 50 Rge. 25 W 5th.

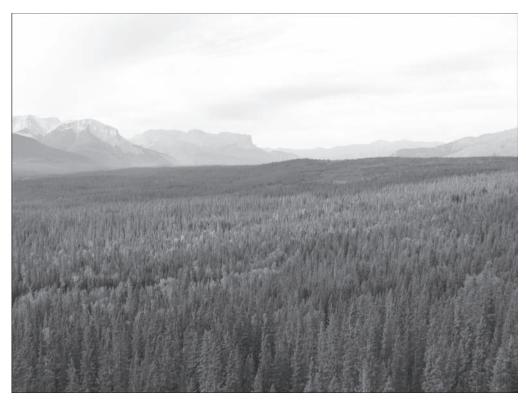
The same perspective in 2006: a mixture of fire-origin and regenerated forests under an active management regime.

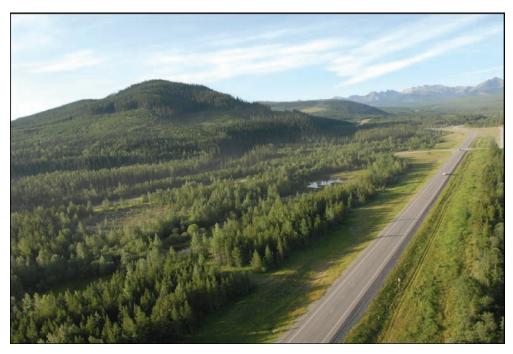
Over the 30 year period since Zimmer's comments, the roadsides and adjacent borrow pits have re-vegetated to a mix of aspen and poplars with subordinate shrubs and grasses. There is no evidence of erosion scars. The adjacent cutblock was scarified in 1969 and planted in 1974 and 1978 and was 86% stocked in 1982. The low-level aerial photograph of the Gregg River Valley immediately west of the Gregg Cabin shows the tree, shrub and grass communities characteristic of this area. Since Zimmer's visit in 1970, the area has sustained major flood damage at various times which resulted in bridge and road washouts. Despite these natural events the area's vegetation and landscape is vibrant and stable. Also, since Mr. Zimmer's photograph, Alberta Transportation has continued to maintain the wide right of way of Highway 40 in grass and herbaceous vegetation.

The above photo shows the area contained in the Zimmer/ Hellum images, looking south along the Highway 40 right of way adjacent to the Gregg River. It shows a healthy young forest in those parts of Block 509 that have not been otherwise impacted by highway construction. The ground image below is at the approximate photopoint of the Zimmer/ Hellum images.

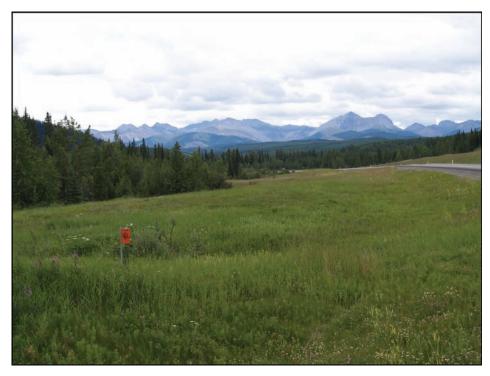
Photopoint: N 53 12.643 W 117 29.764

Close-up of roadside grasses and herbs along Highway 40.

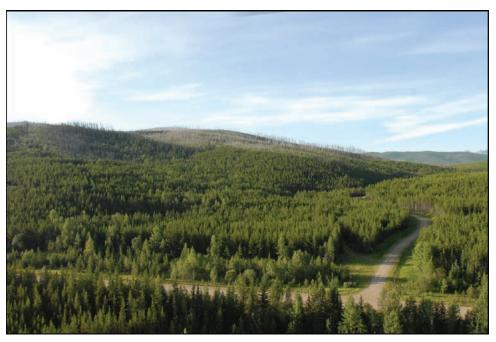
The view of these stands, some of which are deemed to be stagnated, is shown in Zimmer photo 60. Efforts continue to enhance development of economical methods to thin these stands and bring them into the productive cycle of managed forests.

The 2006 photo above shows the area contained in Mr. Zimmer's photos, to the left of the road junction. The view is to the southeast into the Gregg Burn of 1956 and it highlights current forest conditions. There is evidence along the upper horizon of damage from a recent fire in December 1997. The photo below shows interior stand conditions in 2006 in the area thinned by the "young offenders" in 1972.

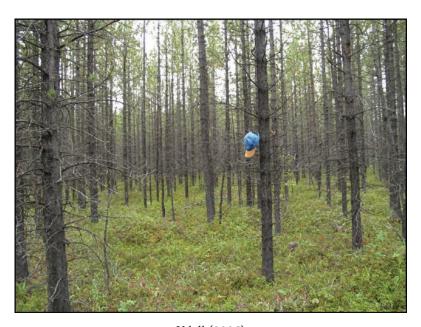
"The background of photos 60 and 61 contain about 53,600 lodgepole pine seedlings per acre judging by two sample plots 10×10 feet in an area located within the camera angle of photo 60. The thinned part contains over 1,670 seedlings per acre and this is still far too dense for good tree growth."

Recognizing the density problem in the Gregg Burn, which is similar to many others sites along Alberta's eastern slopes, research agencies as well as Company foresters have tried a number of different experimental approaches to reduce stocking levels including mechanical and hand thinning along with small, closely monitored trials with specific registered herbicides (tree killers). The stand at the junction of the Gregg River Road and the well-site road, visible on the 1997 photograph, was thinned by a group of so-called "young offenders" early in 1972 in an exercise conducted with the permission of the Company.

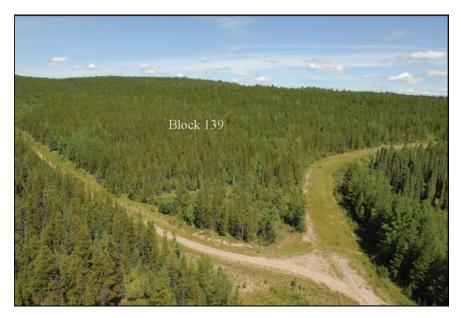
The aerial oblique photograph of 1997 shows fully satisfactory lodgepole pine regeneration, refuting Mr. Zimmer's forecasts. It should be noted that the legislation requirements in 1972 specified that all logged areas be sufficiently regenerated with acceptable species, established and evenly distributed in the cutover by 10 years after logging. The regeneration survey method employed at the time, using one mil-acre (1/1000 acre) sample plots, set 40% as the minimum stocking to designate a logged area satisfactory regenerated (SR). This would require a minimum 400 trees per acre. Thus, to convert the stocking percentages often quoted by Dr. Hellum to trees per acre, multiply the stated percent value by 10. The situation Mr. Zimmer refers to in the lower left of this photograph was not caused by logging and in fact was a minor and localized soil accumulation from the main logging road surface. In 1967, the area was rated satisfactorily restocked at 90% (900 trees per acre).

The aerial photo at left shows the bend in the road in Mr. Zimmer's 1971 photo. Note the rich and abundant tree growth in the image.

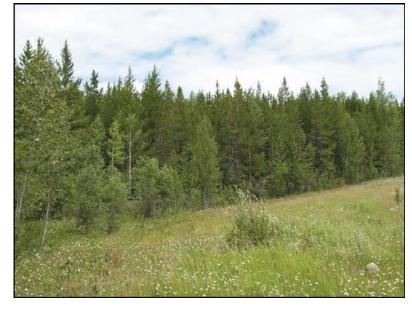
Photopoint: N 53 16.435 W 117 12.271

Image from a ground photopoint near the bend in road in the aerial photo above:

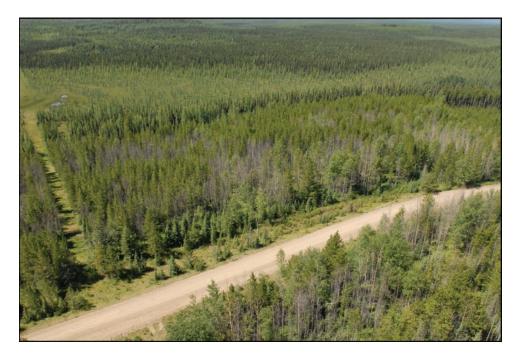
This companion aerial photo shows the block looking southwest across the access road. Note the dead aspen regeneration resulting from a recent conifer release program.

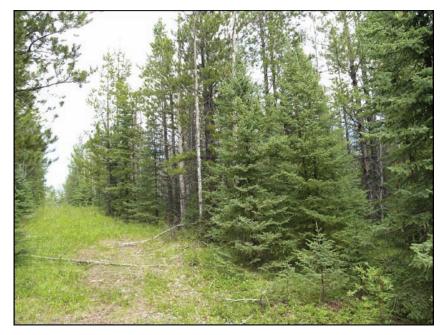
Photopoint: N 53 17.457 W 117 04.562

This 2006 photopoint image was taken along the seismic line above, shooting back towards the access road. Note the young aspen tree on the right side with a black line indicating where the workers have manually girdled it to release the conifer trees growing in the block.

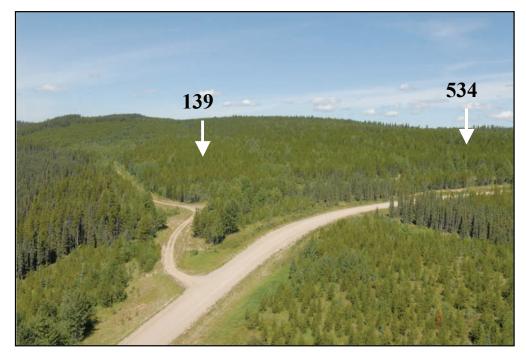
The 1997 oblique aerial photograph shows fully satisfactory regeneration, validating Dr. Hellum's observations and refuting Mr. Zimmer. This photo location is in the same cut block as Zimmer's photo 8, but looking to the southwest. To a passer-by on the access road, no environmental disaster originating from the logging operations would be noticeable because there was none. This area already passed the stage of providing "beautiful environment for pheasants," at least from the perspective of cover.

The ecological assessment of this area in 2000 revealed the young trees to be growing very well, with a site index rating of 19. This means that the large diameter dominant trees are forecasted to be 19 metres (62 feet) tall when the "breast height" age (measured at 1.3 metres, or 4.5 feet above ground) is 50 years. Fire origin stands at this age – such as the original stand on this site – would normally have a site index rating of 12 or 13 due to overcrowding of the trees and competition for light and nutrients in their early years.

The 2006 above image shows Block 534 in relation to Block 139 described earlier. This picture taken in 2006 suggests that earlier comments of the area being a "wasteland" were premature and in error.

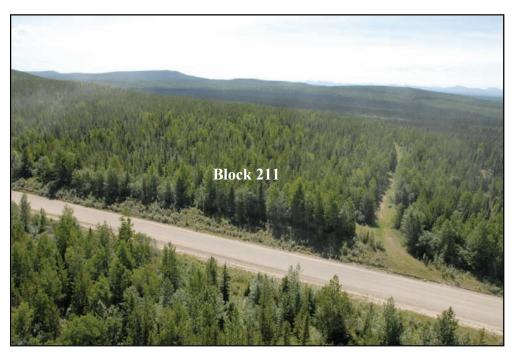
The 1997 photograph for this area showed regeneration where hardwoods, trembling aspen and balsam poplar appeared predominant, replacing what was originally a pine stand on a rich site. Such hardwood incursion is common on rich sites following harvest and reforestation, where the more open spacing of the coniferous seedlings (compared to stocking following fire) encourages other species to also take hold. However, in the ensuing nine years to 2006 pine and spruce appear to have gained predominance over the hardwood, with the end result of a coniferous-dominated mixedwood stand.

Above is the regenerated stand in 2006 looking south across the Robb Road with the ground photo point (below) just off the Robb Road along the old access road leading away from the camera's perspective. Note the mixture of pine, spruce and hardwoods on the site.

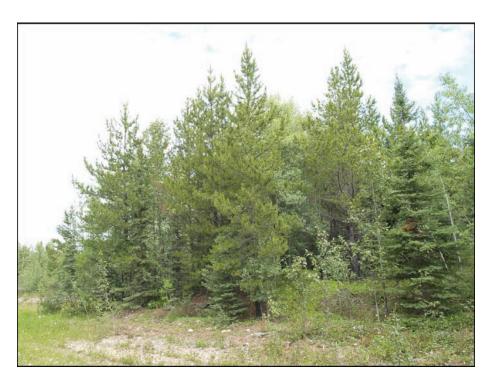
Photopoint: N 53 16.787 W 117 11.093

Ground photopoint just off Robb Road along access trail shown above.

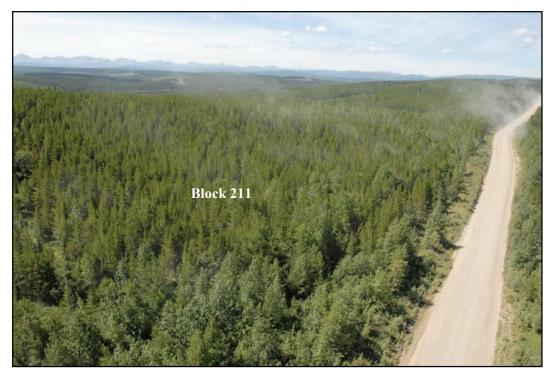
Despite earlier statements suggesting problems at this site, the 1997 photos, taken 28 years after logging, reveal the area to be well forested. Some roadside construction and mechanical disturbance in the immediate areas altered the establishment of trees but seems to have been modified over time with conifers, hardwoods, brush and grass stabilizing the ditch areas. Generally, the site shows a lot of resiliency and is adequately stocked with a productive mixedwood stand. The hardwood component at this cutover and the photo 10 location was greater than normally expected during the average regeneration process for lodgepole pine in the 1997 examination. However, by 2006, conifers had taken predominance in the species mix of the block.

This 2006 photo shows the regenerated cutblock on the south side of the Robb Road and the map below shows the block in relation to block 532, another block in the McLeod 6 series.

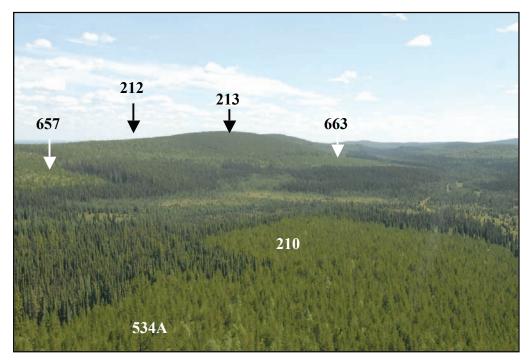
The immediate foreground of these images is Block 534A; just beyond it is Block 210 and on the horizon Block 213 (see map). Harvesting in Block 534A was completed in 1969–70 and reforestation followed right after. Mr. Zimmer was standing in block 534 looking east across these blocks to block 213 on the hill top – quite a distance to see seedlings! Excellent regeneration is evident in the foreground in Block 534A as well as on the far hill in Block 213 in the 1997 picture as well as that of 2006. It illustrates the error of being too quick to judge forestry practices before the healthy reforestation that results from them has had time to become obvious. However, a careful ground examination even at that time would have shown the beginnings of this new crop, as Dr. Hellum invariably pointed out in his review.

The 2006 photo above is taken from above Block 534 looking east across 534A and 210 with Block 213 and some more recent cuts on the horizon — the same perspective as the earlier photos. In 2006, all these blocks, including the "denuded hill" (Zimmer 1971) show excellent reproduction and the continuance of a sustainably managed forest. Note how reforestation and rapid early growth has "greened up" the areas that appear to have been newly harvested in the 1997 photo (Blocks 657, 663).

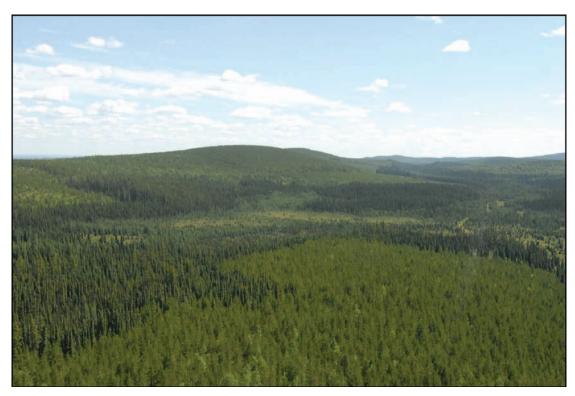
The 1997 and 2006 photos highlight excellent regeneration and stocking. The hilltop (Block 213) is adequately restocked and well along as a productive forest. Portions of the residual stands have now been clearcut and are in the beginning stages of forest recovery, as can be clearly seen in the 2006 aerial images.

This 2006 photo is another view of Block 213 shooting eastwards across Block 210. Excellent regeneration can be seen throughout the area.

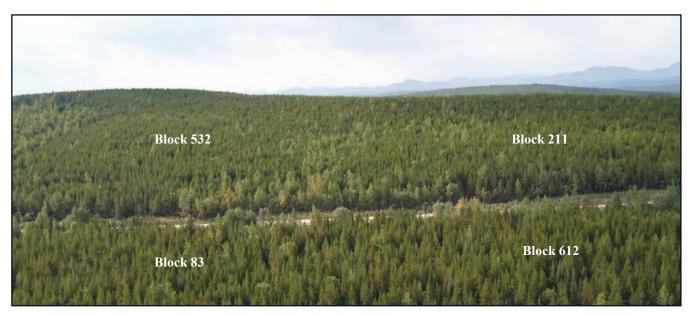
Mr. Zimmer chose this image as the last in his examination of the reforestation and environmental status of McLeod 6. His prophecy — "it very well represents the forest of the future in Alberta" — foretold a far more positive outcome than he envisaged. A sharp contrast is evident from the 1971 photo taken soon after scarification treatment of the clearcut area and the productive well-stocked coniferous forest of 2006. The aerial view highlights both the logged area and adjacent roadside vegetation patterns, which cover ditches and "borrow" pits over a reasonable period of time. There is no baldness in this area. Indeed, the picture shows an attractive well-stocked forest that meets the criteria for sustainable forest management in this area and elsewhere in Alberta.

This 2006 photo looking south across the Robb Road shows a number of blocks logged at different times that have, over the passage of time, regenerated successfully and grown together to the point that the boundaries between them are indistinguishable on the ground.

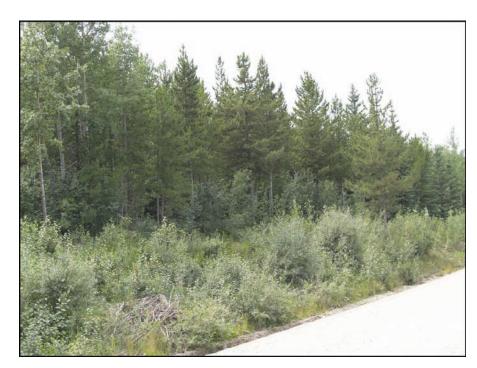
Photopoint: N 53 16.718 W 117 10.120

A view to the south into Block 532 from the Robb Road.

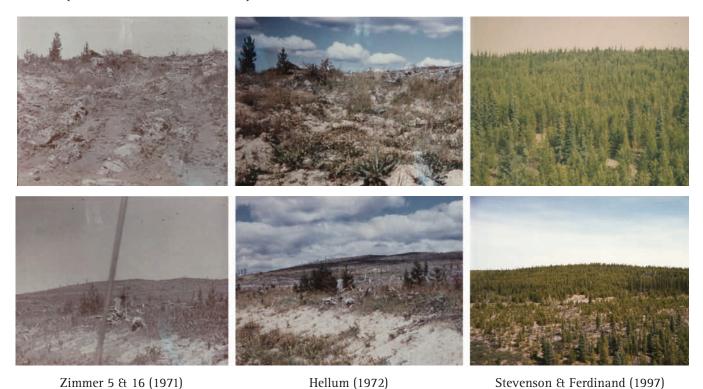
"...again we see this drifted, freshly drifted soil and alongside the road in the ditch. And we see also some pine advance growth on the right hand side. Advance growth as far as I know which has not been restocked by the company but which seems to have stocked itself from mature trees prior to harvesting (photo 5 — upper series)."

A regeneration plot (centre photo 5) was located on the hill in the background. While the foreground was again scarified in July 1971 and supported no recent regeneration, as one might expect, the hill in the background contained 1,110 lodgepde pine seedlings per acre judging by the
plot at photo centre which was again typical of stocking on the whole
hillside. The seedlings were about 10 inches tell and most vigorous.
This area was logged before 1966 and then scarified by J.W.P.&P.
in 1966. It will be in need of thinning in 10 or more years.

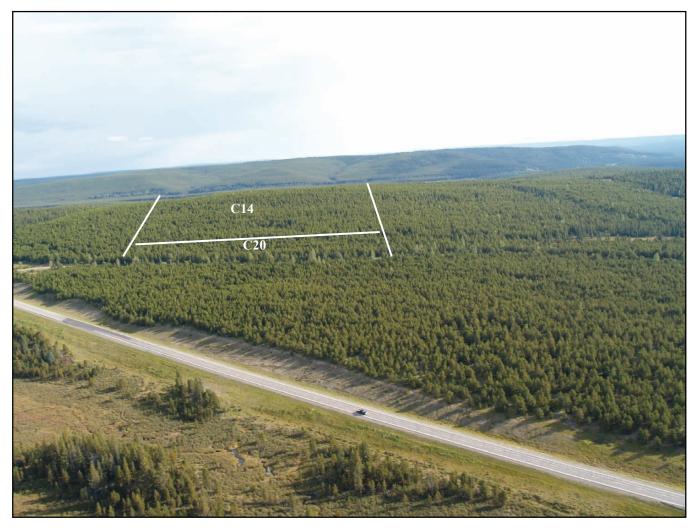
The whole hillside comprising these blocks and others cut at various times is well covered with healthy, vigorous lodgepole pine and some black spruce. The evaluation by Kare Hellum in 1972 determining regeneration to be adequate has been confirmed by the good growth and general condition of the young stands shown here. Hellum's comment about the "foreground" pertains to Block C20 adjacent to the road while the "hill in the background" is Block C14.

This 2006 image along the east side of Highway 40 shows good production from harvest and reforestation. Exact locations between blocks cannot be located due to the passage of time and the rapid growth of the regeneration in adjoining blocks, but approximate locations are shown. Few drivers passing by these stands have any idea that they are travelling through a landscape of regenerated forests arising from the handiwork of the early Company foresters.

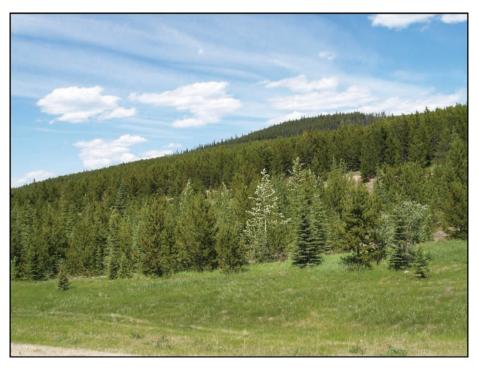
As the above photo shows, the area is "not stripped of all plant life." Good growth and yield in a sustainable forest is evident along east side of Highway 40 (looking northwest), both from the air and along the road. The ground level view below shows the reclaimed and reforested "borrow pit." Photopoint: N 53 39.438, W 118 13.377.

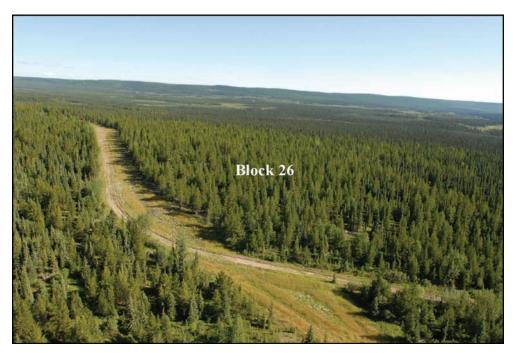
Good regeneration has developed into a vigorous mixed coniferous stand along the slope in the picture and throughout the area. Few open areas remain with subordinate brush and grass in the understory. Erosion is negligible and not a concern.

Block 26, above, supports a thriving mid-rotation stand of lodgepole pine in 2006. In the photo below, taken near the road/pipeline junction above, Bob Udell stands on an old logging trail in the block which, with the passage of time, is also re-vegetated and supporting a healthy crop of trees.

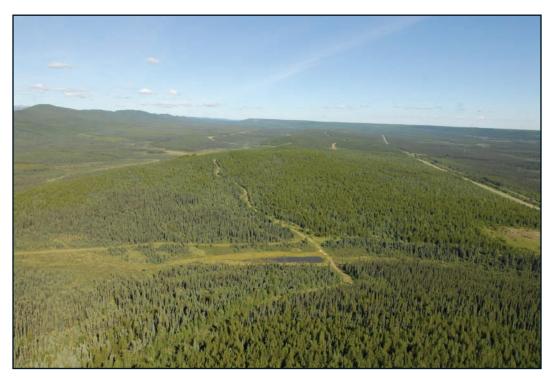
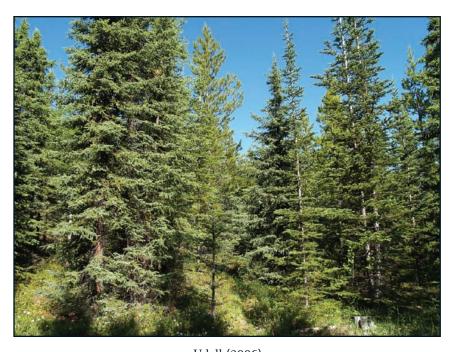
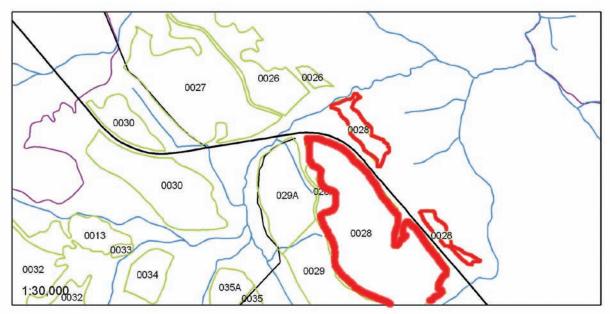
Berland 8, Block 28

The entire hillside is well-covered by productive mixed conifers. This area certainly did not remain "denuded from horizon to horizon."

The 2006 photo above highlights a much larger area than the smaller three images and confirms Hellum's comment "that his plot information (1970) of good regeneration is typical of the entire area."

A healthy mixed pine/white spruce/ balsam fir stand. Photopoint: N 53 35.842, W 118 03.743.

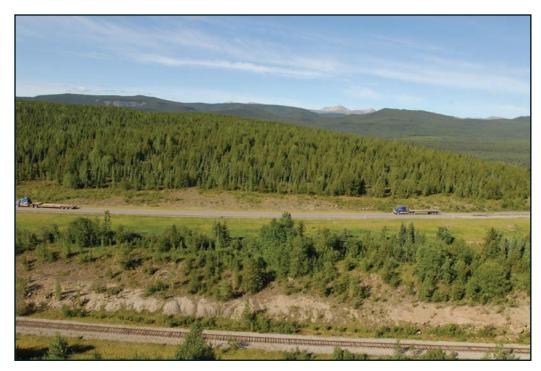
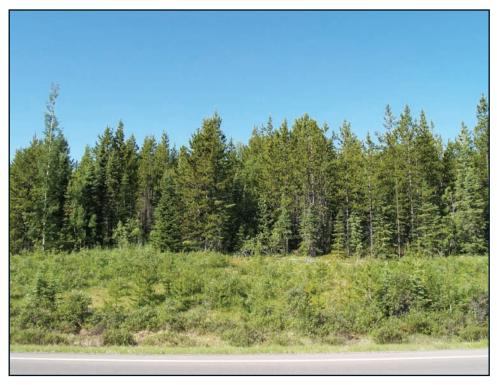
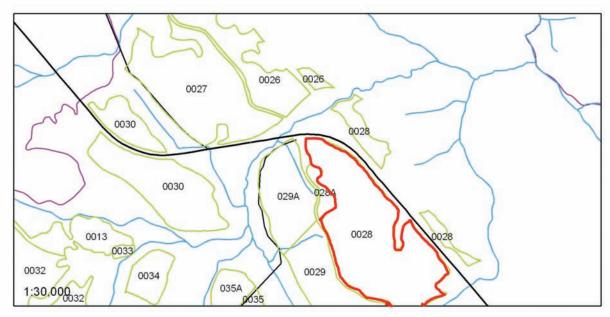
Berland 8, Block 28

The blocks were harvested in 1959–60 and scarified in 1960. The 1997 and 2006 photos of this area highlight a well-stocked coniferous stand "back dropped" with some older spruce and balsam fir. Minor roadside erosion is evident which is an aftermath of the extensive construction and upgrading of the Grande Cache Highway. Again, the logged site is regenerated while the roadside is still showing some minor erosion.

This aerial view of Block 28, looking west across Highway 40, shows a semi-mature regenerated landscape that has responded to the post logging treatments to give good sustained yields and a general healthy stand environment. The stand is seen from Photopoint N 53 36.888, W 118 03.707, along the Grande Cache Highway.

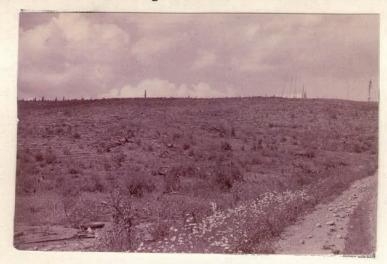
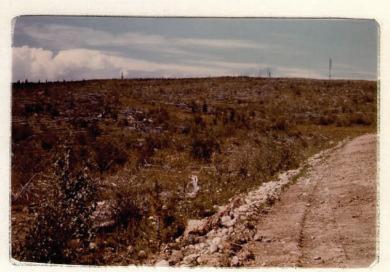
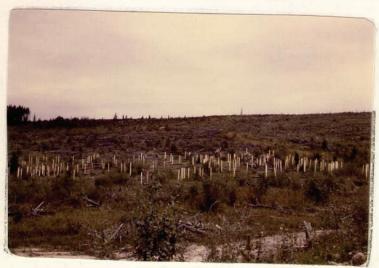
PHOTO COMPLEX I

Photo #8. "...We are back in the Yellowhead tower area and again we can see how sparce coniferous tree life is within this area which I described earlier as being bald from horizon to horizon. I can only notice one or two trees with large magnification, or one or two young trees that is with large magnification on this entire landscape"...(this and subsequent quotations are all from Mr. Zimmer's slide presentation, see Appendix I).

Photo complex 1 shows Mr. Zimmer's black and white photograph #8 and two colour prints taken of the exact same area in late August of 1972 by the Silviculture Section. The white stakes in the second colour picture each represent one coniferous seedling three or more years old. According to our survey, the foreground contains on the average 815 lodgepole pine seedlings per acre. This constitutes overstocking by our standards in that any area with more than 600 seedlings per acre three years or older will encounter crowding problems before the trees reach maturity. Also, mortality among coniferous seedlings after the third year is minimal.

This particular area was cut in 1961-1962 and scarified in 1962 according to N.W.P.&P. cut records. A regeneration survey done by the company in 1967 showed 67% stocking in the area. Average scedling height was about 10". The staked seedlings constitute only a small

It therefore would appear that Mr. Zimmer's charge of paucity of regeneration in this area is in grave error. Photos 6, 11, and 57 are covered by photo 8.

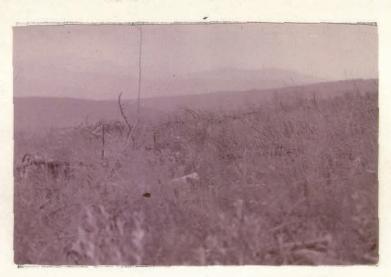
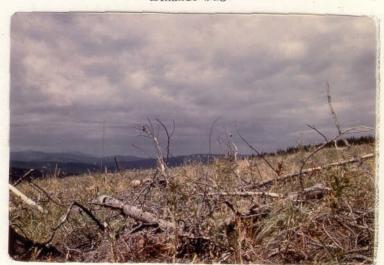
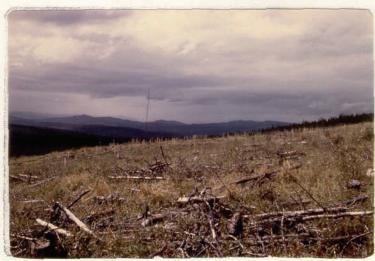
PHOTO COMPLEX 2

Photo #15. "... The grass growth here is very dense; again it would make beautiful environment for pheasants, I would believe, if there would have been enough water there but it sure makes a poor environment for a forest"...

The tree in the far right of photo 8, seen against the horizon, is the same tree as seen in the foreground of photo 15, and the snag seen in photo 15 is the same as the snag next to the same pine tree in photo 8. Both photos 14 and 15 were taken with a telephoto lense thus distorting foreground to the point where it became impossible to relocate the exact photo position. This being the case, the snag and background were aligned and an approximate location chosen. Photo Complex 2 shows the details of the regeneration plot-survey established in August of 1972.

The stocking to pine in this area was 382 seedlings per acre or 38.2% stocking judging by the plot in the second colour photo. Again, the stakes are only a sample indication of the general stocking in the whole photo area. However, this is insufficient stocking to meet the 40% standard, but this area was only logged in 1969 and scarified in the spring of 1970. Seeds are still being released from the pine cones, and a considerable number of additional pine seedlings may be expected from this additional seed. It is therefore too early to retreat this area on the basis on insufficient stocking to coniferous regeneration. The 1961-62 cut, which lies just behind the snag, had considerably more regeneration than the foreground, as indicated by Photo Complex I.

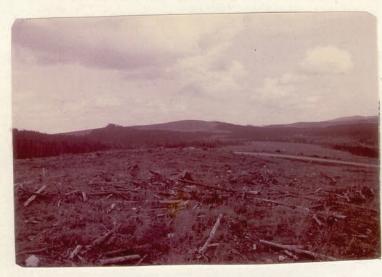
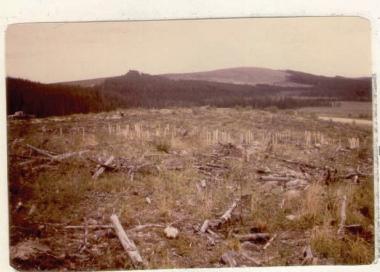
Zimmer #12

Photo #12. "... We didn't detect any regenerated trees either".

This area was logged in 1969 and scarified in the spring of 1970, as in photo 15, and there is probably still pine seed retained in the cones which will be shed over the next one or two years. Again, one must conclude that Mr. Zimmer did not see the abundant pine regeneration and that his statement of no "regenerated trees" is erroneous.

Photographs 43 and 44 were taken in exactly the opposite direction to photo 12, standing virtually in the same spot. Because photos 12, 43, and 44 are of the same area of land only one field sample was taken especially because of the proximity to photo 15. (See Appendix II).

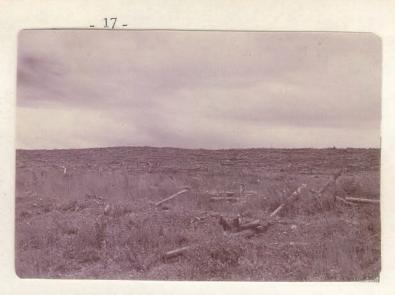
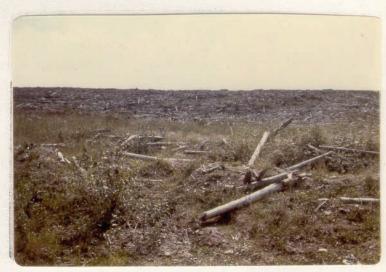
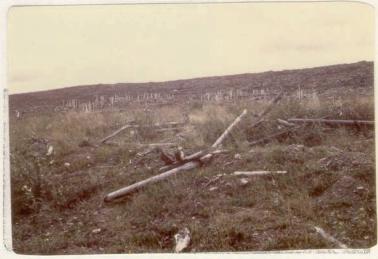
PHOTO COMPLEX 6

This area was cut in 1969 (and not in 1963 as stated by Mr. Zimmer) and scarified in the spring of 1970. According to Photo Complex 6, the photo plot contains 543 coniferous seedlings per acre and both the pine and the spruce are about 6" tall. The plot is again representative for stocking over the whole area. The immediate foreground is the Robb road right-of-way.

This was Mr. Zimmer's closing picture to depict how desolate the landscape is because of clearcutting and scarification practices by N.W.P.&P. It is indeed regrettable that such charges be based on such inadequate knowledge of fact.

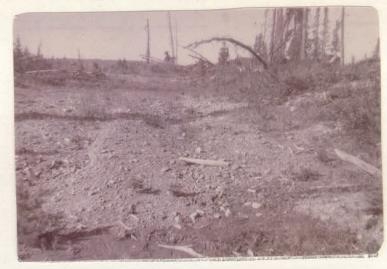
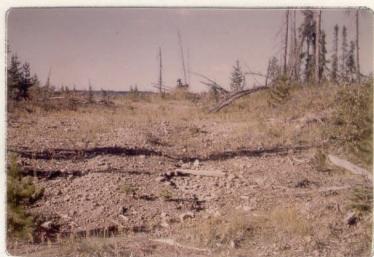
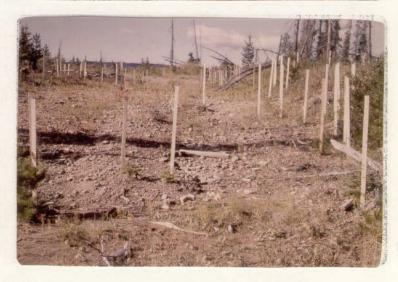
Zimmer #49

en de la companya de Replación de la companya de la comp Photo #49. "...What you are looking at here is some remains of earlier methods of scarification used in the area". "If I may ask you to put the picture on the sharp focus you will probably agree with me that there is hardly a blade of grass which grows between those windrows".

This is not intended as scarification. The area was cut in 1956-57 and, according to N.W.P.&P. records, this is an extraction road. The mineral soil is indeed scraped off and the most exposed parts of these roads are poorly regenerated. However, this method of extraction was not used after about 1957, and is certainly not used today. Photo Complex 8 shows again that the general area within the photo angle has ample regeneration. There are in fact 856 seedlings per acre in this general area judging by this photo location which is typical of much of the general area. The predominant regeneration is to lodgepole pine and white spruce with some balsam fir and black spruce also present. Seedlings in this area are on the average 12 inches tall.

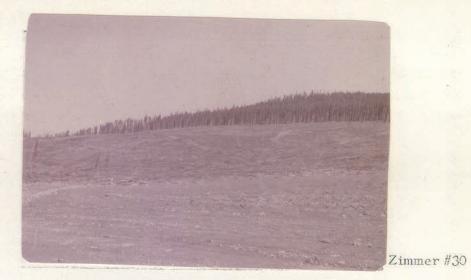
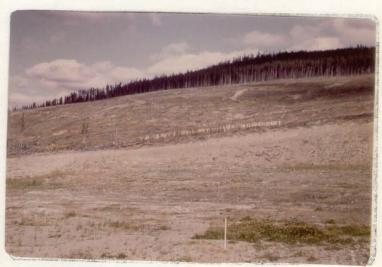
Photo #2. "...What we see here is a completely denuded area almost bald from horizon to horizon... A little immature timber is left in the foreground."

The new Grande Cache Highway was completed in 1969 and the borrow pin in the foreground should not be blamed on forestry operations. Log-ging in this area was completed in 1963-64 and the land was scarified in 1966. This is the old E7 - L3 timber licence issued before the time of N.W.P.&P. logging in the area.

This area will need to be thinned in another 10 years or less if good growth is to be maintained for the remaining trees.

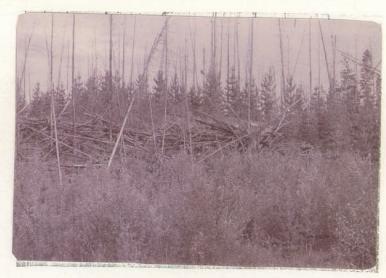
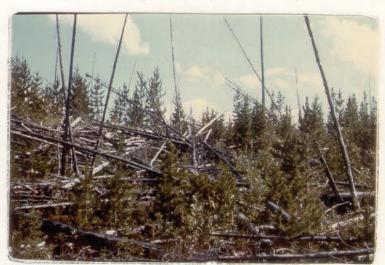
Zimmer #59

Photo #59. "...On slide 59 we see just how dense mother nature seeds trees in order to prevent environment destruction following fire". "And thus natural selection will only let the strongest and healthiest trees survive this close competition, what remains then is a healthy forest".

There are over 10,000 stems per acre in the foreground on photo 59 and over 3,700 stems per acre in the background. This is far too dense for good tree growth. Lodgepole pine does not thin itself well and Mr. Zimmer's statement that a healthy stand will result is not factual for this species (Photo Complex 11).

This area is in the Gregg burn of 1956 in Section 24, Township 49, Range 24, W5.

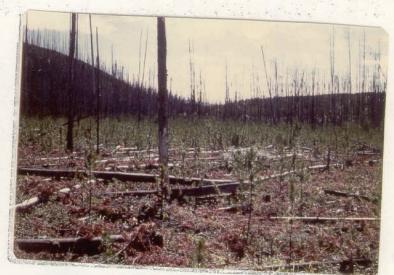
Photo #60. "...I estimate that the pine in this particular area regenerate at a density of at least one tree every two square feet". and photo 61 "I can not agree with some foresters' opinions who claim that such dense regeneration will result in stagnation of the entire regrowth".

Both Photos #61 and #60 were taken in Section 15 of Township 49, Range 24, W5, in the Gregg Burn of 1956.

Photo Complex 12 shows where N.W.P.&P. "accidentally" thinned the pine in photo 60 in between the time that Mr. Zimmer took his photo in July of 1971 and August of 1972 when the colour photos were taken. The background of photo 60 and 61 contain about 53,600 lodgepole pine seedlings per acre judging by two sample plots 10 x 10 feet in area located within the camera angle of photo 60. The thinned part contains over 1,670 seculings per acre and this is still far too dense for good tree growth.

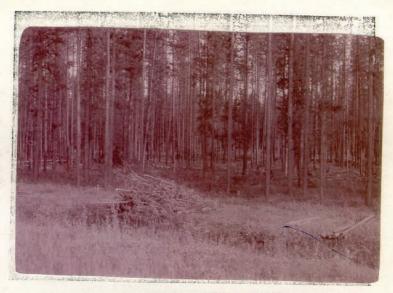
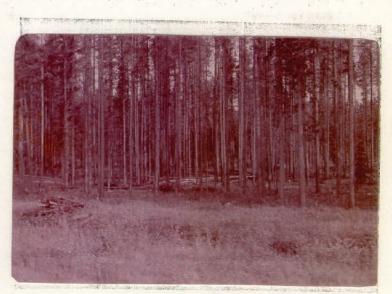
Photos 62 and 63. "... Now I have reasons to call this a method of selective cutting". "I understand that this operation was started by Muttart Lumber at one time and I also understand that at the present the thinning of the stand is being continued by inmates of a close-by limited security camp." "Once the new regeneration has successfully been established, and following another five years of that, the remaining mature timber can then be cut without too much damage to the still flexible young growth and the forest environment will never suffer."

This thinning was done only for aesthetic reasons (Photo Complex 13) and could scarsely be considered an economic operation. This work is carried on today by the Department of Lands & Forests with the aid of minimum security inmates. Removal of residual pine after initial thinning would raise havoc with existing regeneration unless current methods of logging be abandoned. Pine would certainly not be able to establish an understory stand and spruce invasion would be very slow. Seeding with spruce, or underplanting would not be wise in view of the need to scarify for seeding or planting. Spot scarification, as recommended by Mr. Zimmer, has proven only marginally successful in the past in Alberta, and in order to establish 400 seedlings per acre very much of the natural forest floor would have to be disturbed even with spot scarification.

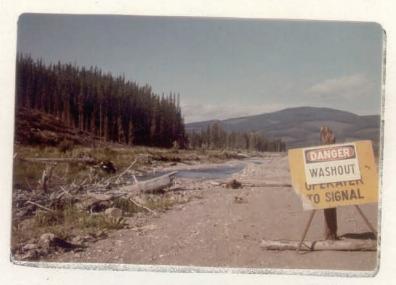
Photo #31. "... Here we have what happens when the timber is cut right into a watershed, in this case you are looking at an Alberta river. This is water conservation, pulpmill style. This has been tolerated by the former government; I think the new government should put an end to this".

Photo Complex 14 contains four of Mr. Zimmer's photos (31, 32, 33, 34) showing what would appear to be logging to waters' edge. The water seen in the foreground is indeed a part of the Gregg River. When the Gregg River crossing upstream from this picture was put in before 1969, the road ditch on the upstream side was not protected from river water entering it because the ditch was several feet above normal water level. In 1969 the Gregg River flooded and the ditch was eroded and despend so that part of the river now flows year-round in the ditch. This matter has been brought to the attention of N.W.P.&P. through their silviculturist.

What is important is that logging which was done in the winter of 1968/69 was done before the river changed this part of its course. The whole matter can be rectified by closing off the road ditch. The washout at this point in the Gregg River Road is regularly forded by all cars at present.

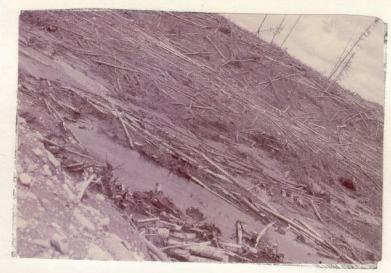
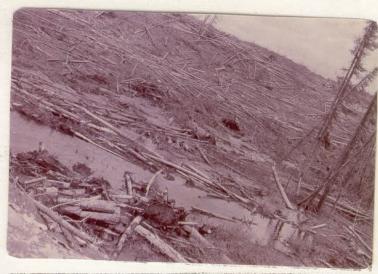
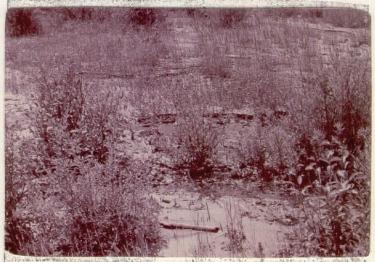
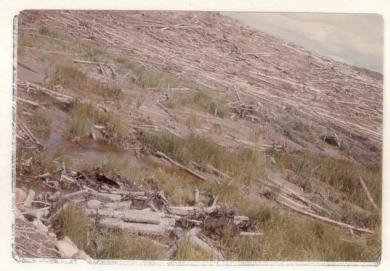
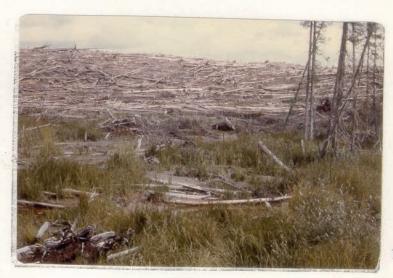
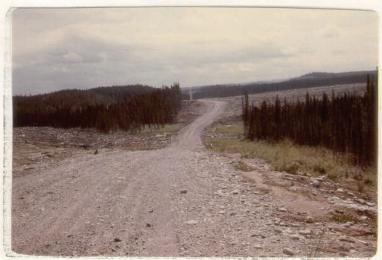
PHOTO COMPLEX 15

Photo Complex 15. "...We are along the same road below the area where the timber has been cut right into a small creek, the head-waters of a small creek".

This set of photos (38, 39, 40) indeed shows flowing water but what Mr. Zimmer neglected to say is that the creek crosses the road flowing out from behind the photographer (in the centre of the photo). The creek then turns sharply to the right and disappears into the timber to the right on photo 39 (see also bottom colour photo for general area orientation - Photo Complex 15). The colour photograph shows the general area from a different angle to show how logging does in fact not approach closer to the creek than 66 feet except in the right-of-way of the road itself where the timber has been removed.

The road ditch may at times carry water, but it is not even an intermittent creek.

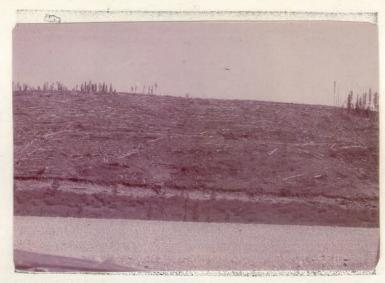
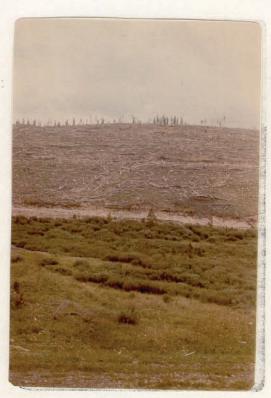
Zimmer #7

Photo Complex 16 shows, however, that the white line is not the creek. It is an old logging road which Mr. Zimmer would have seen had he gone there to look. The creek flows in the middle of the "willow flat" and is no where in this picture closer than 150 feet to the area logged.

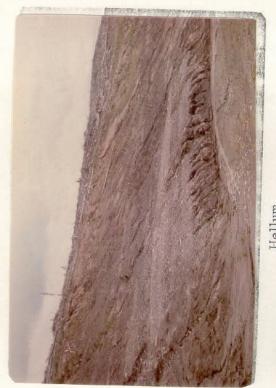
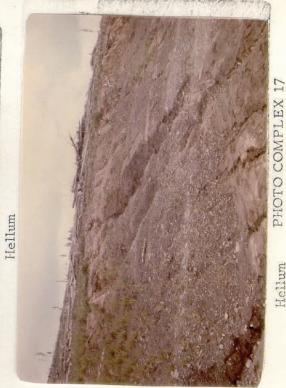
Photo #23. "... It can be seen very clearly that this erosion is not caused by the road but is caused by water which could not be retained on that clearcut hillside and thus float towards the road causing excessive erosion"...

In photos 23, 27, 28, and 29 (Section 6, Township 55, Range 2, W6) the bare and sloping mineral soil surface is simply the cutback slope for the New Grande Cache Highway and not due to erosion as a result of carification (Photo Complex 17).

Photo 23 shows an erosion gash which was formed as a result of the road bed lowering the flow-grade for an already intermittent creek, seen as a slight draw behind the scar. There is little or no surface flow as a result of scarification and the erosion seen in Photo 23 would probably have only been somewhat smaller had the trees not been removed and the area not scarified.

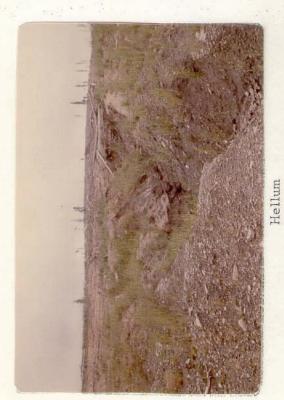
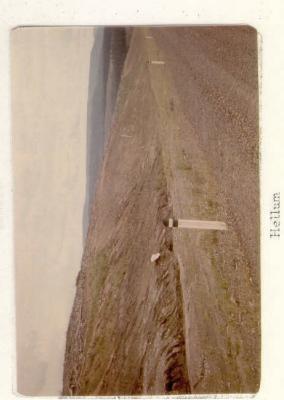
Photo #24. "...as a matter of fact this very same wash which again is not caused by the road but is caused by the clear-cut on the left side".

The erosion in photos 24 and 26 are again the result of the new Luscar road having changed the angle of flow in a small stream. This erosion is probably again accentuated by the logging but should not be blamed entirely on this operation. Photo 25 is a picture of a gravel pit created during road construction of the Luscar road in 1970 (Sec. 7, Twp. 49, Rgc. 24, W5). There is no sign of logging in this picture. (see Fhoto Complex 18).

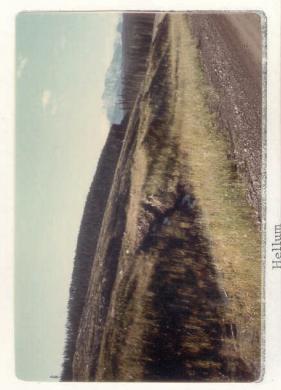
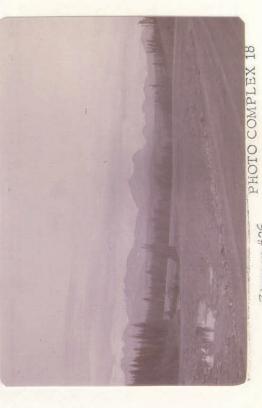
Zimmer #26

Photo #26. "... Here is another detail of this very same wash-out in the Berrys creek area as it rises in the culvert underneath the road".

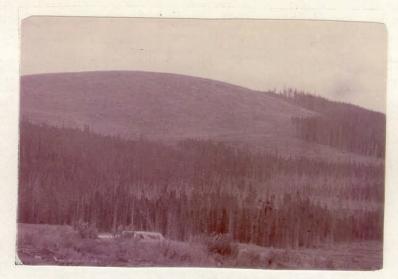
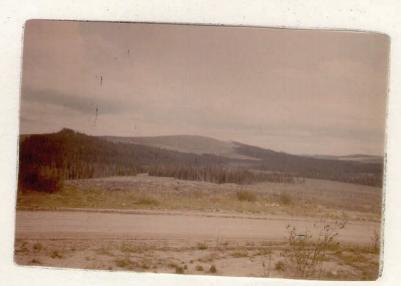
Zimmer #13

Photo #13. "...but there is quite some erosion going on on the very top of that hill"...

This area was logged in the spring of 1971 only a few months before Mr. Zimmer visited the area. The fresh slash and recent scarification might appear as crosson from the distance of two miles or more,
but one can hardly make careful assessment from such a distance (Photo
Compley 20)?

This photo 13 is in the same area as that of photo 12 where there were 646 seedlings per acre. It is too soon to tell whether or not the far hill will regenerate properly, but the charge of "quite some erosion" is unlikely in view of what has been found to be the case everywhere else where Mr. Zimmer photographed scarification and regeneration.

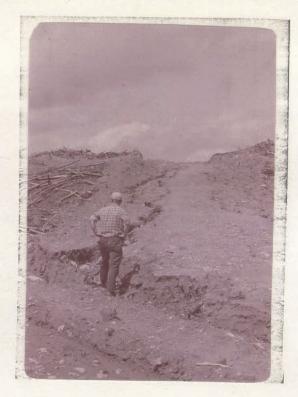
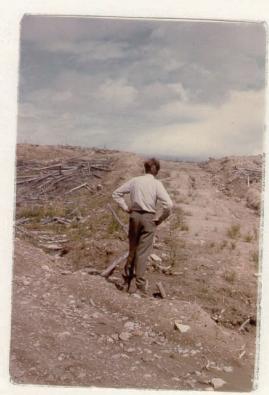
Zimmer #19

Photo #19. "... Just one more proof that these kinds of conditions exist all over the area".

This photo was taken along the same "Loffland Rig Read" as referred to for photos 38 and 39 (see page 39 of text). This road was put in for the 1970 logging of this area which was subsequently scarified in 1971, just before Mr. Zimmer visited the area. Access roads of this nature should be blamed on forestry operations and should have been removed after operations ceased in this area (Photo Complex 21).

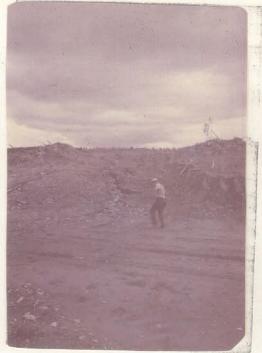
Zimmer #18

Photos 17, 18, and 21 were all taken at the junction of a logging road (eroding) and a fire road established in 1961. The junction is located in Section 1, Township 50, Range 23, W5. The adjacent land was logged in 1969 by N.W.P.&P. and scarified in 1970 and this access road should again have been treated. However, even if Mr. Zimmer's comments are warranted here it is doubtful whether or not the silt which is eroded does find its way into the nearby creek because this creek is at least 150 feet away from this road junction and the vegetation which covers the ground between the creek and this erosion impedes water flow considerably, (See Photo Complex 22), should water and silt flow across the road during heavy rains.

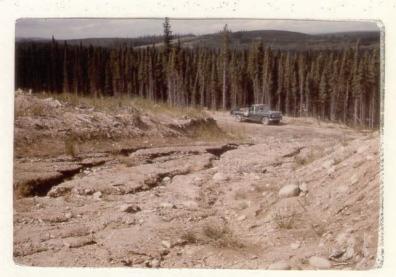
Zimmer #17

Photo #17. "...We are getting now a few more pictures here from what former logging access roads look like. This is what the company leaves them in when they are finished with harvesting;..." and "This eroded soil in this case is getting into the water-ways which is just on the other side of the car"...

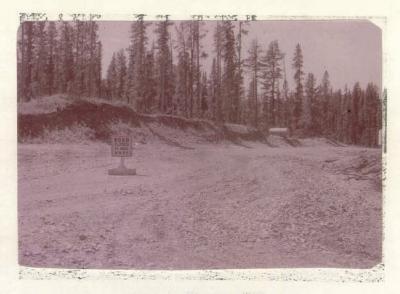
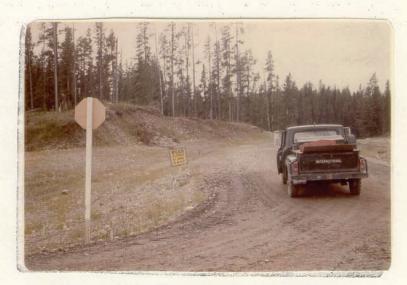
Zimmer #20

Photo #20. "...We were always informed or people in Alberta had been informed by the former government, I should say, that the company has only the right to place these signs if there is work going on in the area, or if the road is wet and muddy, and neither one had seemed to have been the case on this nice Sunday afternoon when the road was absolutely dry"...

Photo Complex 23 shows Mr. Zimmer's black and white photo and a color photo taken a year later. The sign was by this time lying face down, on the side of the road, but it was raised to show that it was still in the approximate location in Mr. Zimmer's photo.

N.W.P.&P. officials told the Silviculture Section of the Department of Lands and Forests that the sign was placed on the road in July of 1971, when Mr. Zimmer visited the site, because vamdals had caused considerable damage to machinery left unattended in the area. The validity of this statement can not be determined but it is a well-known fact that the public is prone to damage forestry equipment left unattended in the field.
